## Seagrass Integrated Mapping and Monitoring Program

## Mapping and Monitoring Report No. 1

Florida Fish and Wildlife Conservation Commission  
FWRI Technical Report TR-17

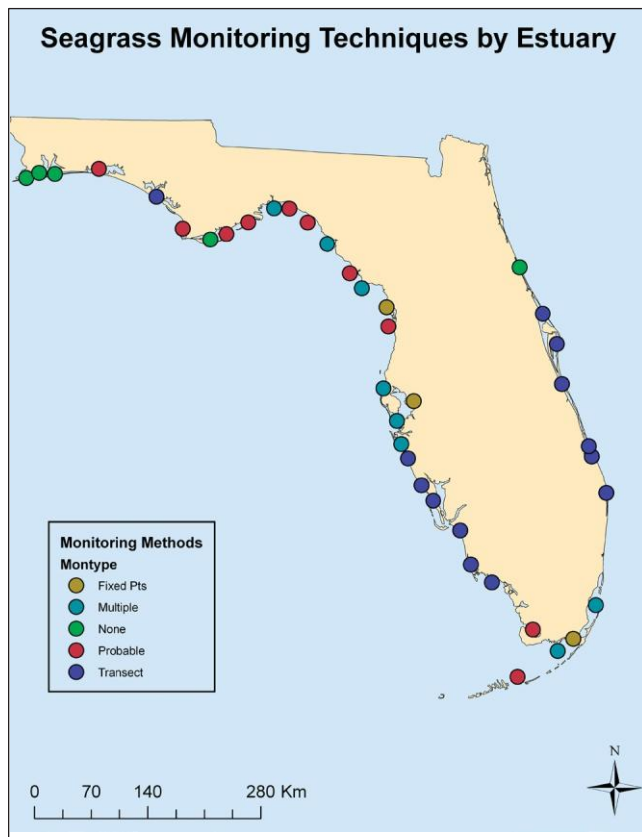
Figure ES-2 Seagrass monitoring methods.

Sampling methods are basically variations of two types: transect and point (Figure ES-2). FDEP Coastal and Marine Assessment (CAMA) programs and programs administered by the Southwest Florida Water Management District (SWFWMD), SJRWMD, and SFWMD use established transects that evaluate the presence or absence of seagrass and the extent of cover
