The Nature
Conservancy

Pensacola East Bay Oyster Reef Restoration Project Phase 2 Update

Presented by Laura Geselbracht
Senior Marine Scientist & Project Manager
Florida Chapter
lgeselbracht@tnc.org

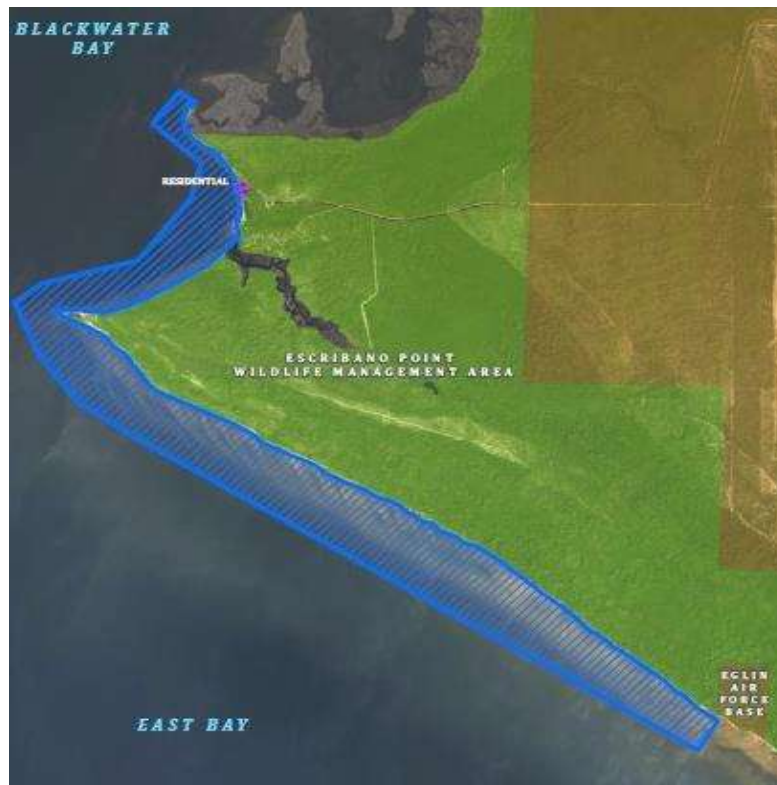
Project Description

- Sited along NE coast of East Bay and SE coast of Blackwater Bay.
- 33 reefs spaced along ≈ 6.6 km of the shore
- Total reef area ≈ 6 ha
- Reef shapes are half moons pointing towards shore with fingers extending from the reef. Some of the smaller reefs are S-shaped.
- Average depth from -1.3 m to 0.8 m msl.
- Reef are offshore approx. 50 – 150 meters.
- Reefs extend above water at low tide.

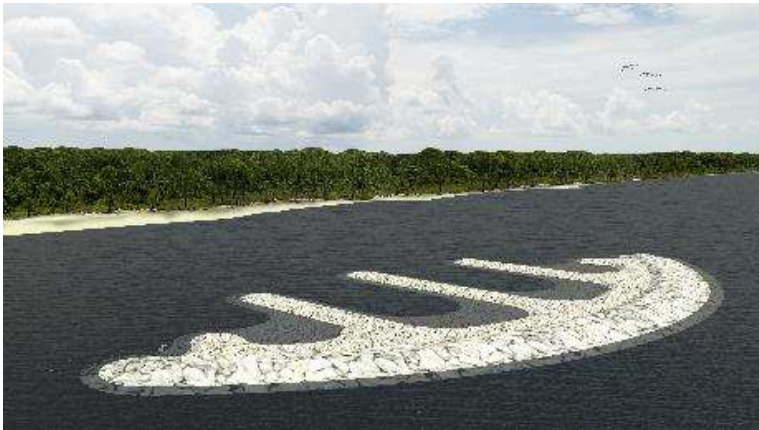
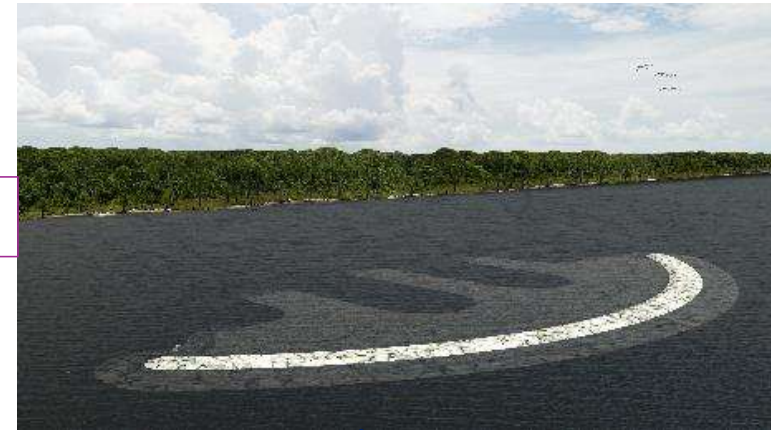
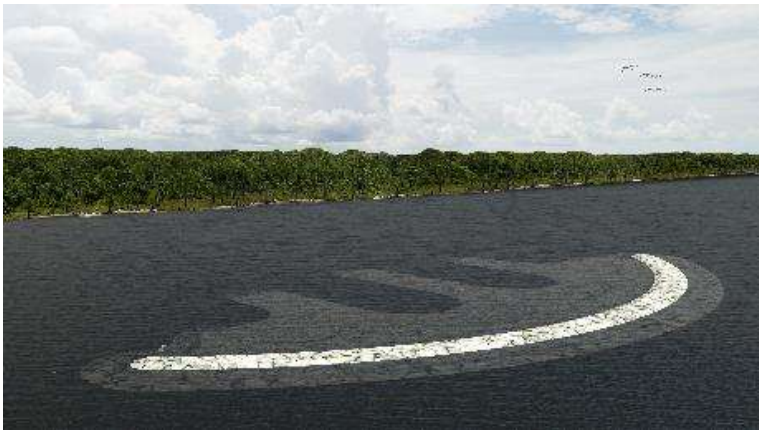
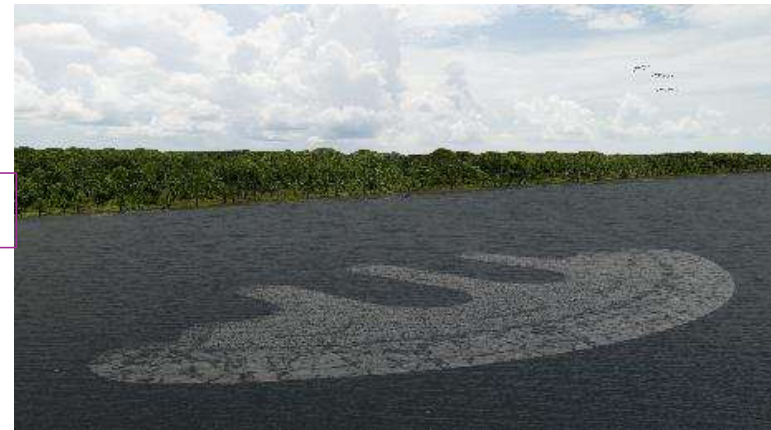
Renderings at Average Low/High Tides

January

Average Low Tides

June

Average High Tides

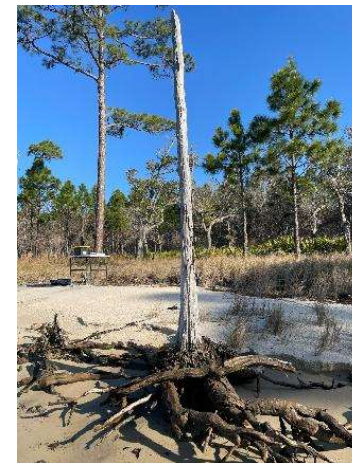
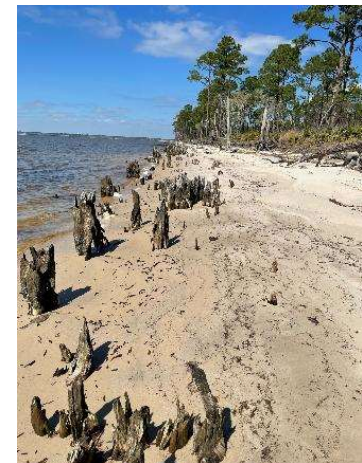
The Reefs are not stabilizing the shorelines, but help is needed.

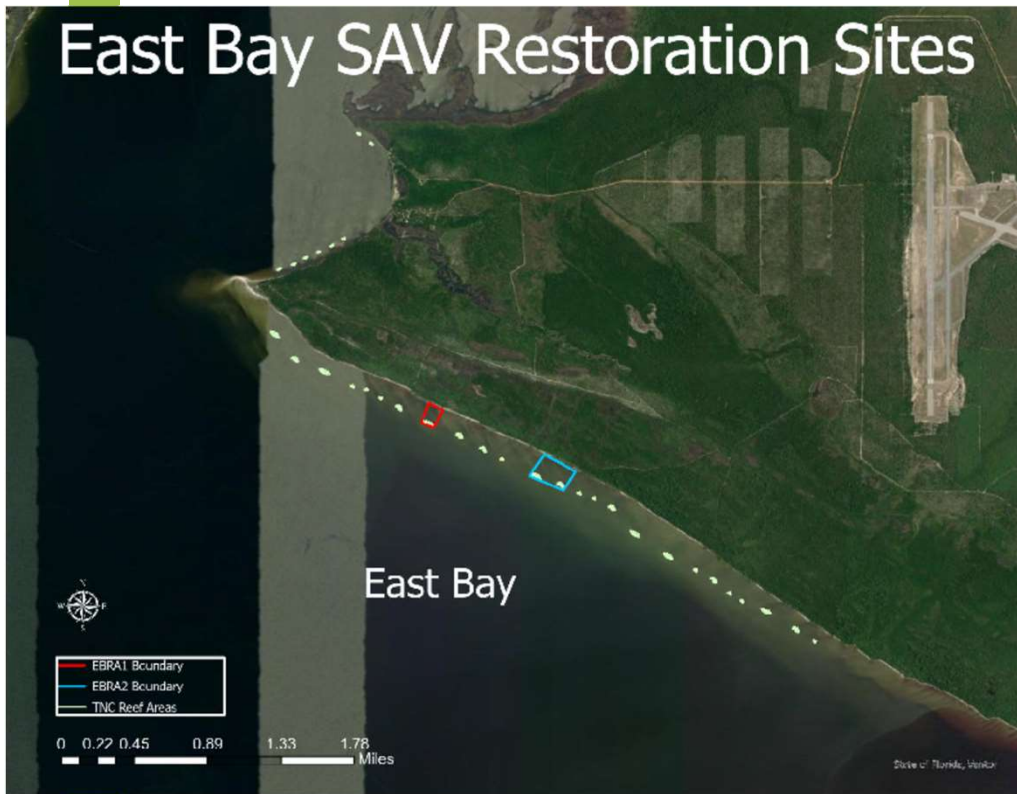
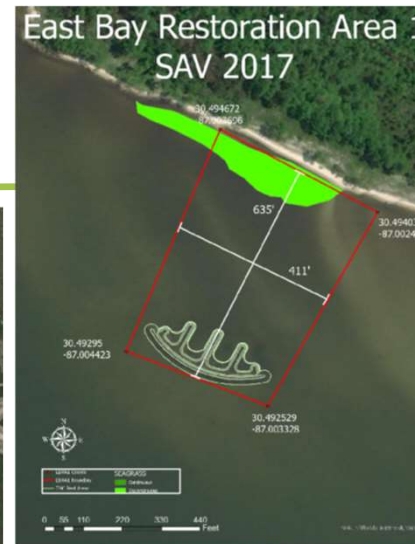
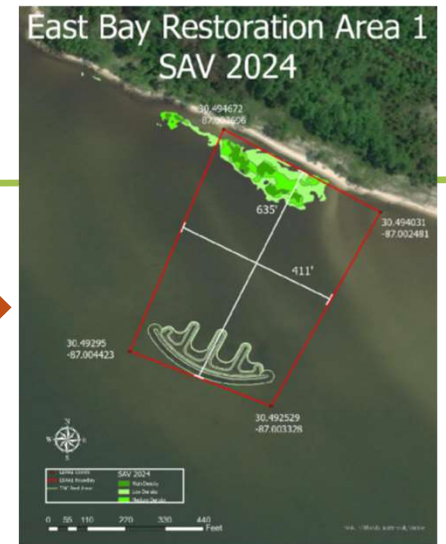
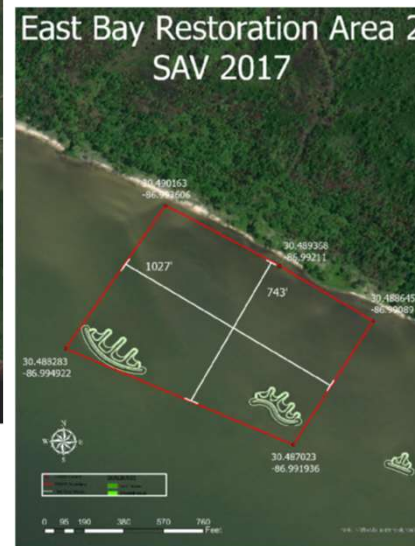
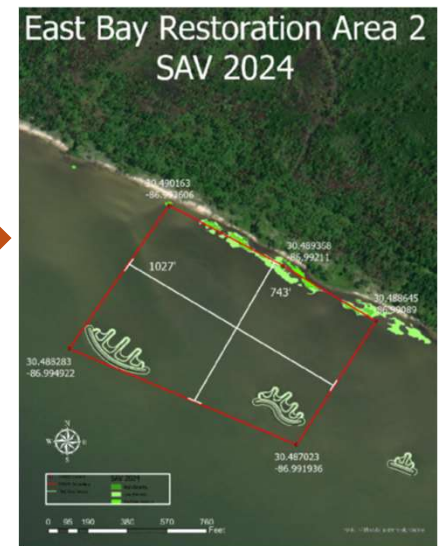
SAV Expansion Near PEB Reefs 2017 to 2024

We can't say if the reefs were the reason or one of the reasons. More analysis is needed.

- Quadrats done near the reefs are absent of seagrass
- Aerial drone photography adjacent to the shoreline of two reefs show an increase of seagrass. **More on next slide**

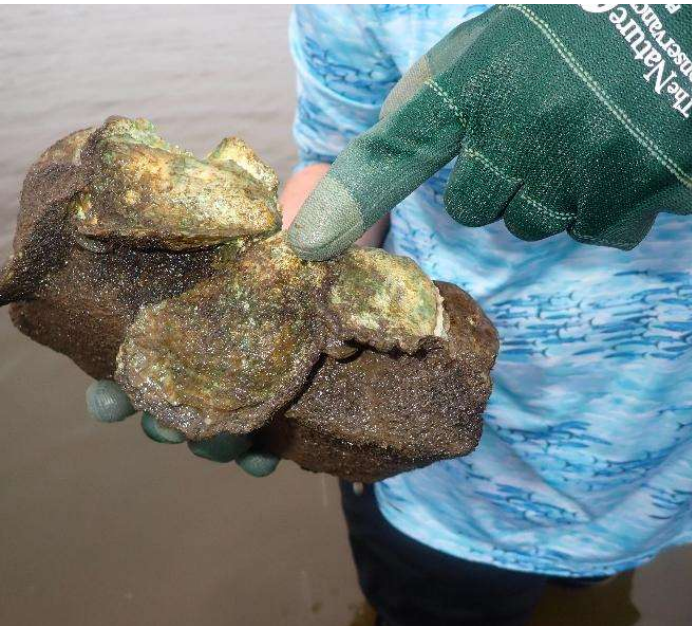
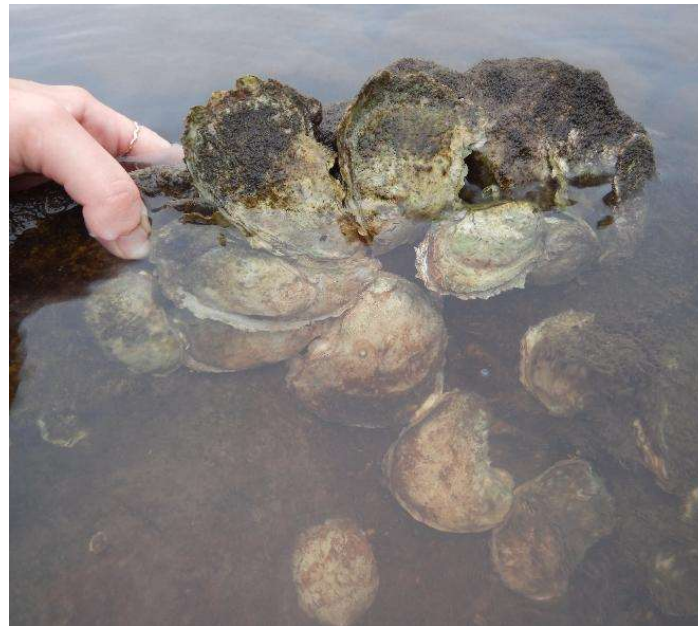
October 2023

Even more oysters growing on the reefs

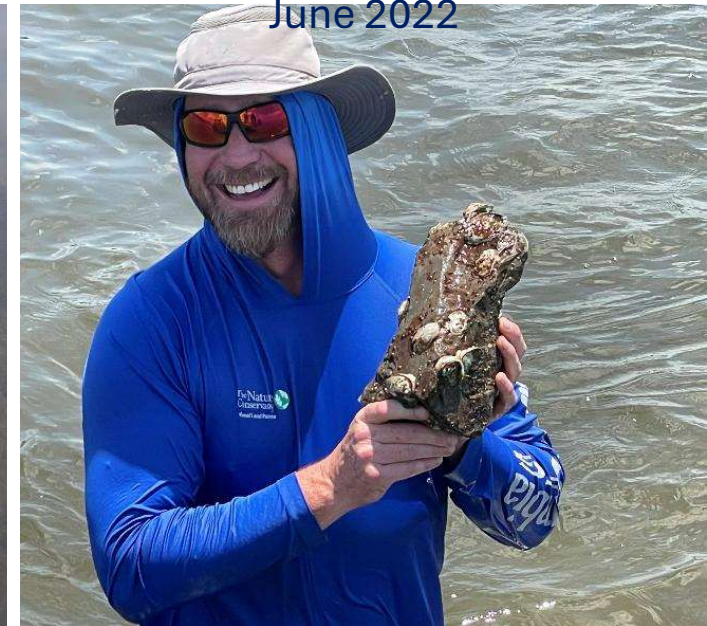
June 2022

1st oysters found growing on the reefs 10 months after construction!
