Update on the Lone Cabbage Reef Restoration Project in Suwannee Sound

Peter Frederick, Bill Pine, Leslie Sturmer, Steve Beck

University of Florida

Oyster Integrated Mapping and
Monitoring Program Workshop

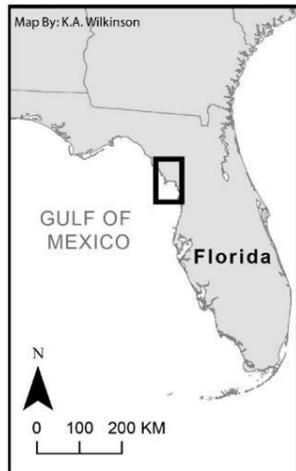
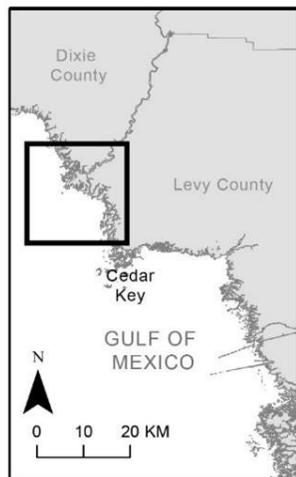
PROJECT AREA:

Degradation of Lone Cabbage Reef: 70% lost from 1982-2010

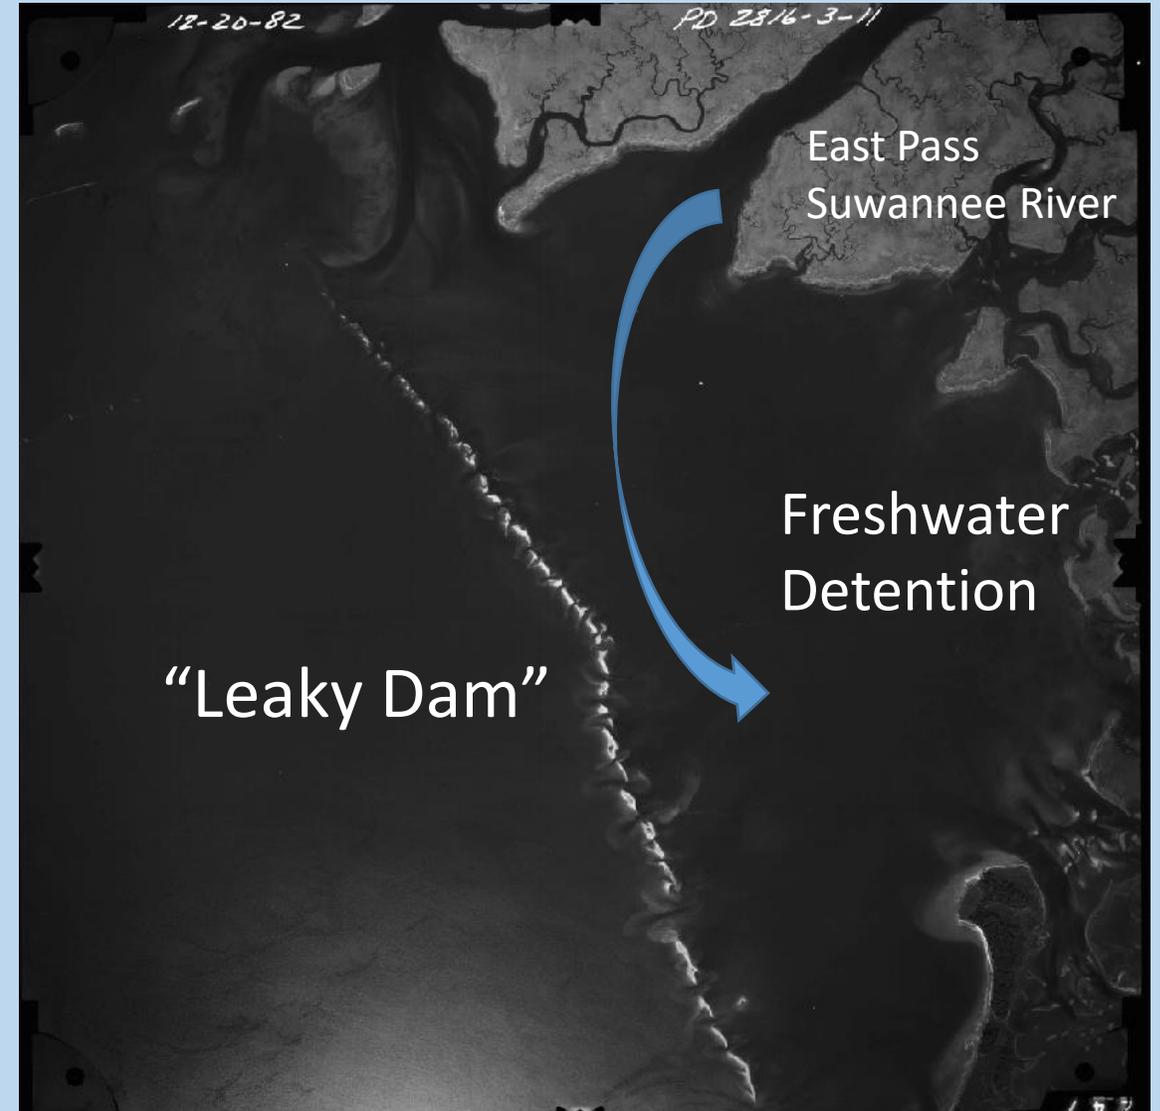
Kaplan, D.A., M. Olabarrieta, P. Frederick, A. Valle-Levinson. 2016. Freshwater detention by oyster reefs: Quantifying a keystone ecosystem service. PLOS One.

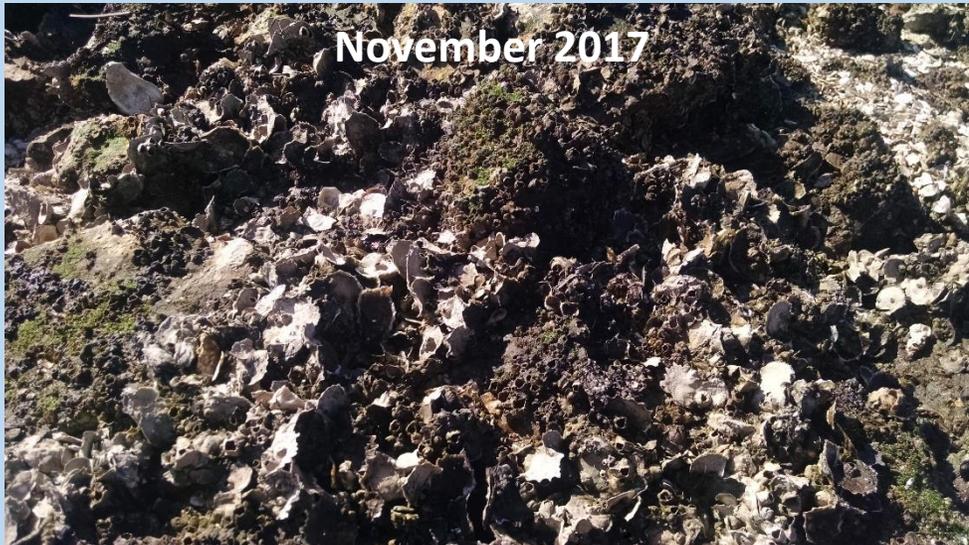
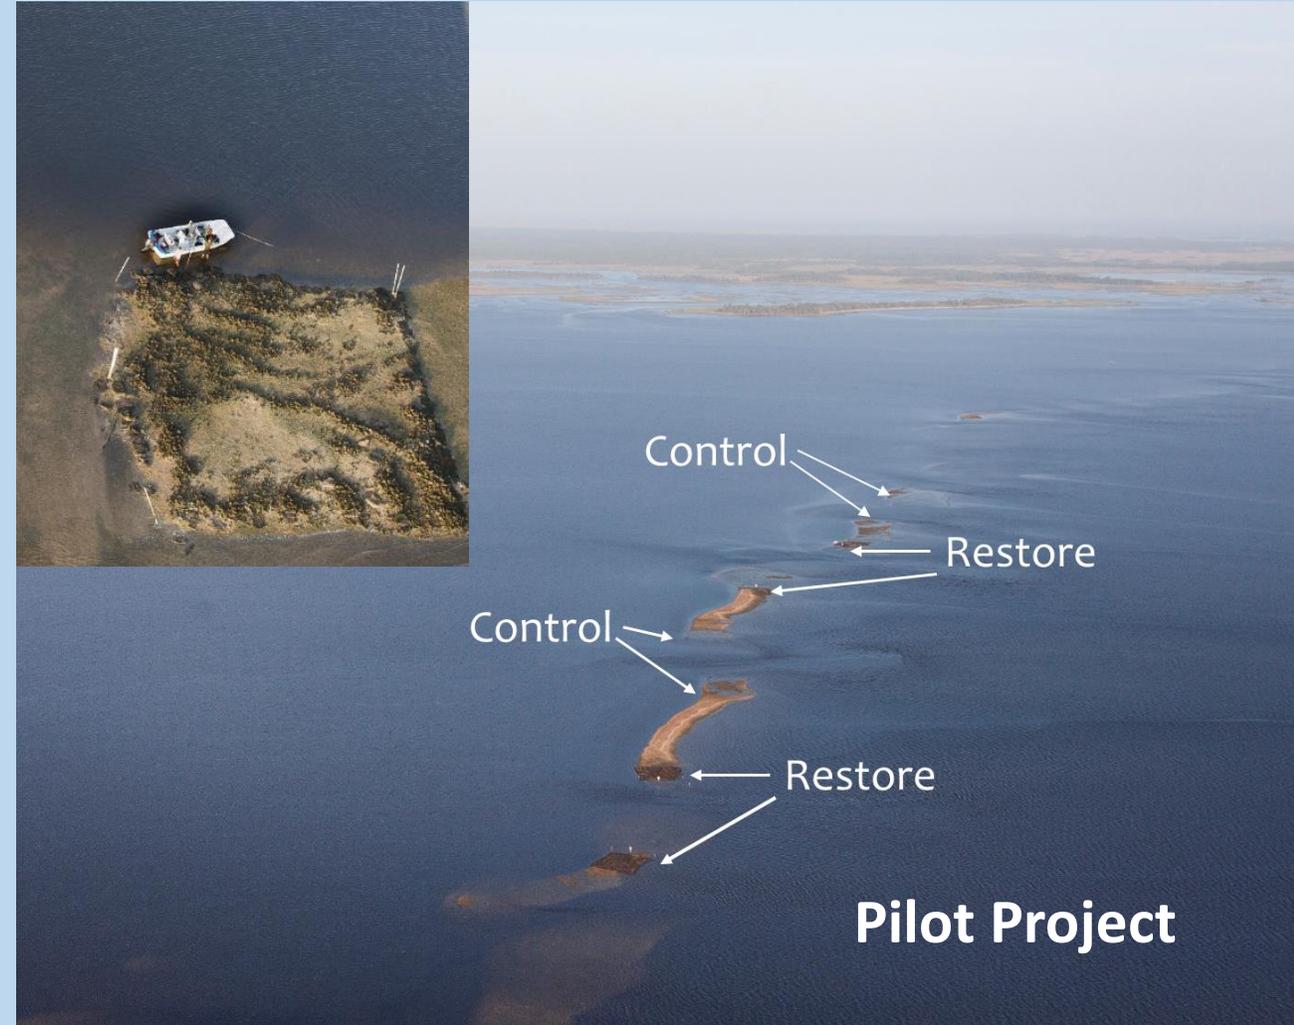
Lone Cabbage Reef Substrate Limited

- **Pilot Project success**
 - **After 18 months:**
 - **9.2x increase in oyster density**

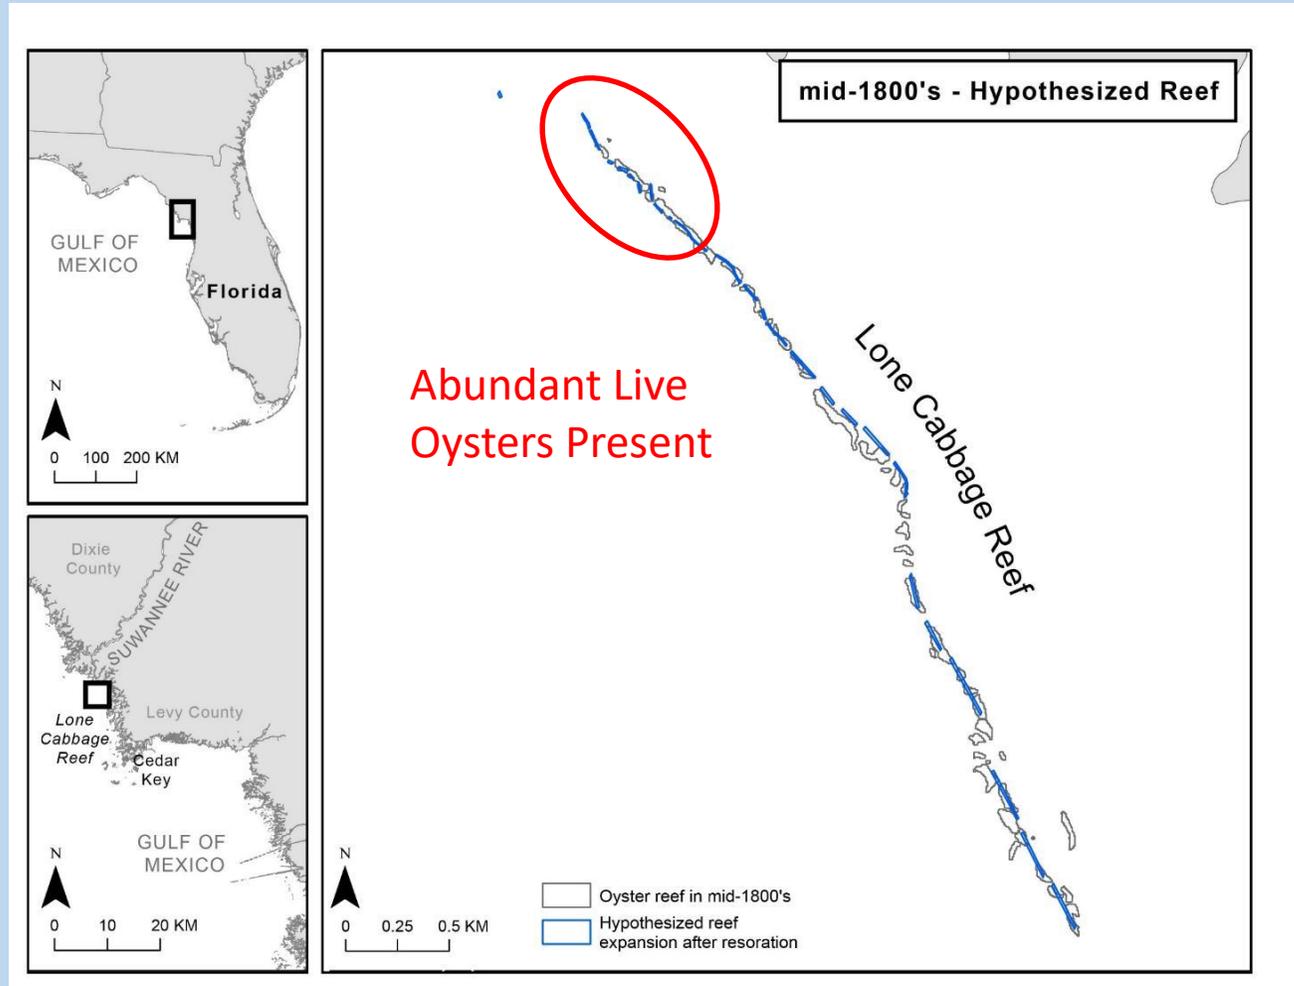
Lone Cabbage Reef Restoration Project

- Long, linear reef needed for best chance of hydrologic effect
- Restore reef to mid 1800's extent and elevation
- 22 reef elements
- Large local Ocala limerock
- Topped with clam/oyster shell
- Construction cost: \$3.6 M

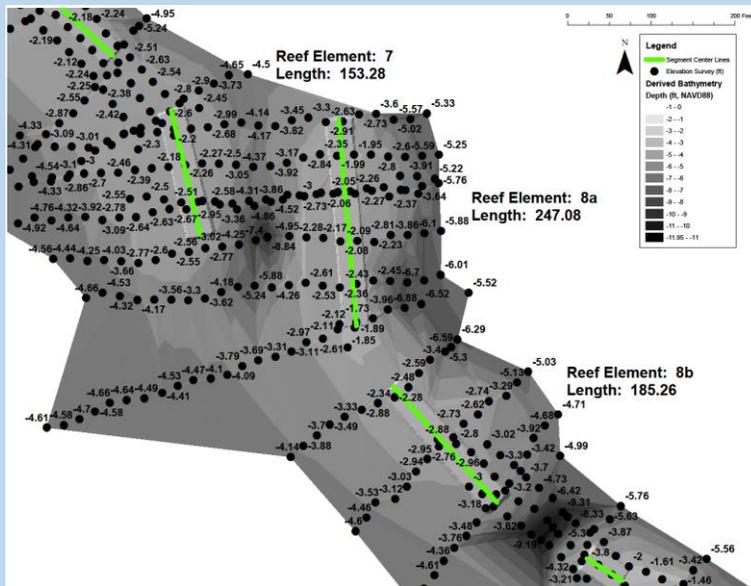
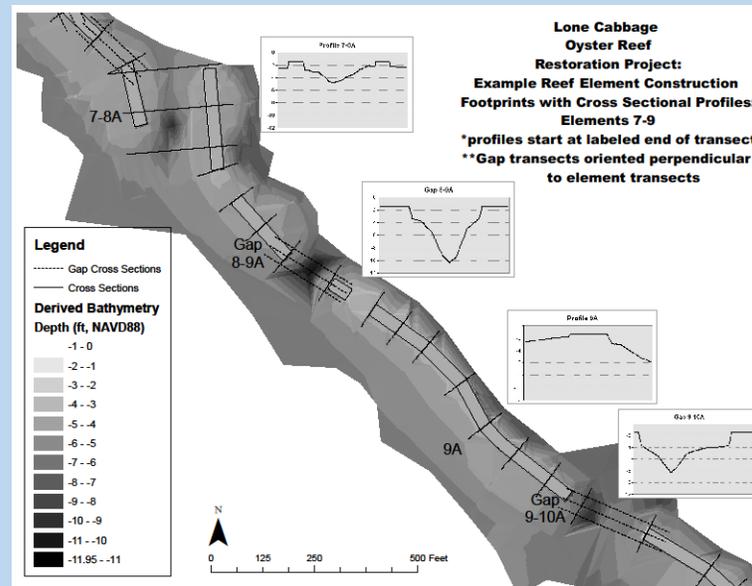
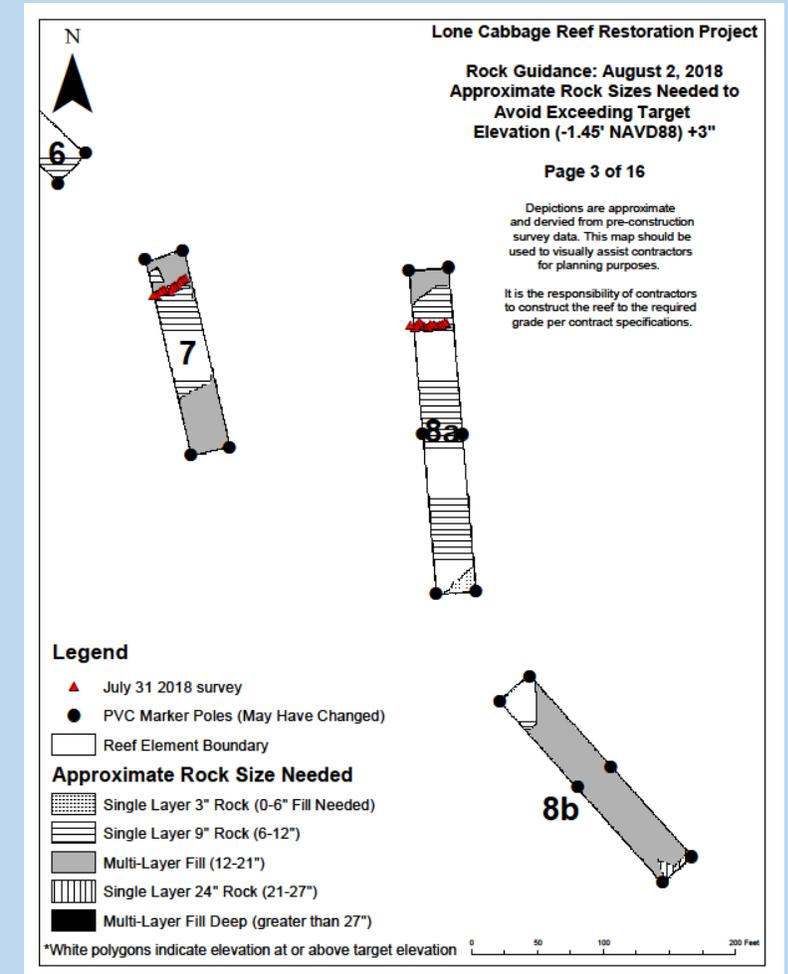
Construction Guidance:

- Derived from precon bathy survey:
 - Volume rock per element
 - Rock size/amounts within each element

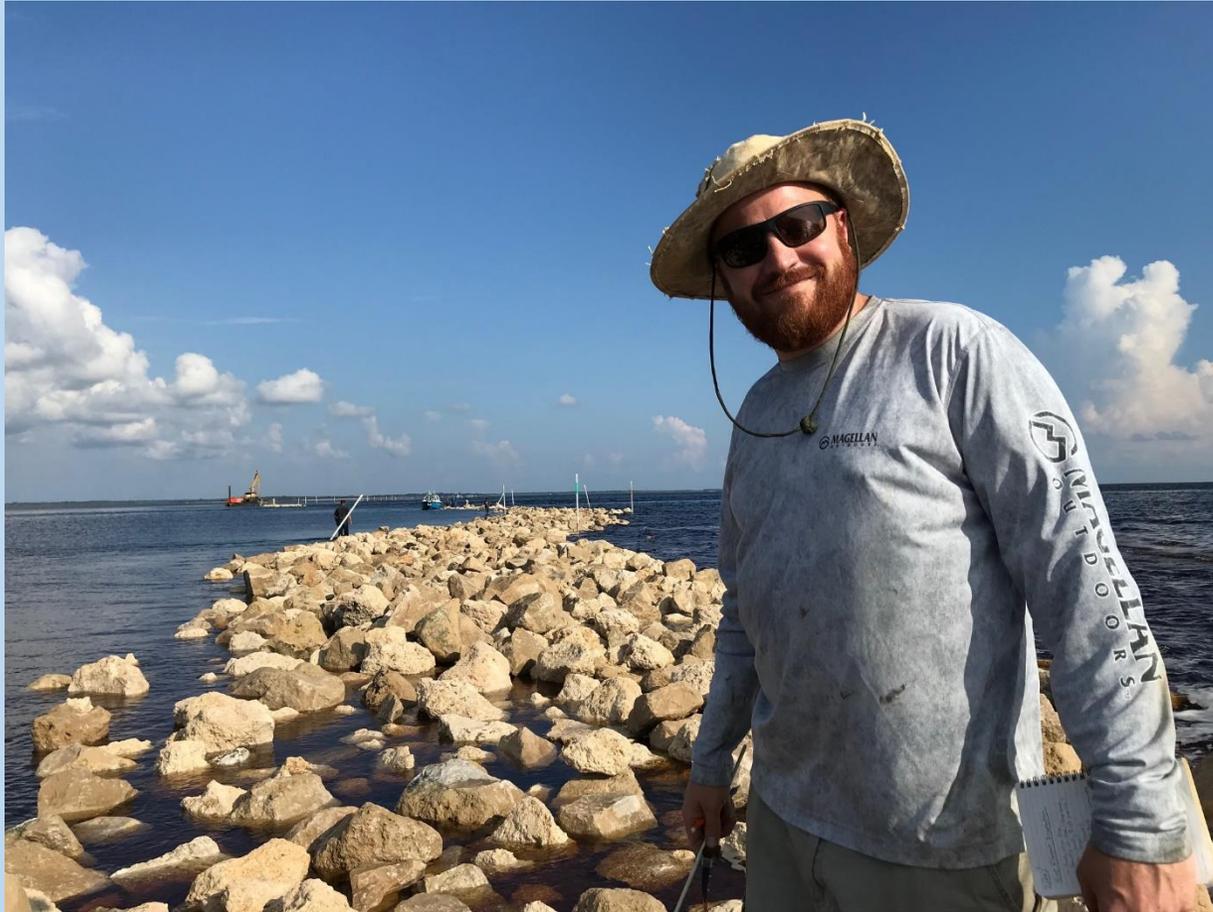
Construction Completed: July-October 2018

- Elevation surveys and shell addition conducted as elements completed

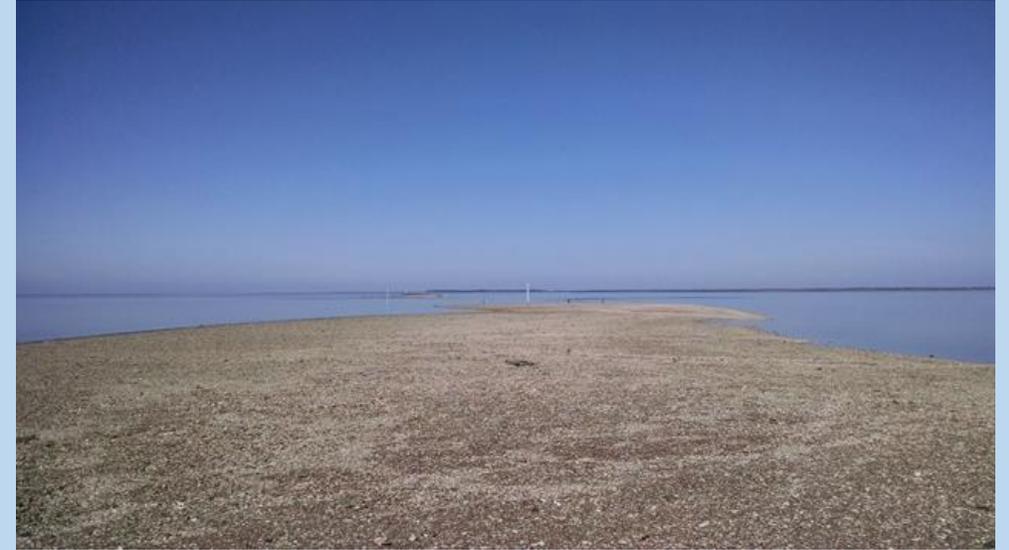
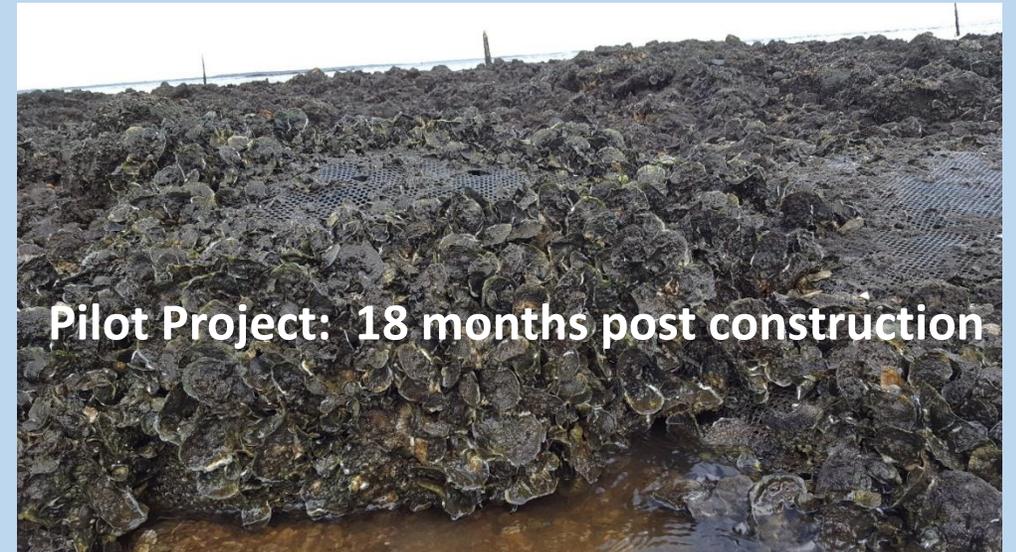
Water Quality Monitoring

- Did reef construction affect salinity regime?
- Continuous Salinity Recorders:
 - Nine sensors deployed August 2017
 - Hourly: Salinity, Temperature, Depth
- Water Chemistry (UF funded):
 - Monthly: chlorophyll, N, P, color, turbidity
- Effects of River Discharge on Salinity/FW Detention Effect:

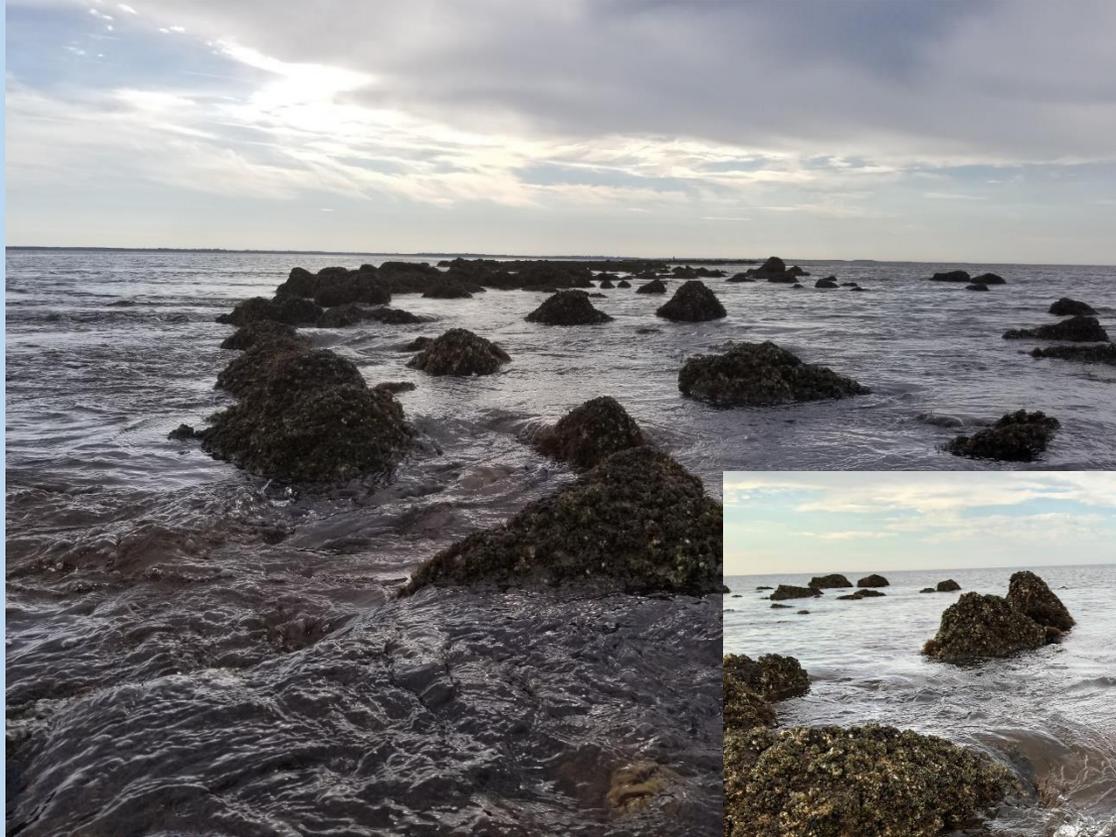
- **Falling Tide**

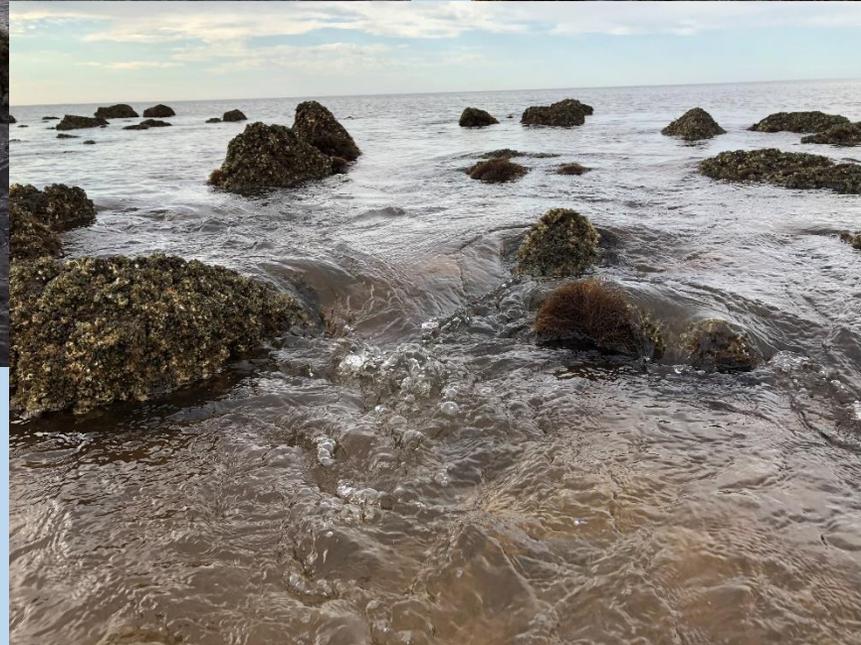
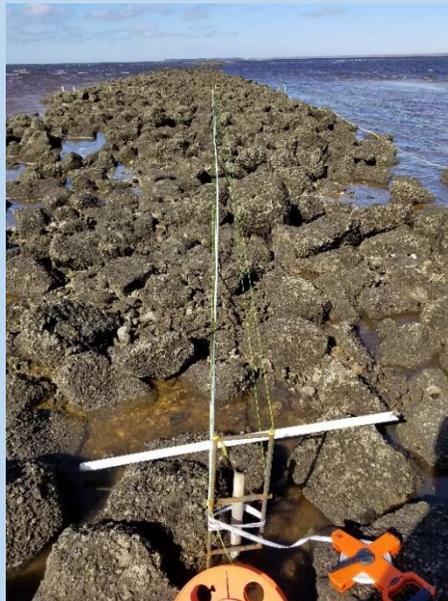
Oyster Monitoring: Design

- **Gear: Intertidal Belt Transects**
 - 0.15m (6") wide
 - Power analysis: total transect length needed
 - Total length proportional to strata reef area
 - **Wild reef digitization**
 - Labins 2013 imagery
 - Random selection: 2x2m N-S, E-W grid
 - **Reef elements:**
 - Parallel to reef
 - Random selection: 20m lengths/2m widths

- **Rock Size Strata:**
 - Large rocks (>24")
 - Small rocks (<24")
 - No Rocks (wild reef)

- **Harvest Strata:**
 - Harvestable
 - Harvest Prohibited

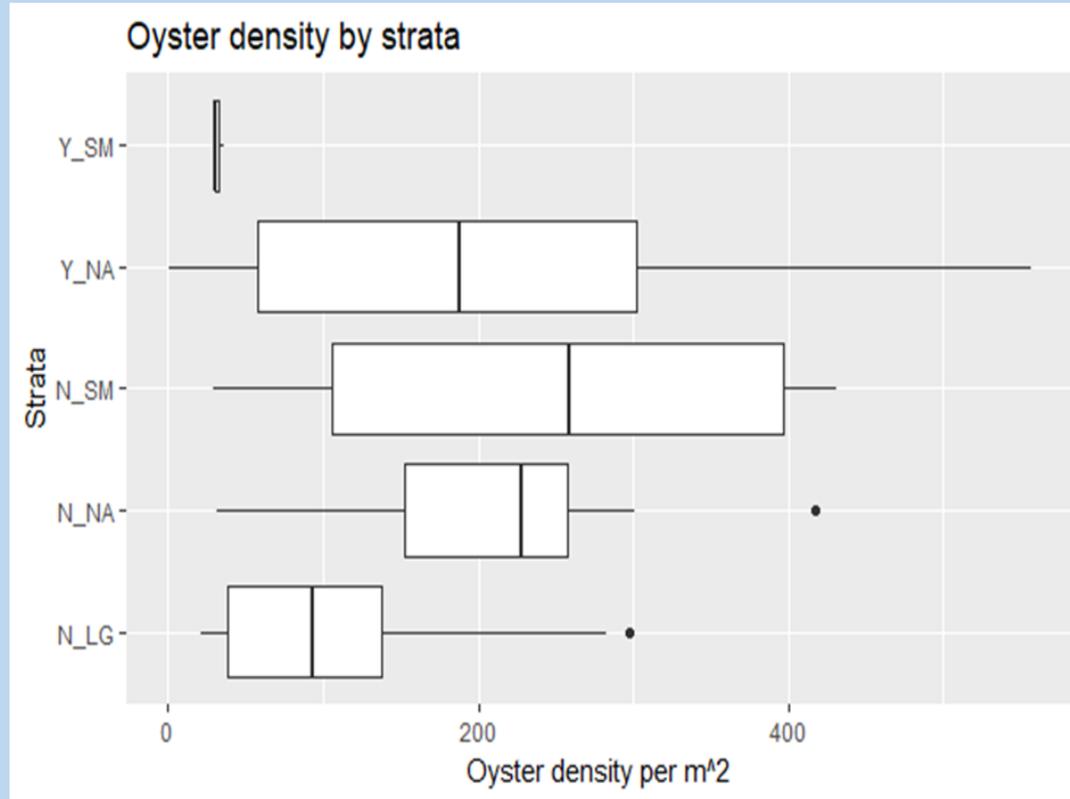
Oyster Monitoring: Results

Harvest
Small Rock

Harvest
Wild Reef

No Harvest
Small Rock

No Harvest
Wild Reef

No Harvest
Large Rock

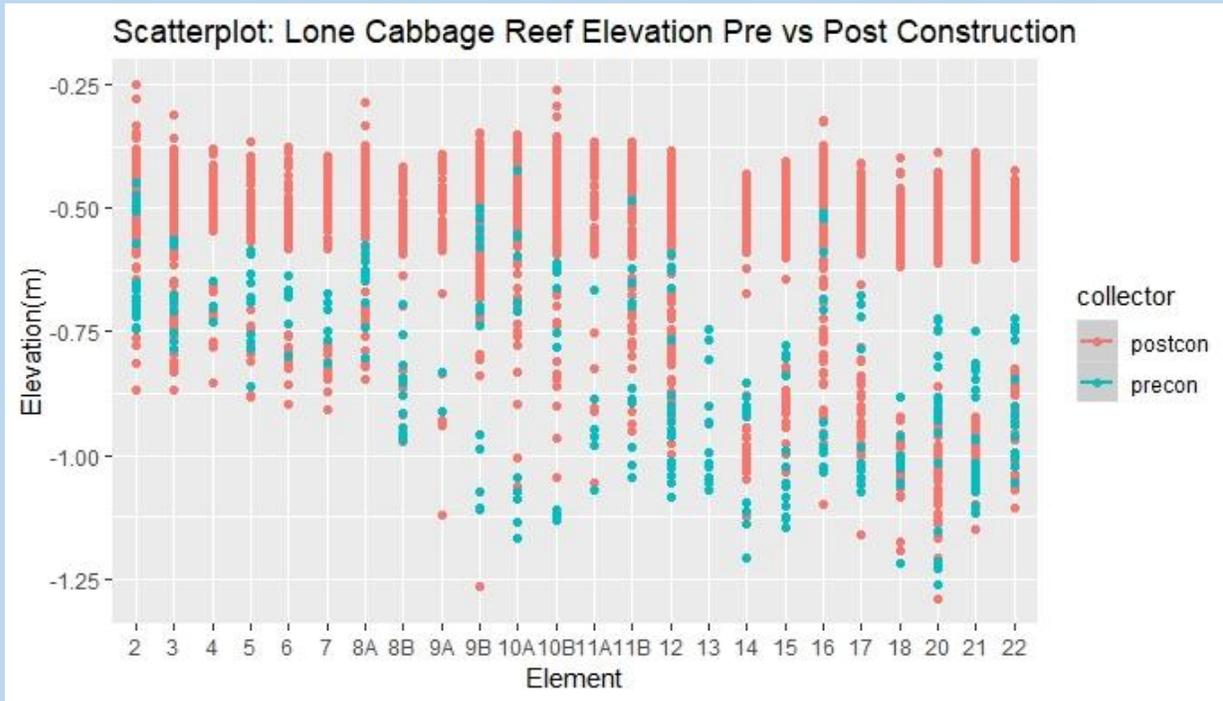
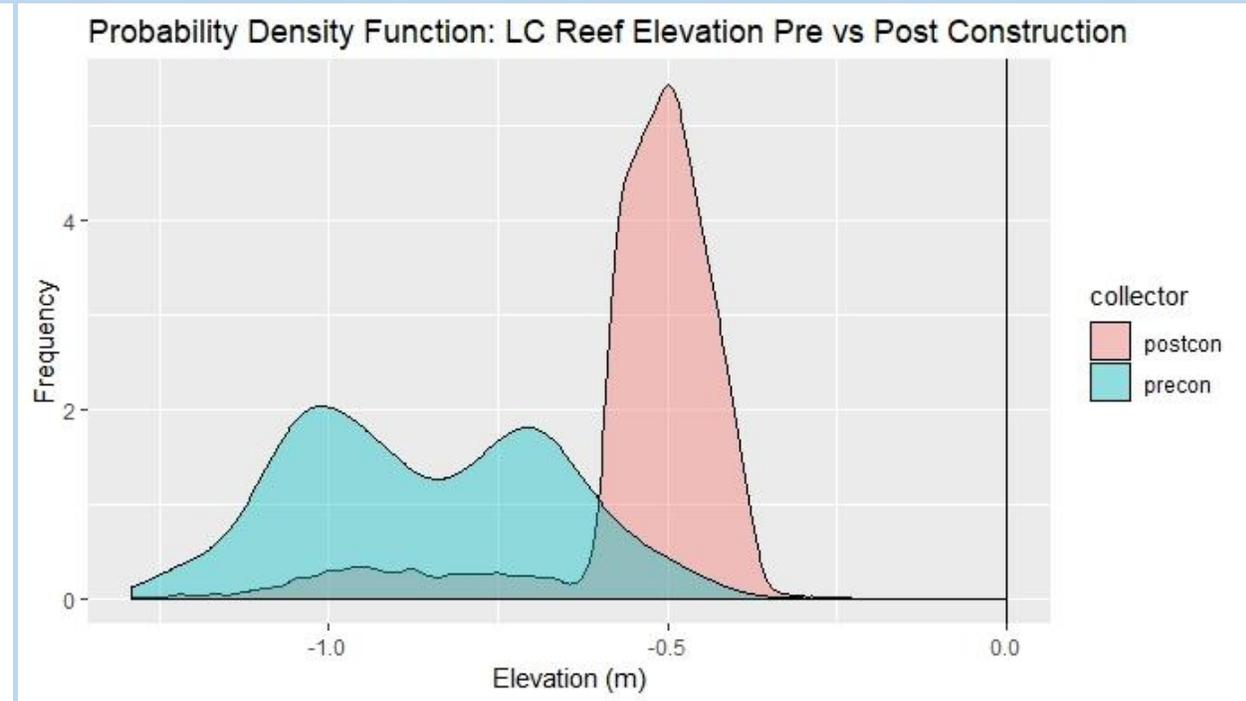
Monitoring Efforts: Elevation

- Project Target Elevation: -0.44 m (-1.45 ft) NAVD88
- Contracted RTK Survey (As-Built Report)

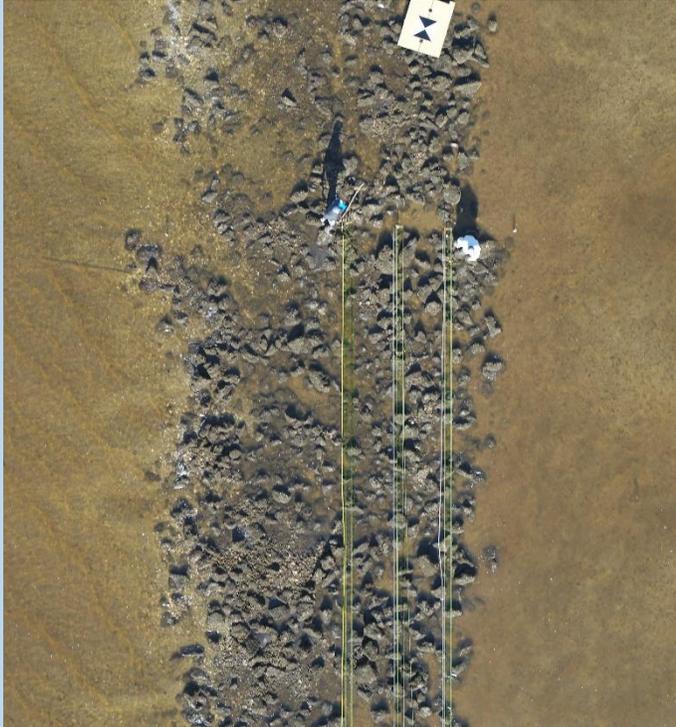
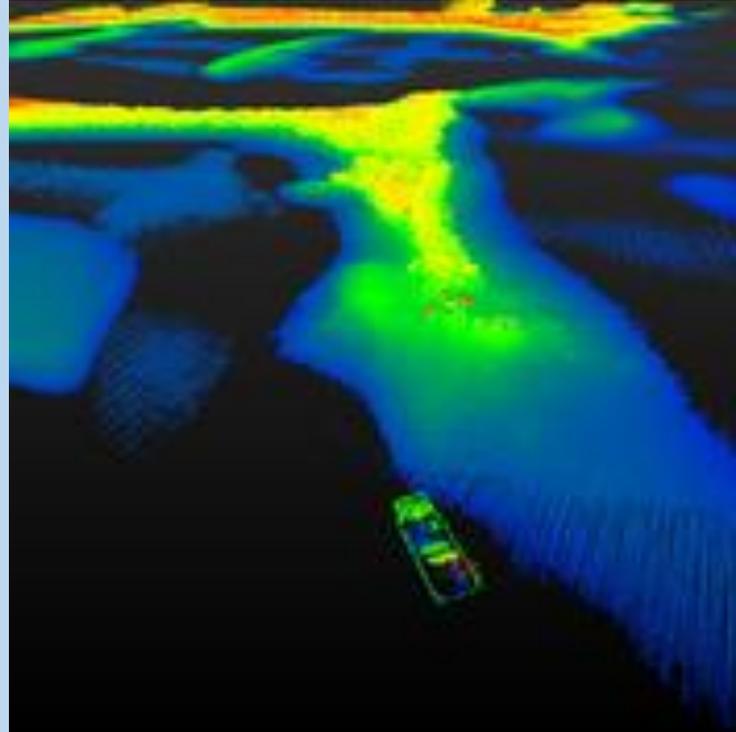
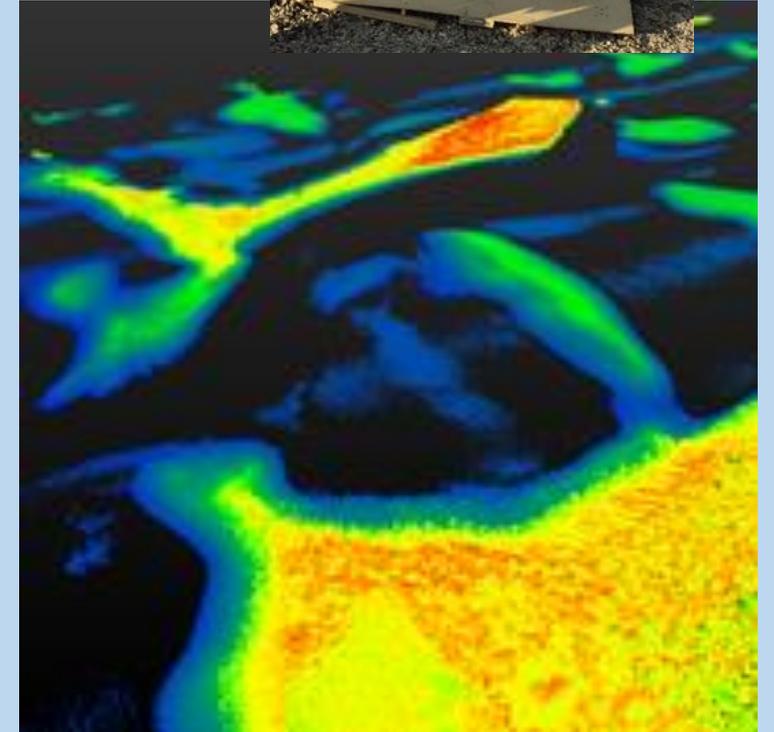
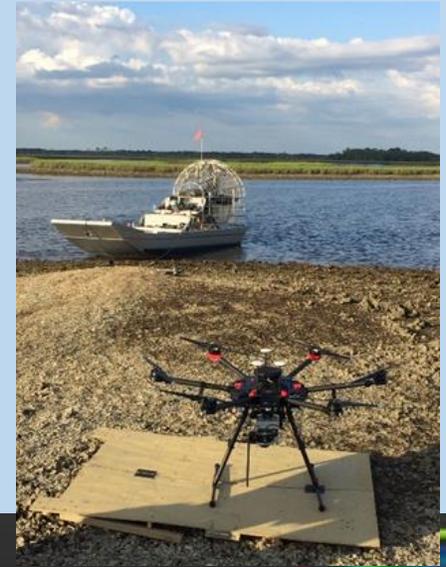
Monitoring Efforts: Elevation

- Drone Surveys: RGB and Lidar Photogrammetry
- Characterize rugosity
- Oyster density/elevation relationships
- Chose not to proceed with sonar survey
