# Final Report--Apalachicola Bay Subtidal Oyster Reef Mapping

Florida Fish and Wildlife Conservation Commission (FWC) Contract #19286  
University of New Hampshire Fund #14G312

Ray Grizzle and Krystin Ward  
University of New Hampshire  
Durham, NH 03824

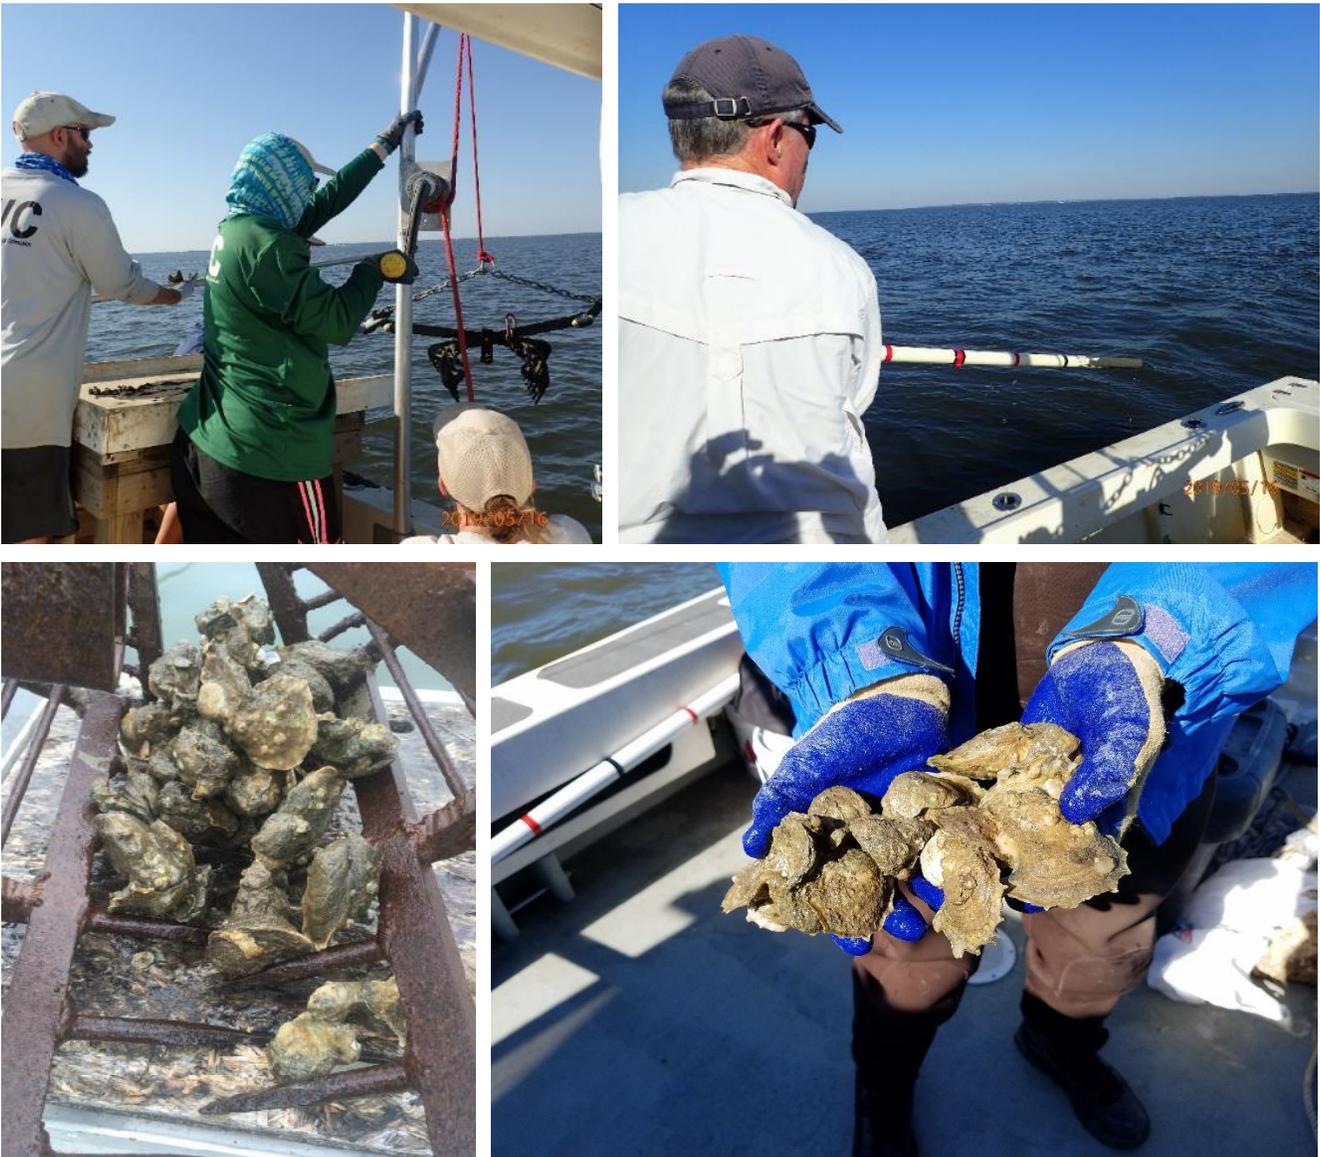
**Figure 5.** Top: Deploying patent tongs, and marked PVC pipe used to probe the bottom; note bottom penetration depth indicated by mud on the far end of the pipe. Bottom: Patent tong sample from Hotel Bar in southeastern Bay. Right: Handheld tong sample from restoration area in western Bay; note multiple size/age classes of live oysters and rock cultch.

Ground-truthing included probing the bottom with a PVC pipe and extractive sampling with handheld tongs, patent tongs, and a van Veen grab (**Figures 3 and 5**). As noted above, the PVC pipe was essentially the same method used by Swift (1897) who produced the first map of oyster reefs in Apalachicola Bay based with a wooden pole. In the present study, the surficial sediments at each site were classed as *predominantly*: mud, sand, shell hash, rock, or live oysters. The classification was determined mainly by probing. No samples were extracted for quantitative analysis of textural characteristics, but handheld or patent tong samples were taken at most sites where classification by probing was ambiguous or to confirm the presence of live oysters. At some sites, the pipe was pushed into the bottom as much as 1 meter or until firm bottom was reached and notes were made on vertical variations in sediment type. Bottom sampling data obtained by others during 2019-2021 involving diver observations and extractive sampling (FWC and Apalachicola National Estuarine Research Reserve [ANERR]) and handheld tongs (Florida State University [FSU]), were also used in map production. Regardless of method, all ground-truthing data were qualitative, except FSU tong data in the final maps were presented in a relative abundance metric determined by assigning the total number of oysters collected in 6 tong “licks” to one of five classes: 1 – 50, 51 – 100, 101 – 300, 301 – 500, and >500.

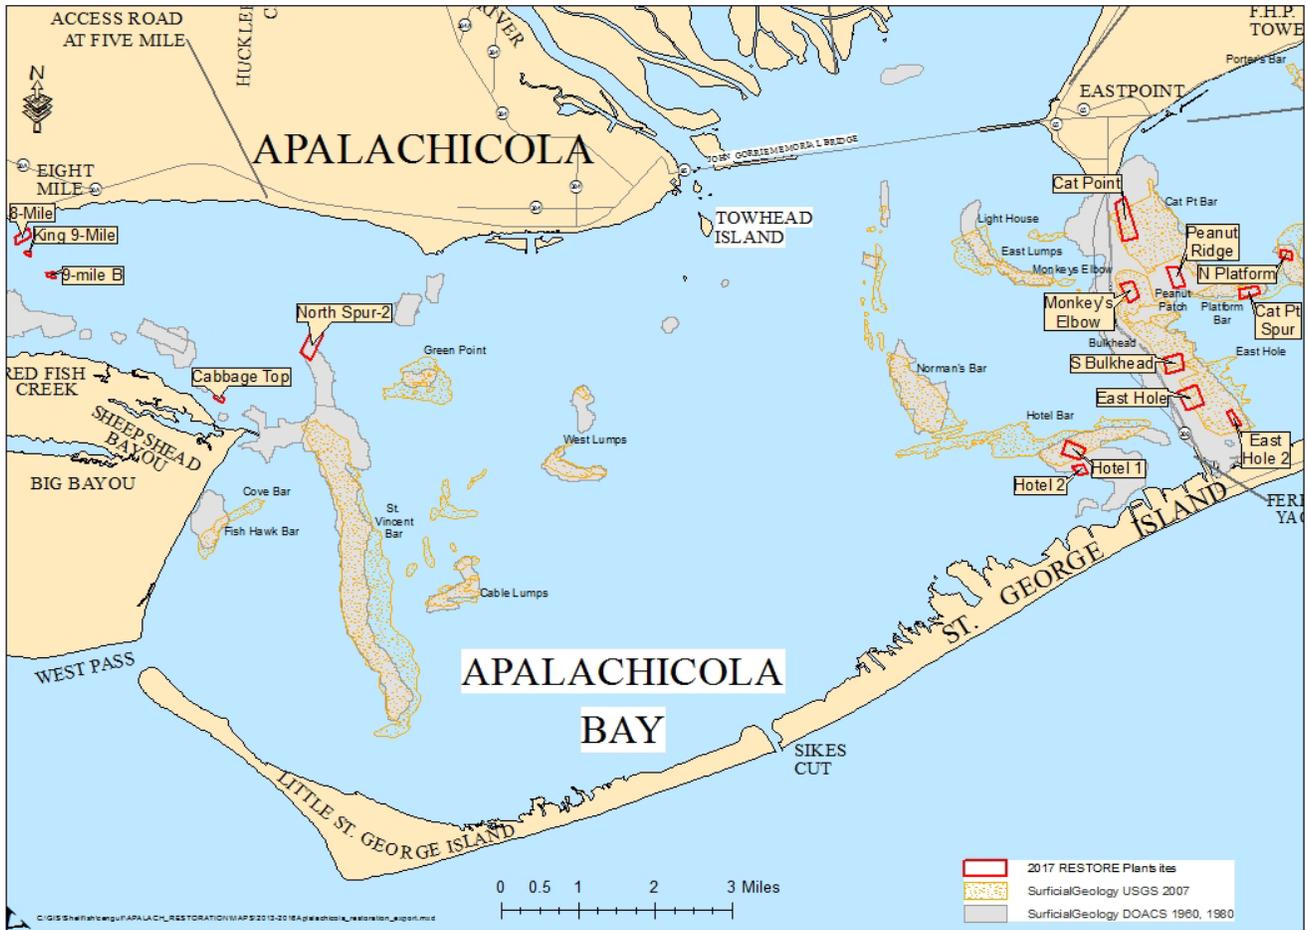
**Figure 11.** RESTORE 2017 restoration sites (from FDEP 2021).

The RESTORE (Oyster Reef Restoration Project) restoration sites were constructed in November 2017 on 14 degraded natural reefs using ~95,500 yd<sup>3</sup> of lime rock aggregate covering a total area of 317 acres (FDEP 2021). Most of the sites had been cultched previously using a variety of materials. RESTORE sites were Bay-wide but focused in eastern areas, particularly the Cat Point area (**Figure 11**). Annual sampling during 2018-2020 indicated much better reef development (i.e., increases in mean oyster size, density of adult oysters, and consistent annual spat sets) compared to the NRDA sites (FDEP 2021).
