Oyster Integrated Mapping and Monitoring Program

Suwannee Sound Oyster Reef Mapping 2019

Florida Fish and Wildlife Conservation Commission

Report Date: November 1st, 2019

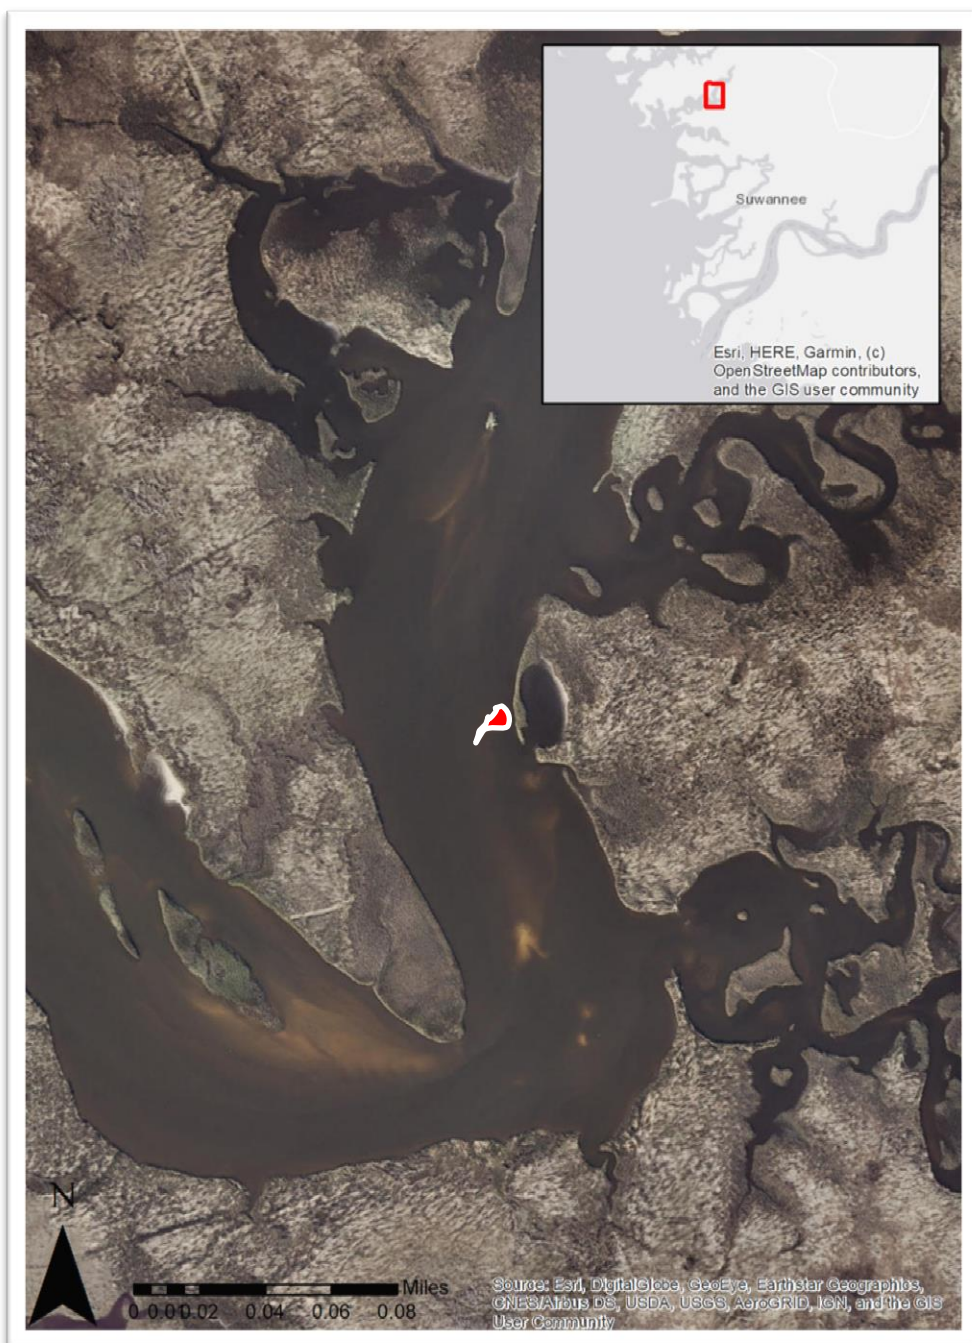
Figure 4. Single misidentified area (red) that did not contain oysters in 2019.

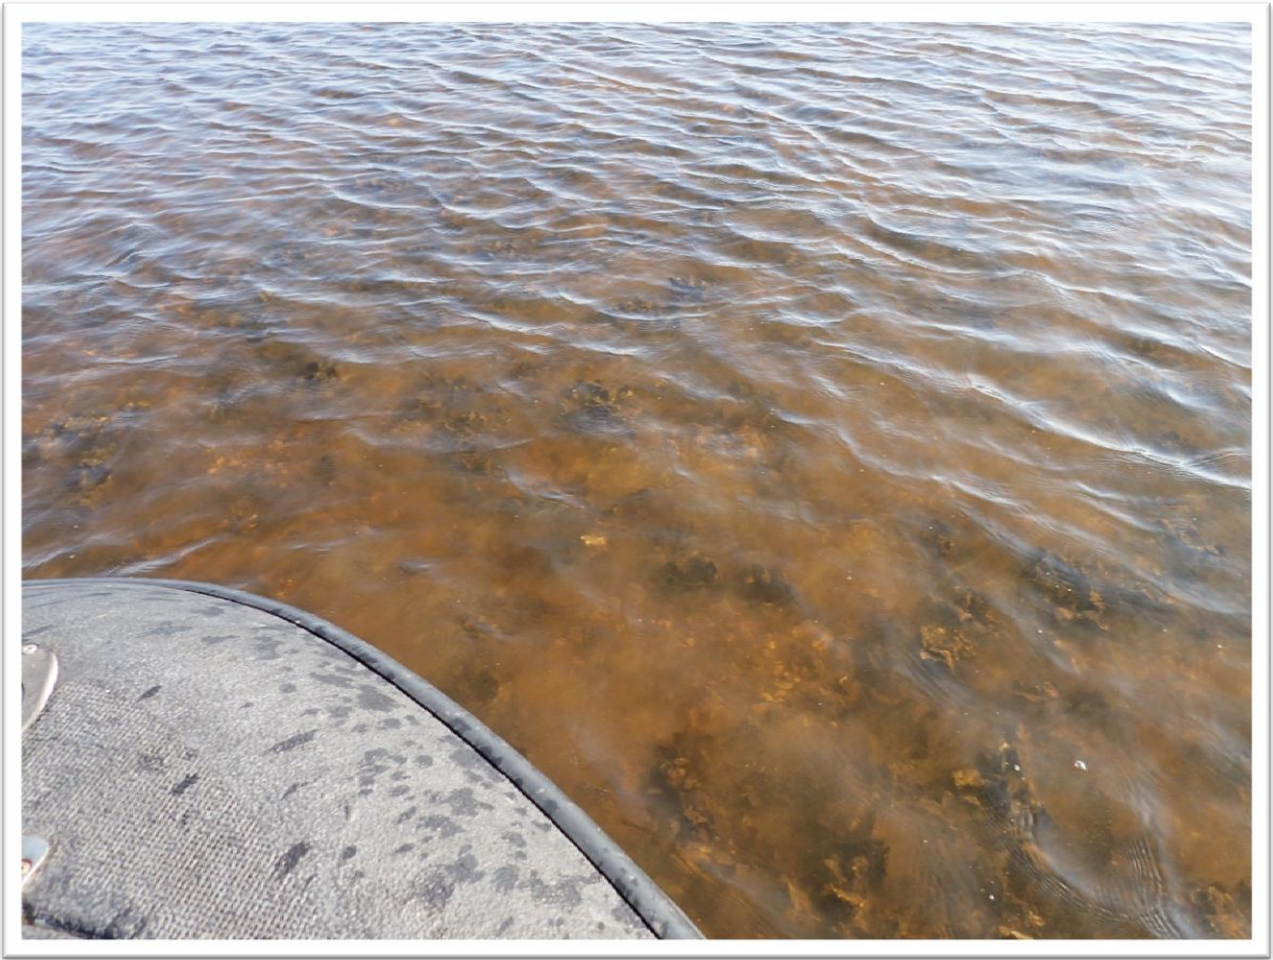
Figure 5. Photo of a visible, intertidal oyster reef north of the Suwannee River.
