# Roadblocks to Seagrass Recovery: Seagrass Restoration Planning

Tallahassee, March 7, 2016

## Project Goals:

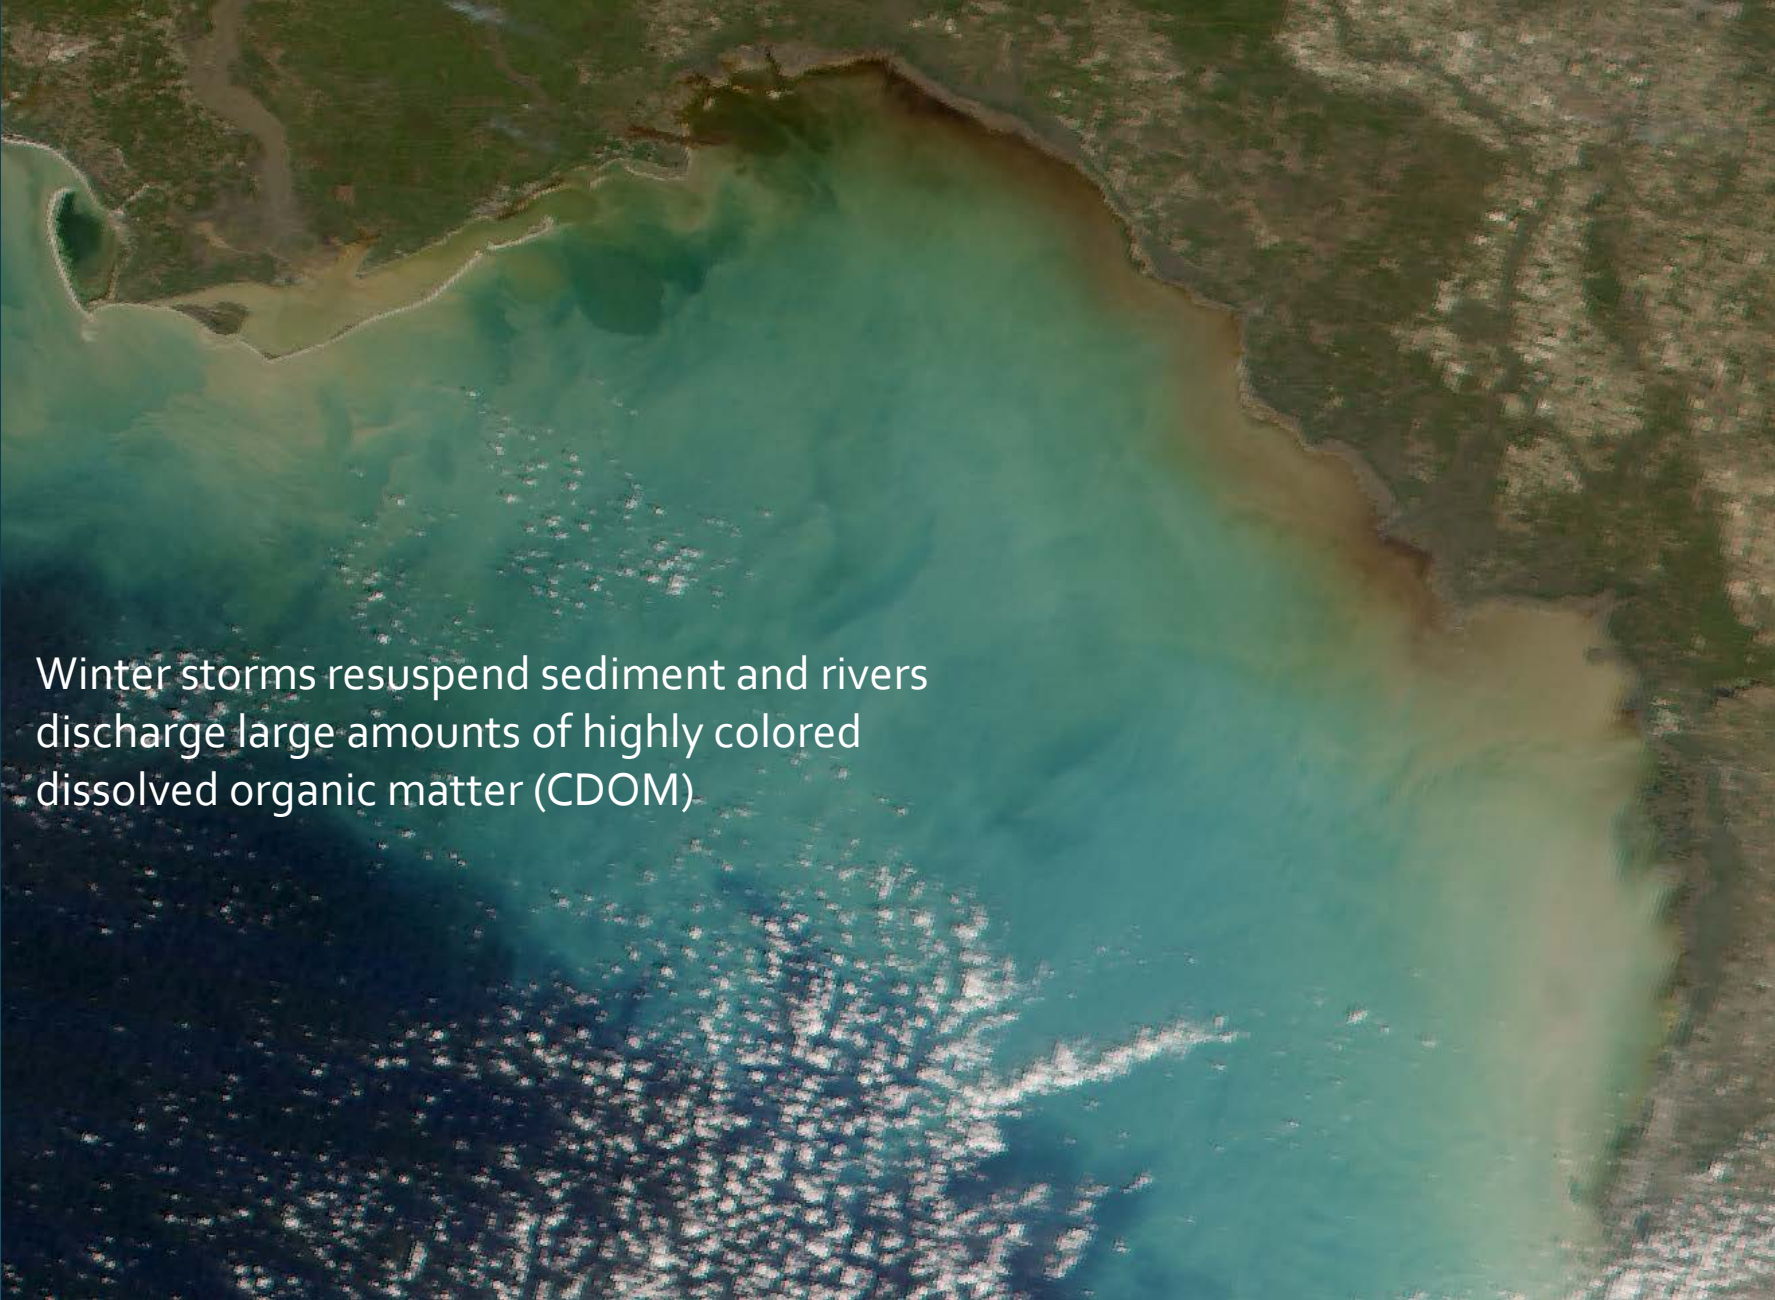
# Big Bend FDOT Imagery: December 2015

Winter storms resuspend sediment and rivers discharge large amounts of highly colored dissolved organic matter (CDOM)

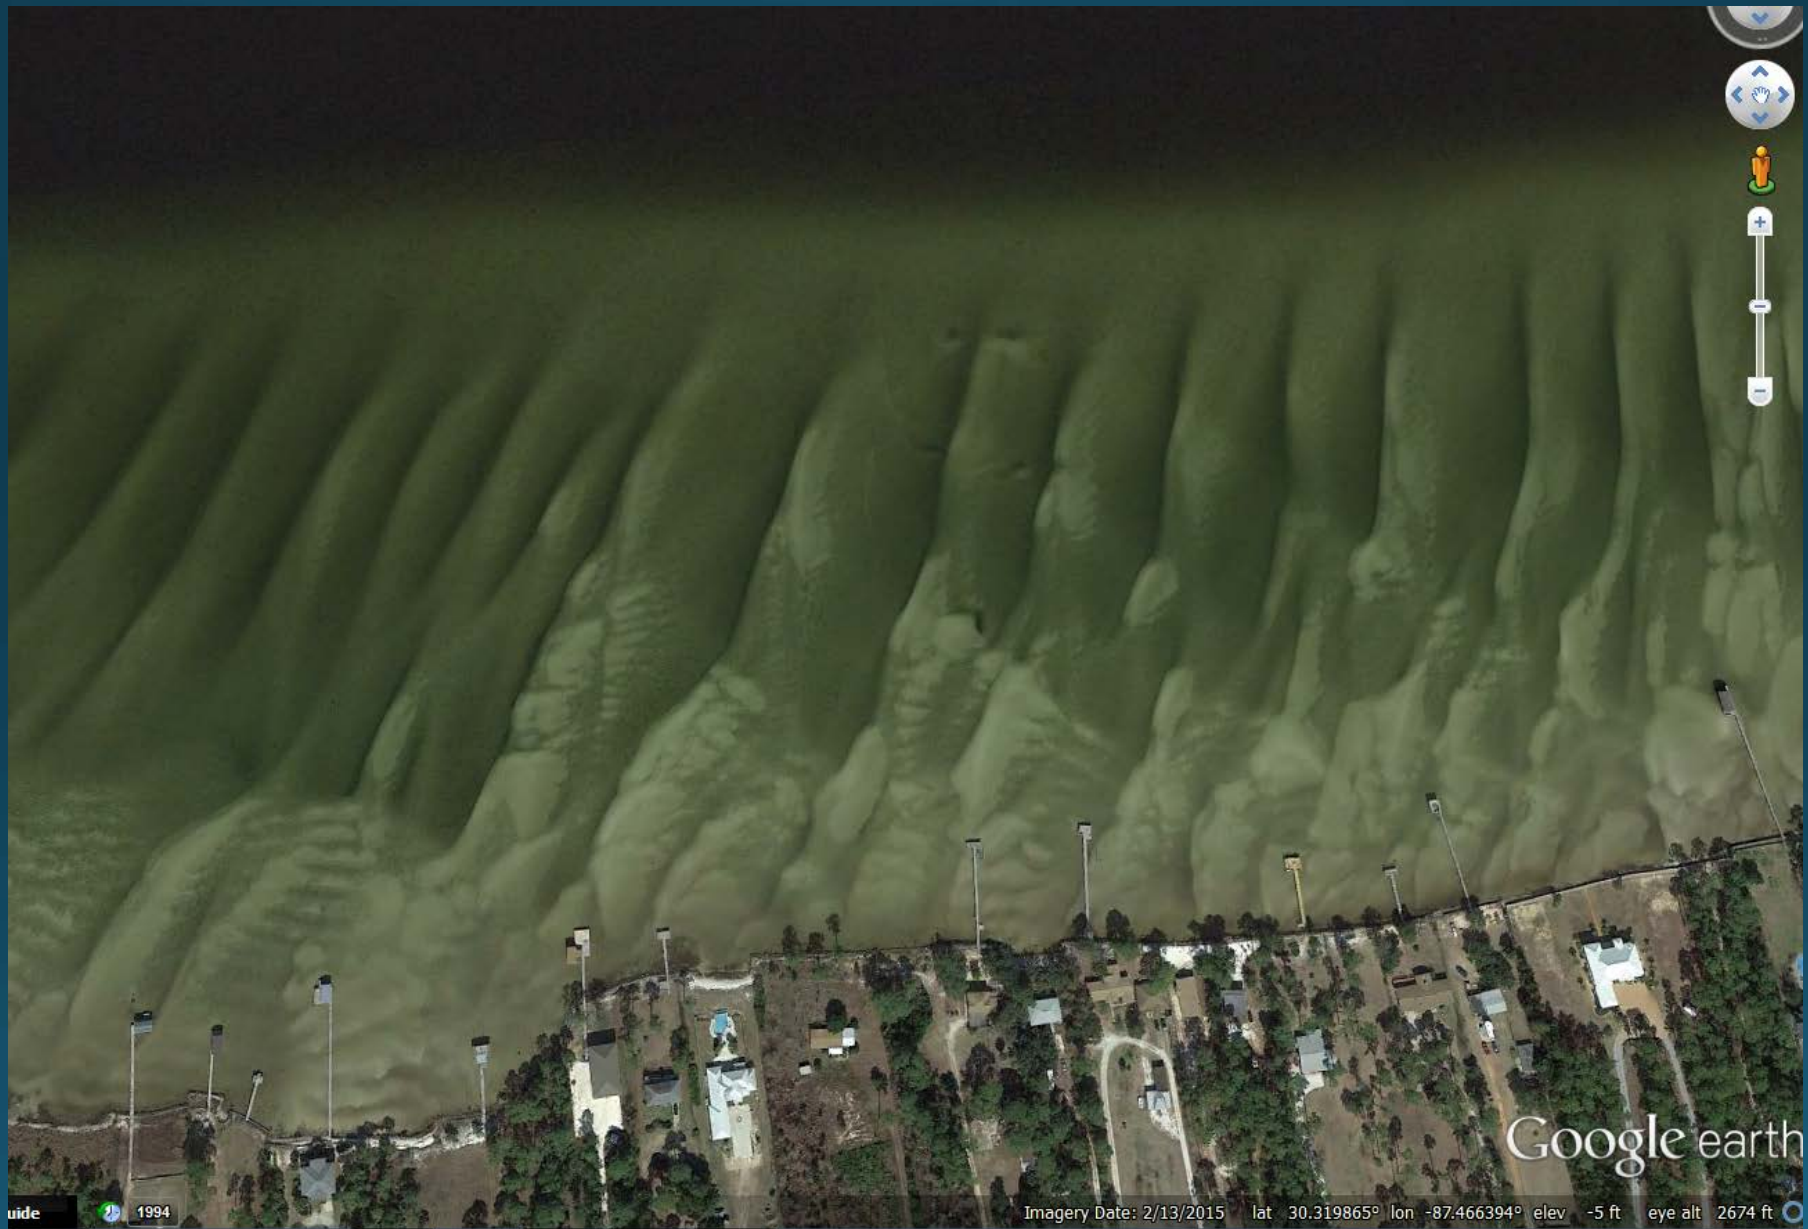
# Physical Disturbance Suggested by Sediment Bed Form

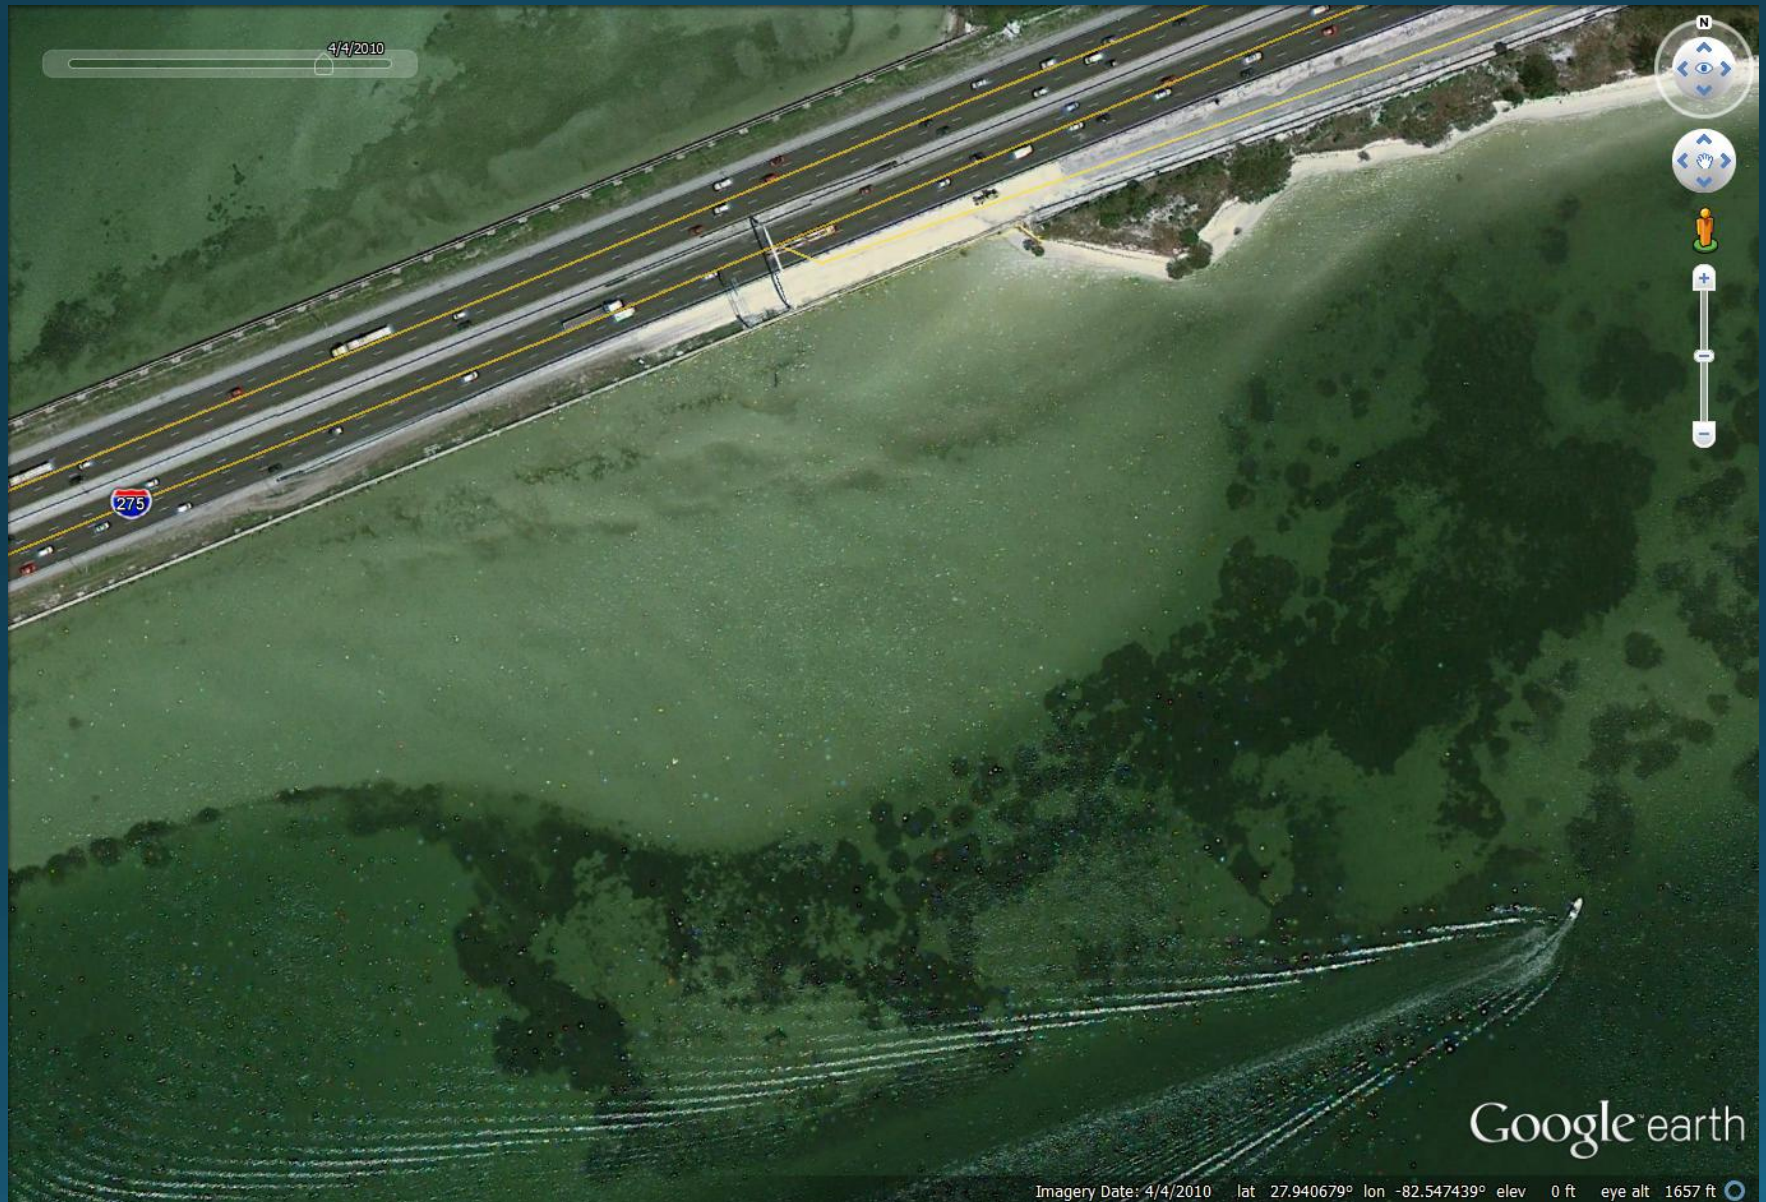
# Example of Wave Action and Erosion Along I-275 in Tampa, April 2010

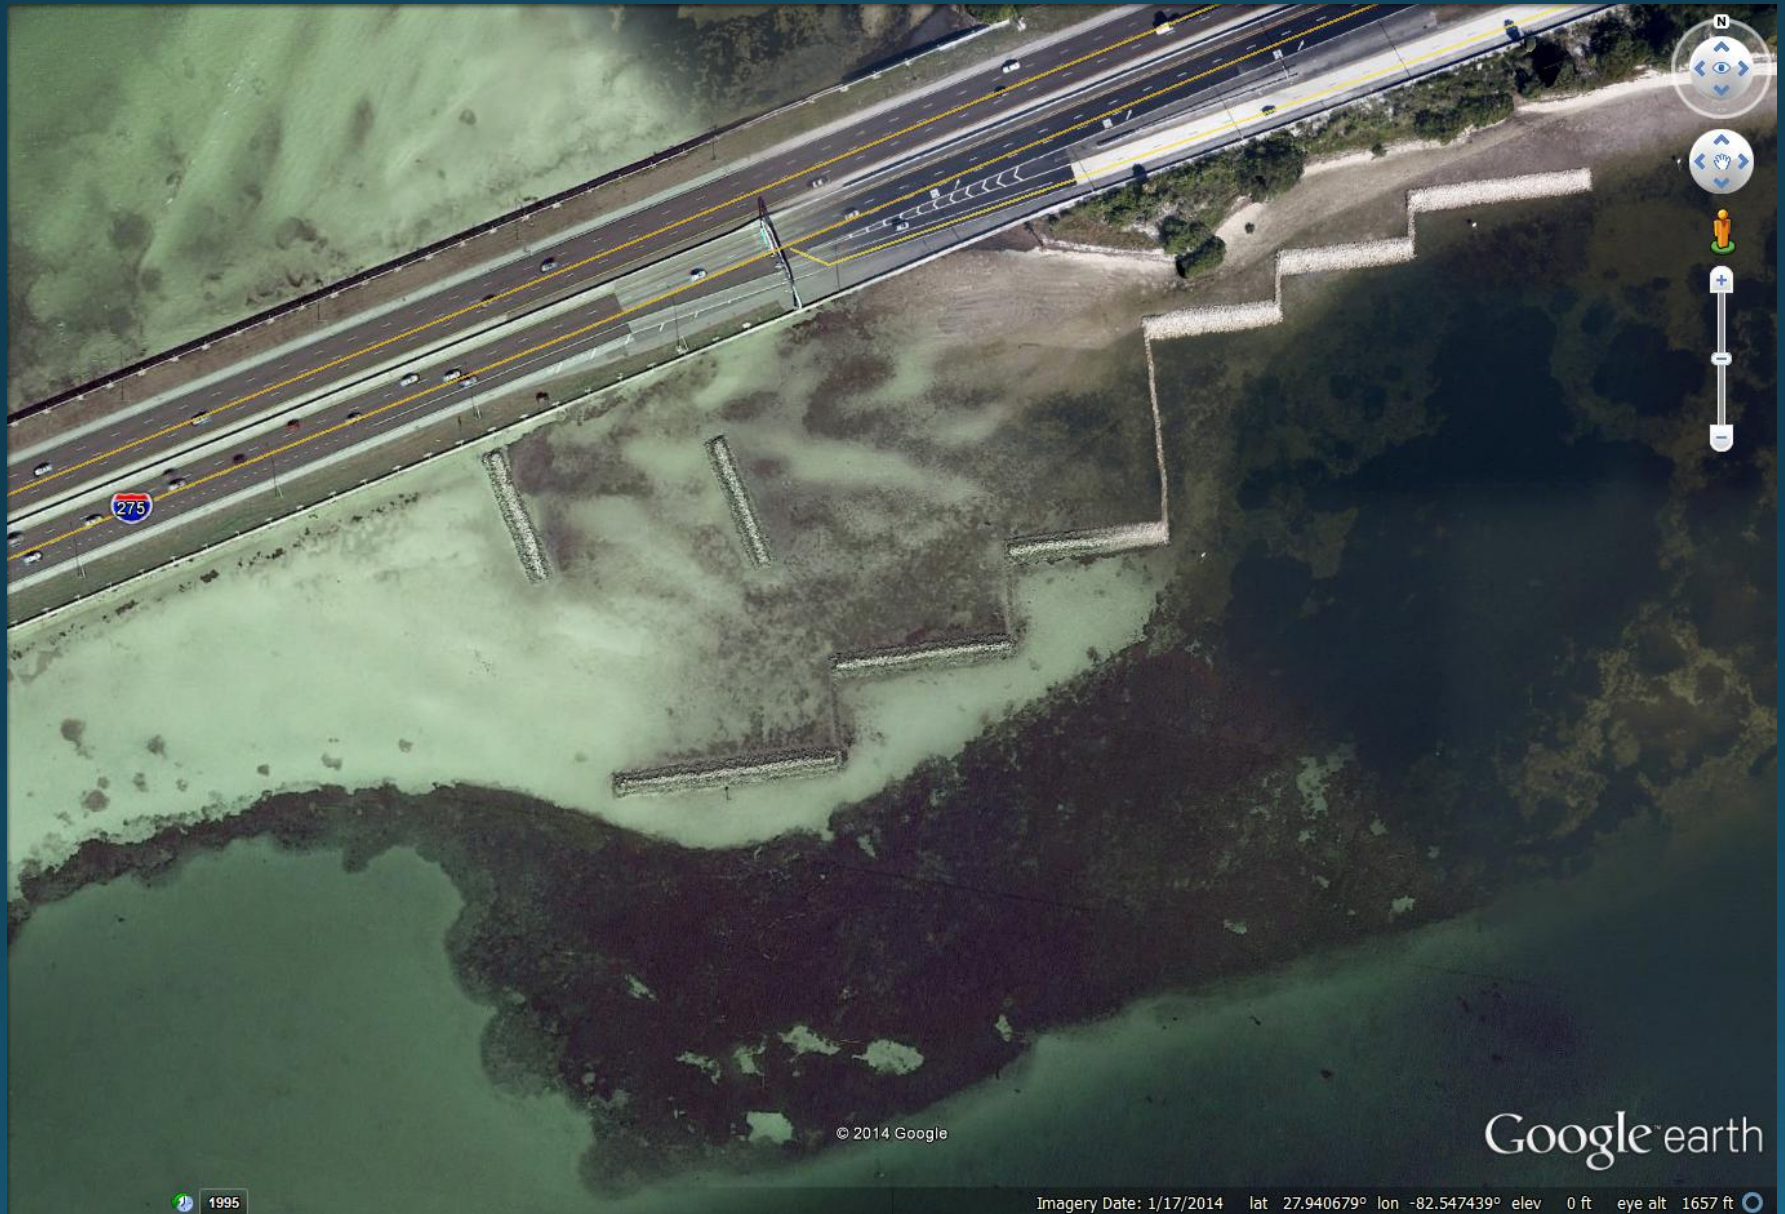
# Effect of Rip Rap Barriers, January 2014

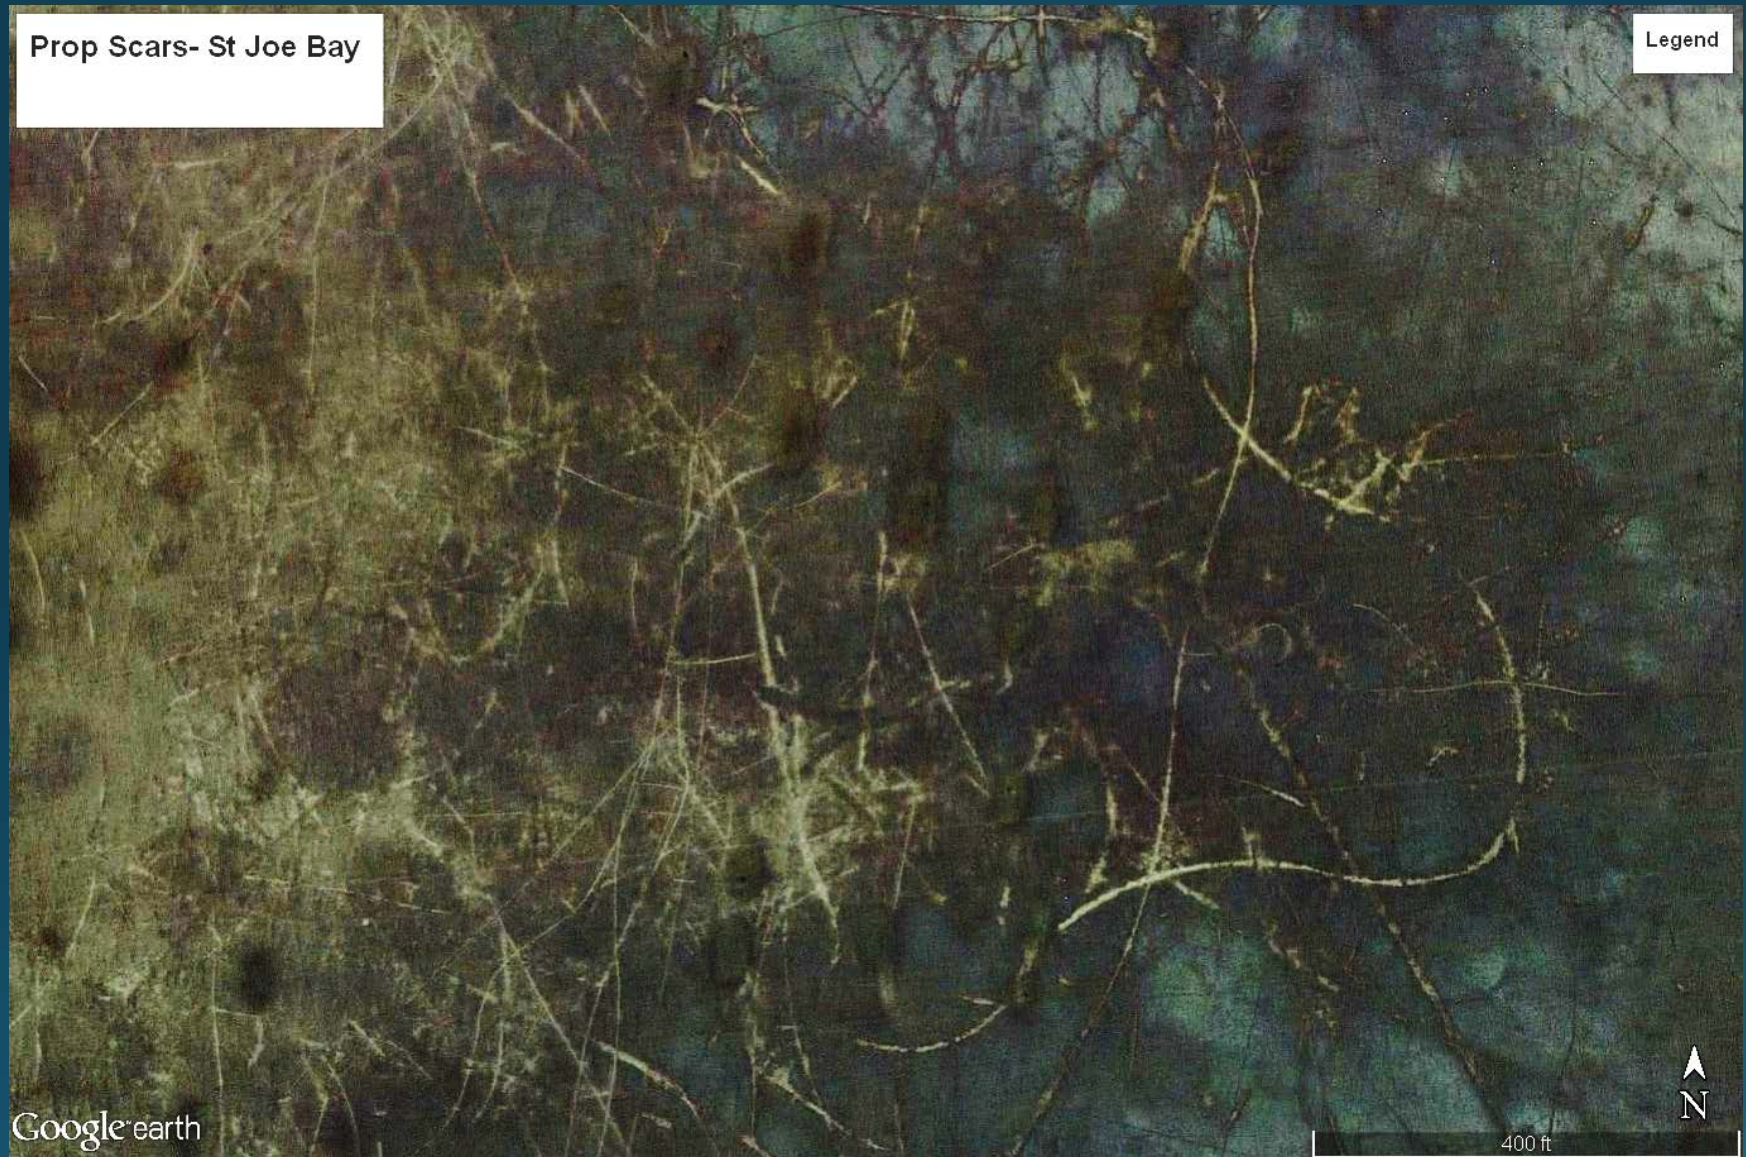
Human activity impacts include propeller scarring.

Data in progress; obtained from GIS assessment of imagery collected in 2013.
