APPENDIX A

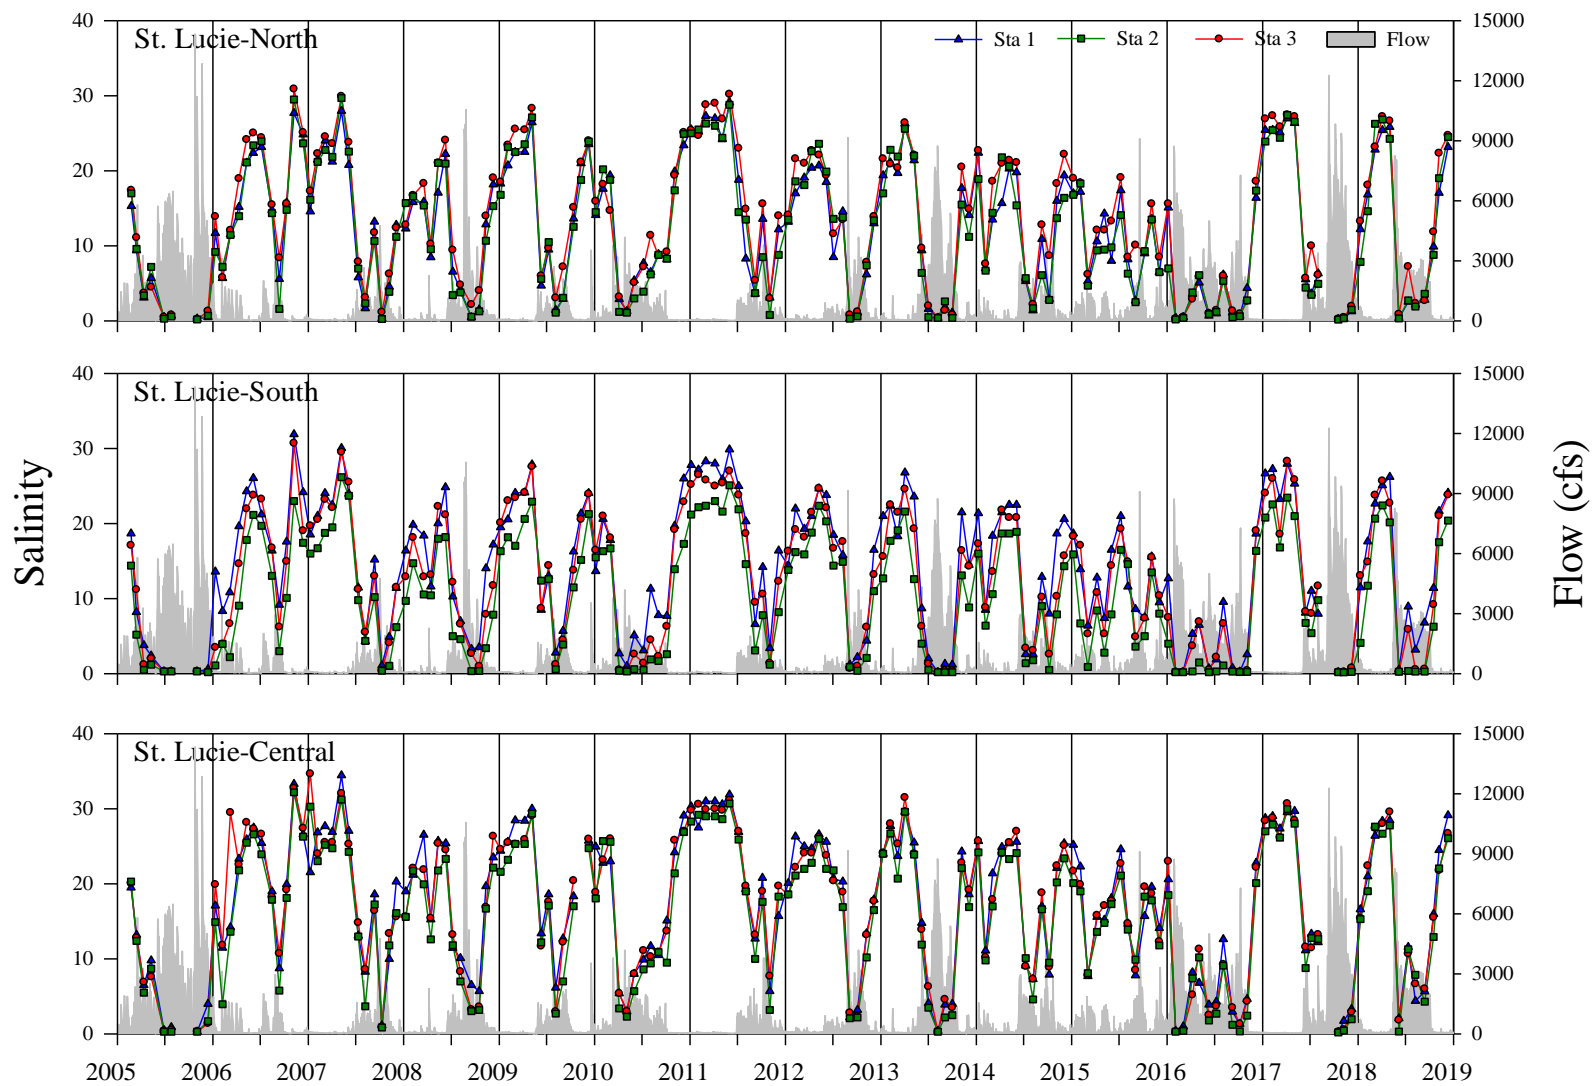
Figure A1. Monthly salinity recorded at stations from 2005 – 2018 in the St. Lucie-North (top), St. Lucie-South (middle) and St. Lucie-Central (bottom) study sites and the sum of the mean flow rate at the S80, S97, S49 and Gordy structures as recorded by the South Florida Water Management District.

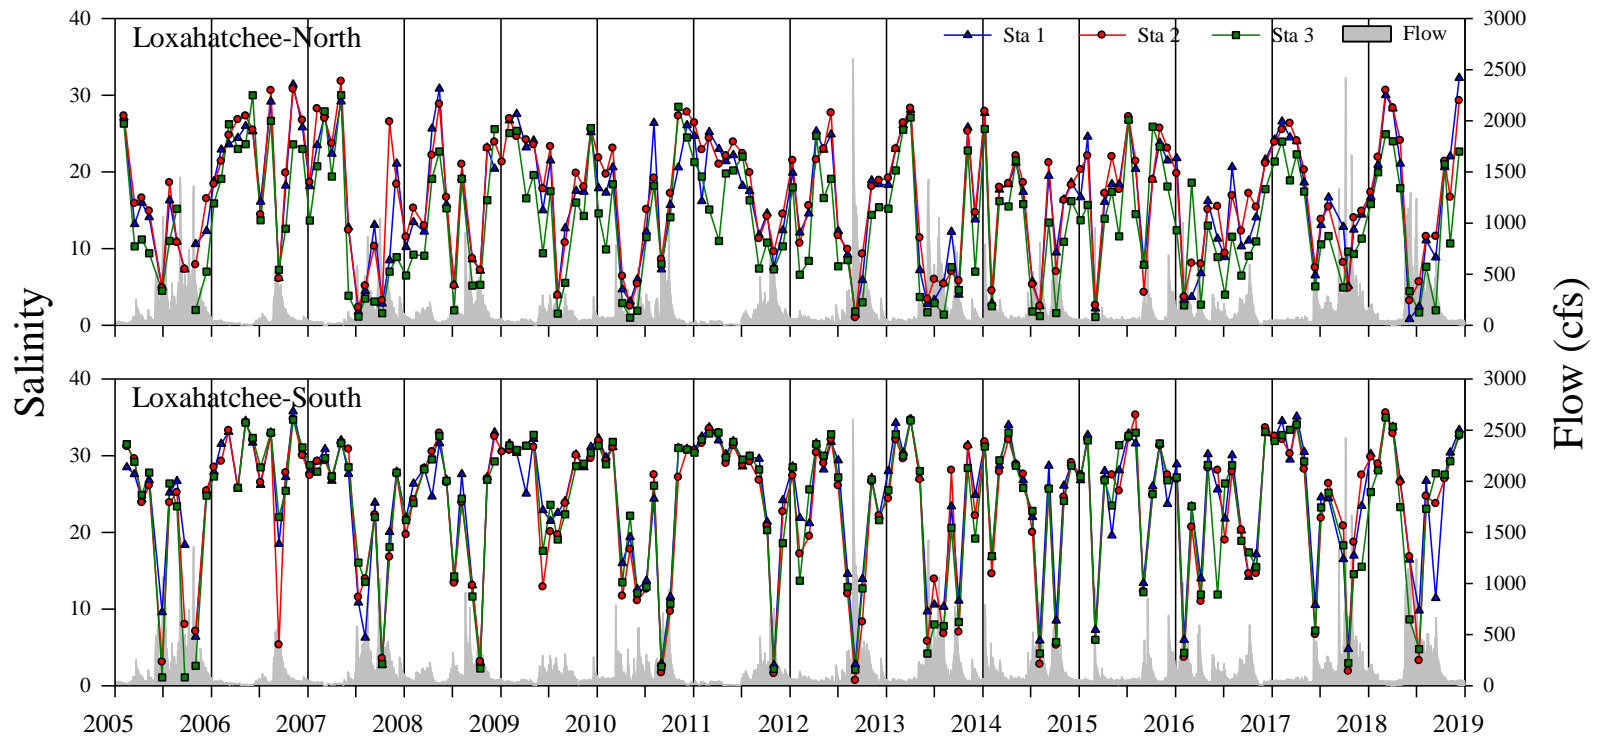
Figure A2. Monthly salinity recorded at stations from 2005 – 2018 in the Loxahatchee-North (top) and Loxahatchee-South (bottom) study sites and the sum of the mean daily flow rate at the Lainhart Dam and S46 structures as recorded by the U.S. Geological Survey and the South Florida Water Management District.

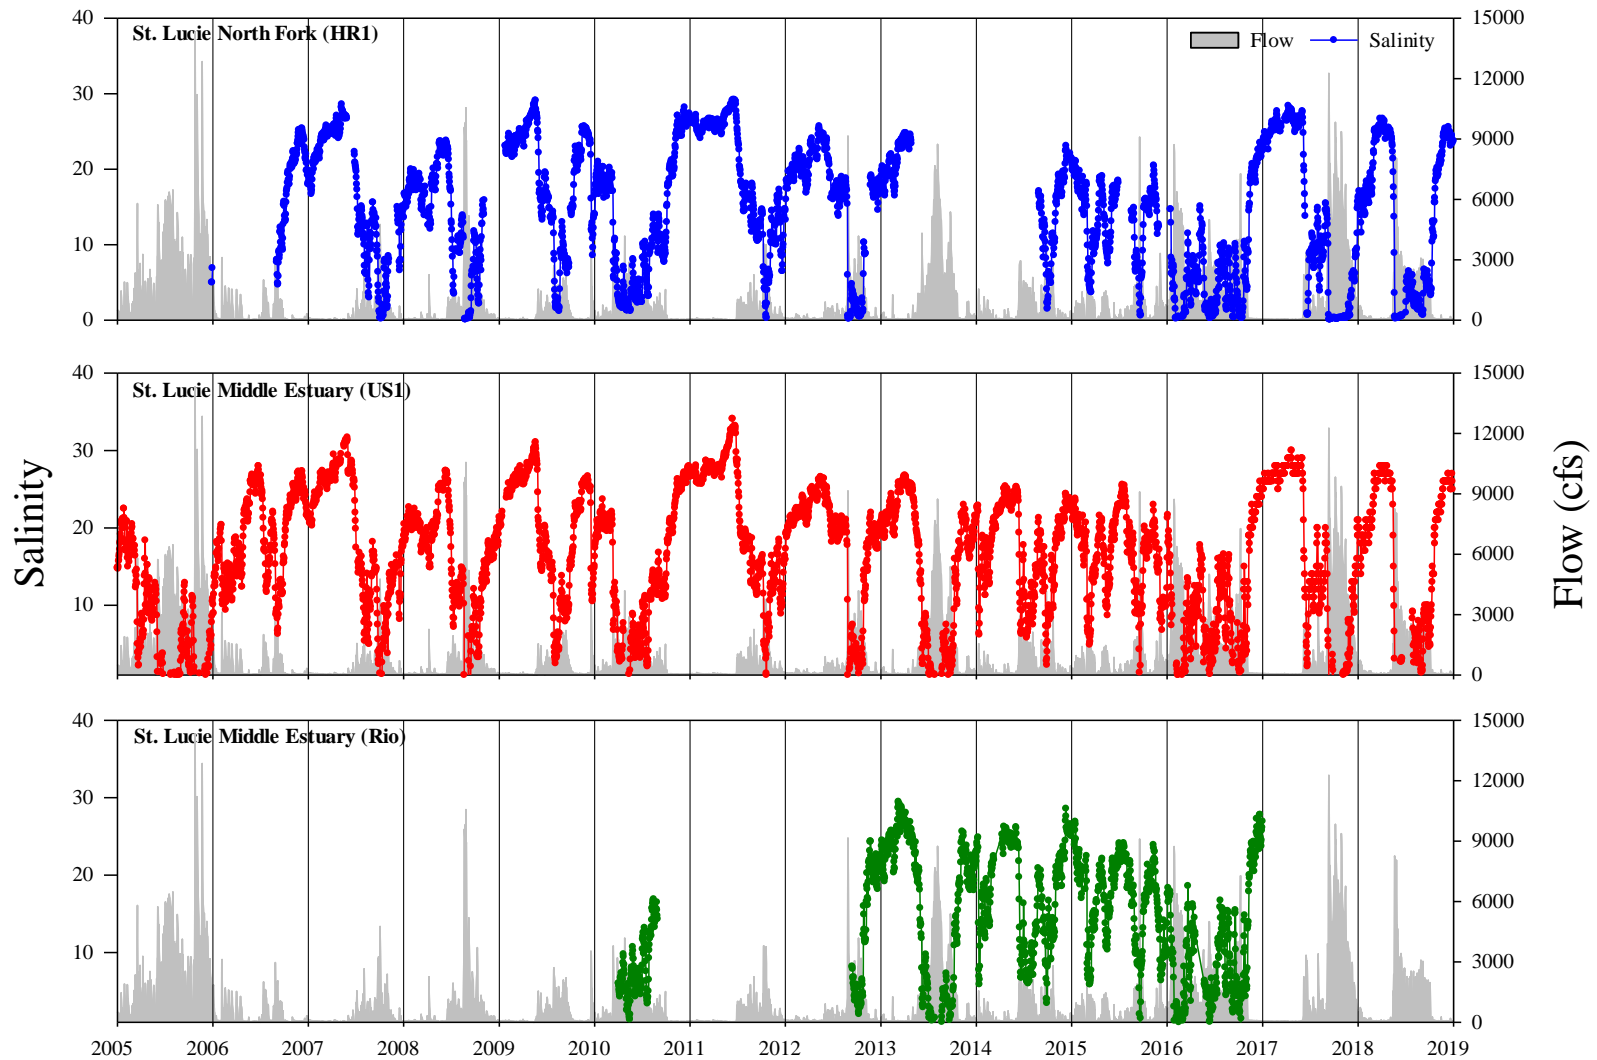
Figure A3. Mean daily salinity recorded by continuous data loggers from 2005 – 2018 at the St. Lucie North Fork HR1 (top), St. Lucie US1 Roosevelt Bridge (middle) and St. Lucie middle estuary Rio (bottom) stations and the sum of the mean flow rate at the S80, S97, S49 and Gordy structures. Salinity and flow data from the U.S. Geological Survey and the South Florida Water Management District.

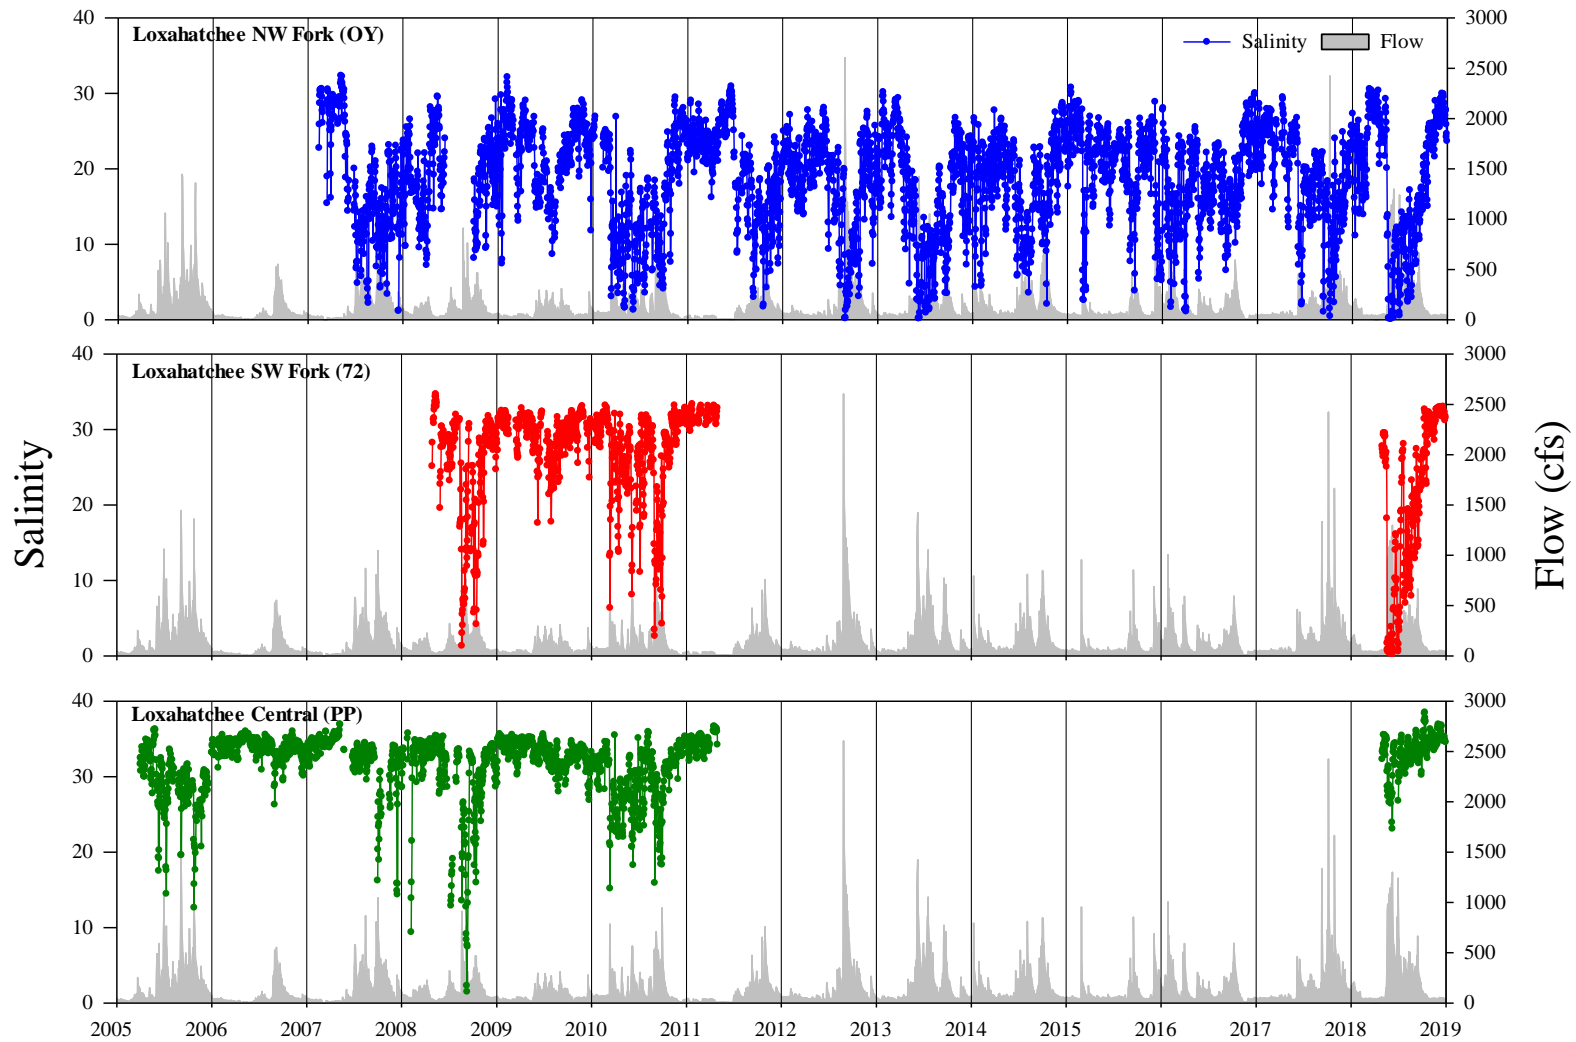
Figure A4. Mean daily salinity recorded by continuous data loggers from 2005 – 2018 at the Loxahatchee NW Fork OY (top), Loxahatchee SW Fork 72 (middle) and Loxahatchee central estuary PP (bottom) stations and the sum of the mean flow rate at the Lainhart Dam and S46 structures. Salinity data from the Loxahatchee River District and flow data from the U.S. Geological Survey and the South Florida Water Management District.

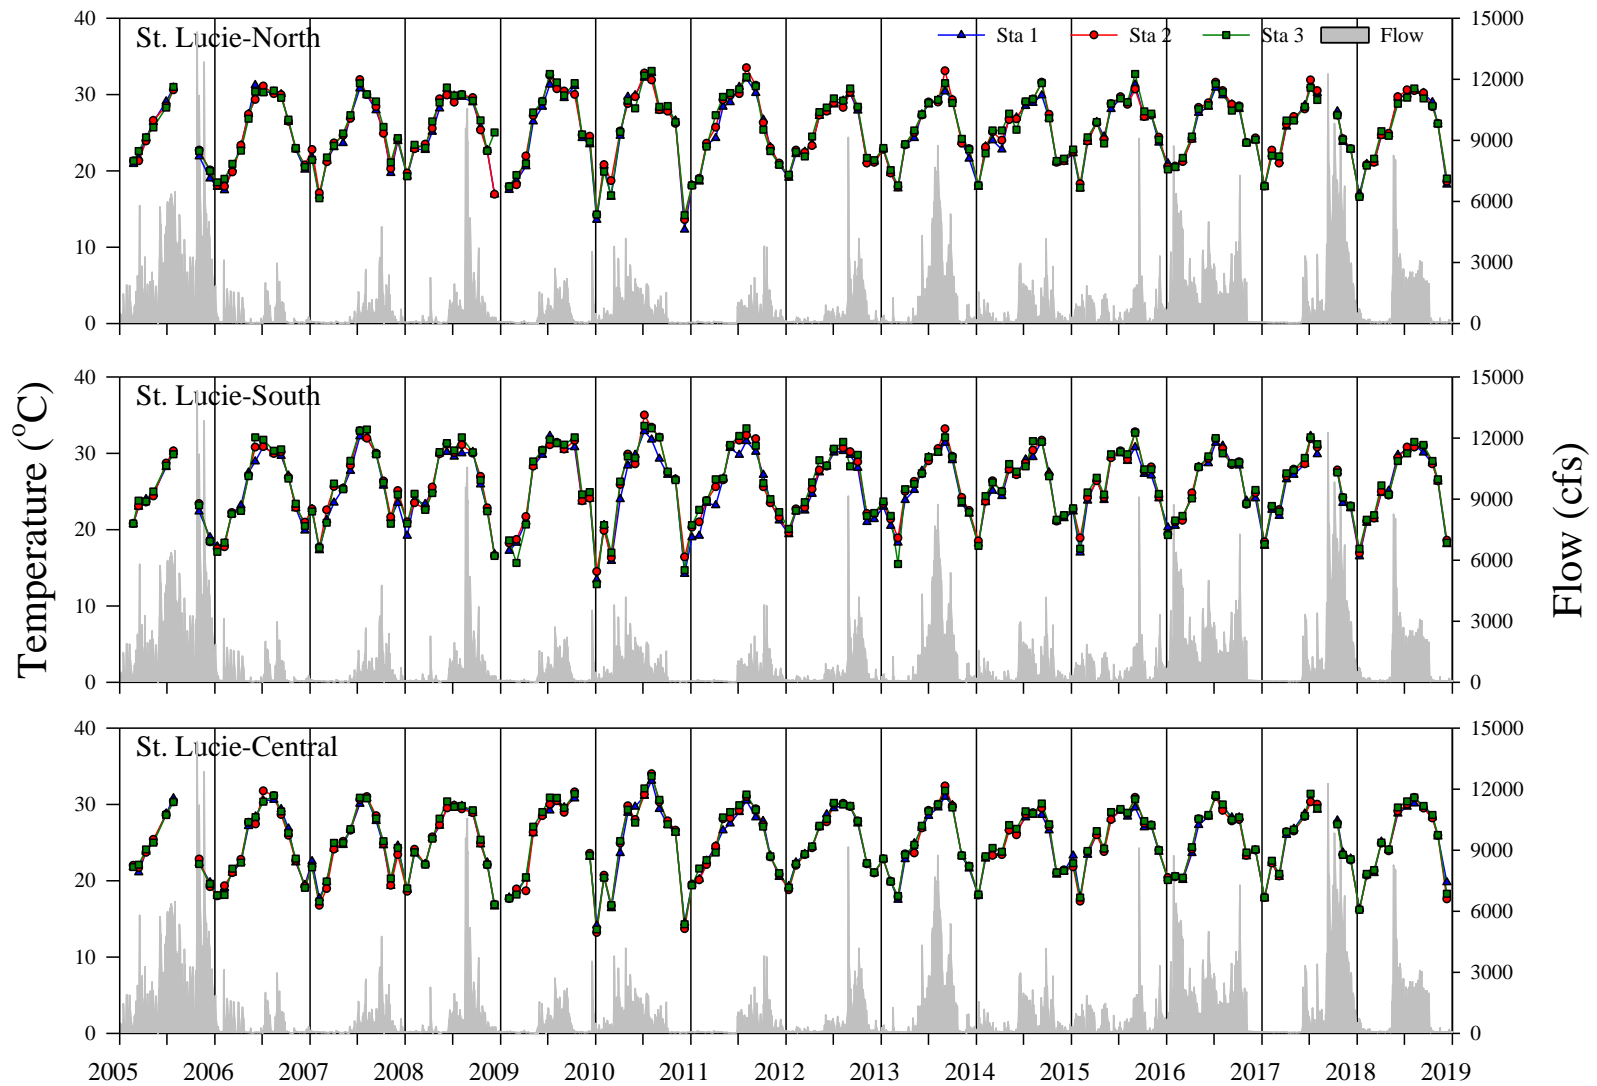
Figure A5. Monthly water temperature recorded at stations from 2005 – 2018 in the St. Lucie-North (top), St. Lucie-South (middle) and St. Lucie-Central (bottom) study sites and the sum of the mean flow rate at the S80, S97, S49 and Gordy structures as recorded by the South Florida Water Management District.

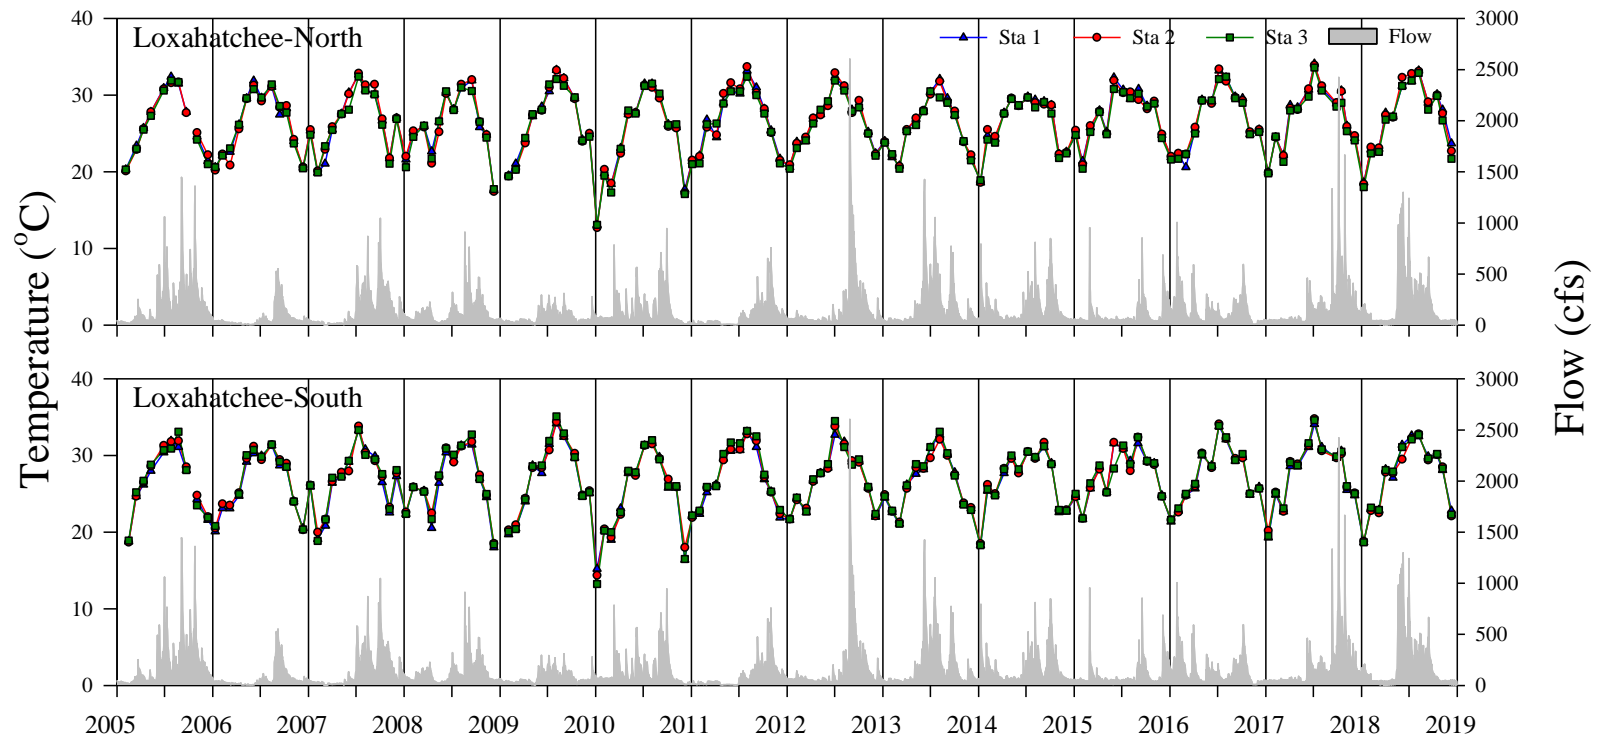
Figure A6. Monthly water temperature recorded at stations from 2005 – 2018 in the Loxahatchee-North (top) and Loxahatchee-South (bottom) study sites and the sum of the mean daily flow rate at the Lainhart Dam and S46 structures as recorded by the U.S. Geological Survey and the South Florida Water Management District.

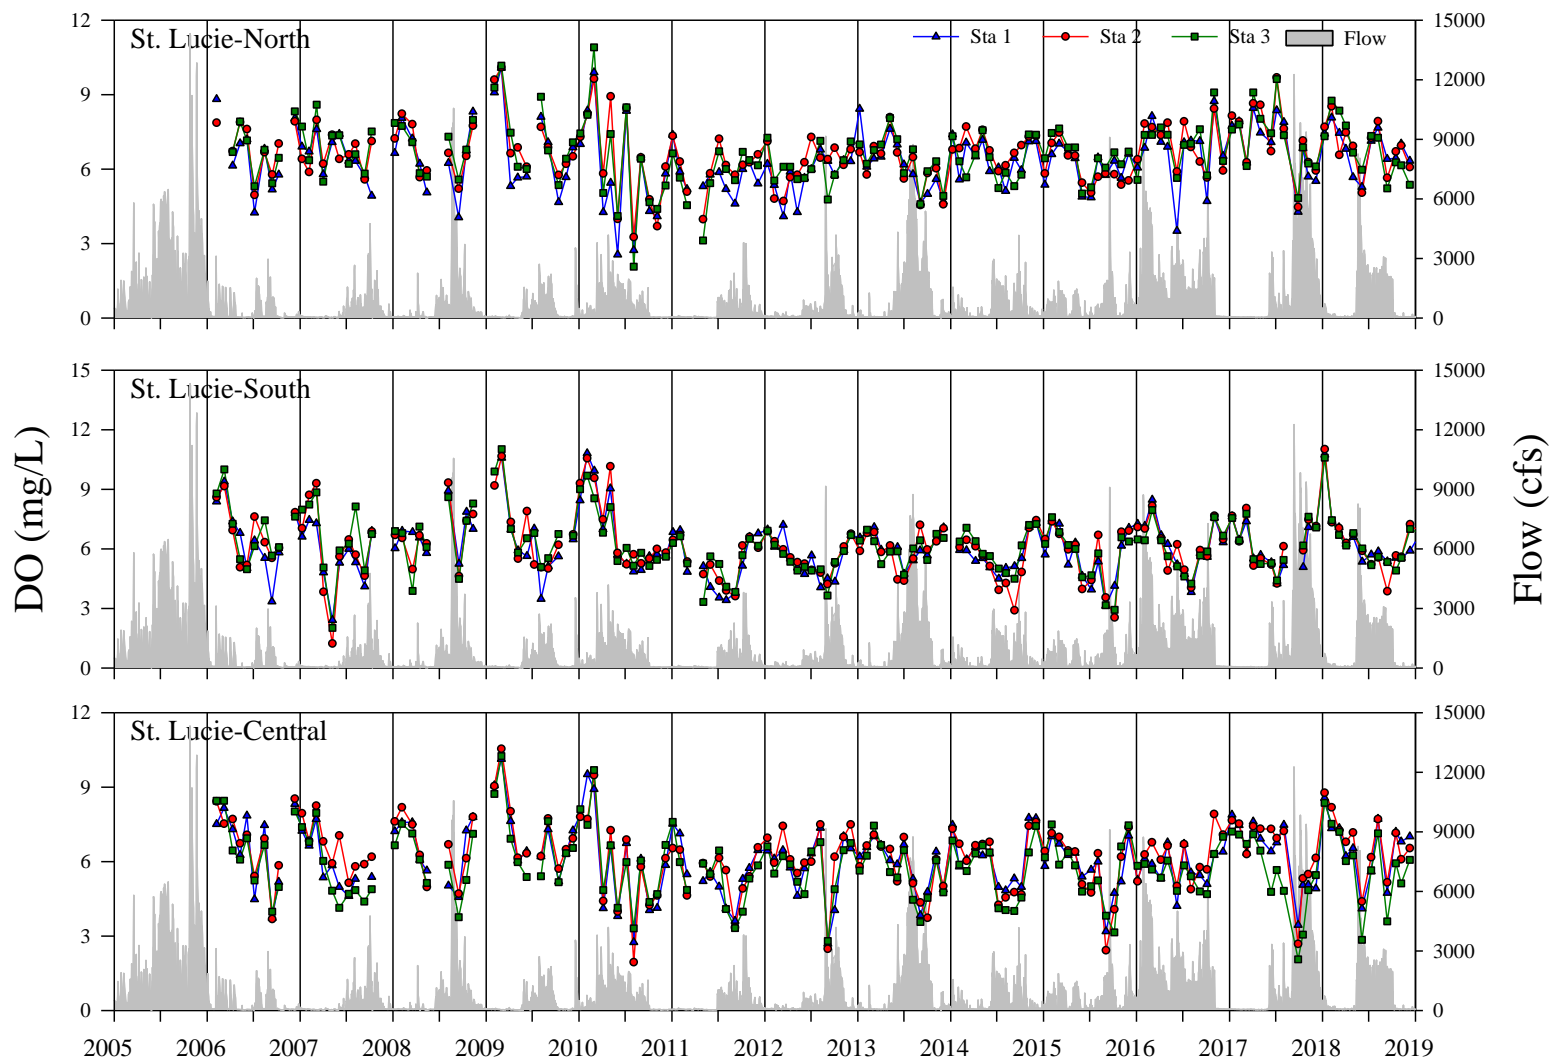
Figure A7. Monthly dissolved oxygen concentration recorded at stations from 2006 – 2018 in the St. Lucie-North (top), St. Lucie-South (middle) and St. Lucie-Central (bottom) study sites and the sum of the mean flow rate at the S80, S97, S49 and Gordy structures as recorded by the South Florida Water Management District.

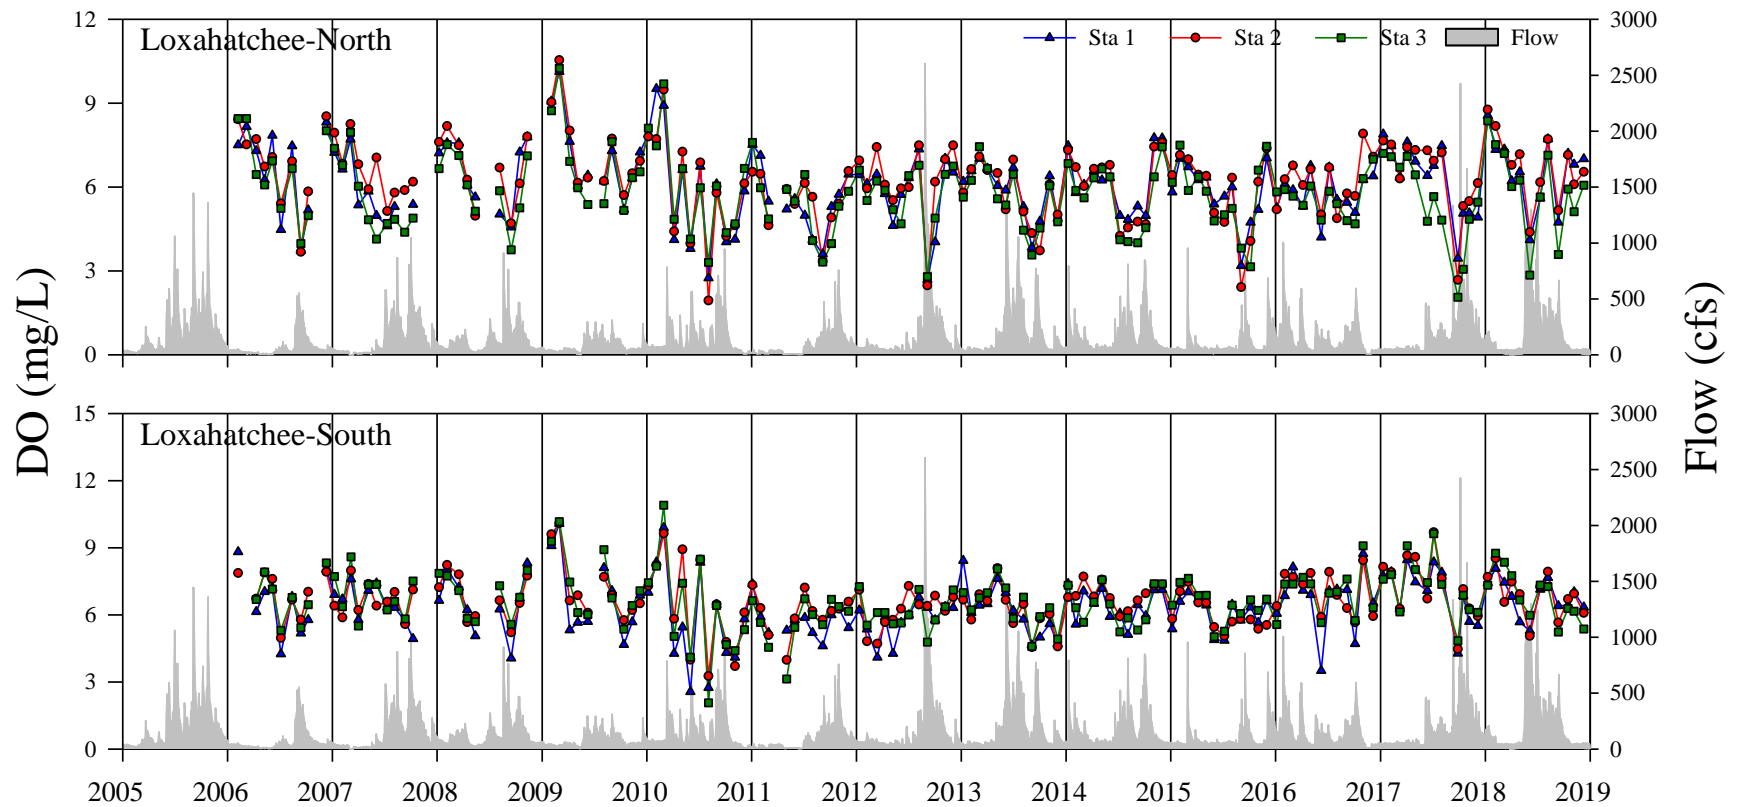
Figure A8. Monthly dissolved oxygen concentration recorded at stations from 2006 – 2018 in the Loxahatchee-North (top) and Loxahatchee-South (bottom) study sites and the sum of the mean daily flow rate at the Lainhart Dam and S46 structures as recorded by the U.S. Geological Survey and the South Florida Water Management District.

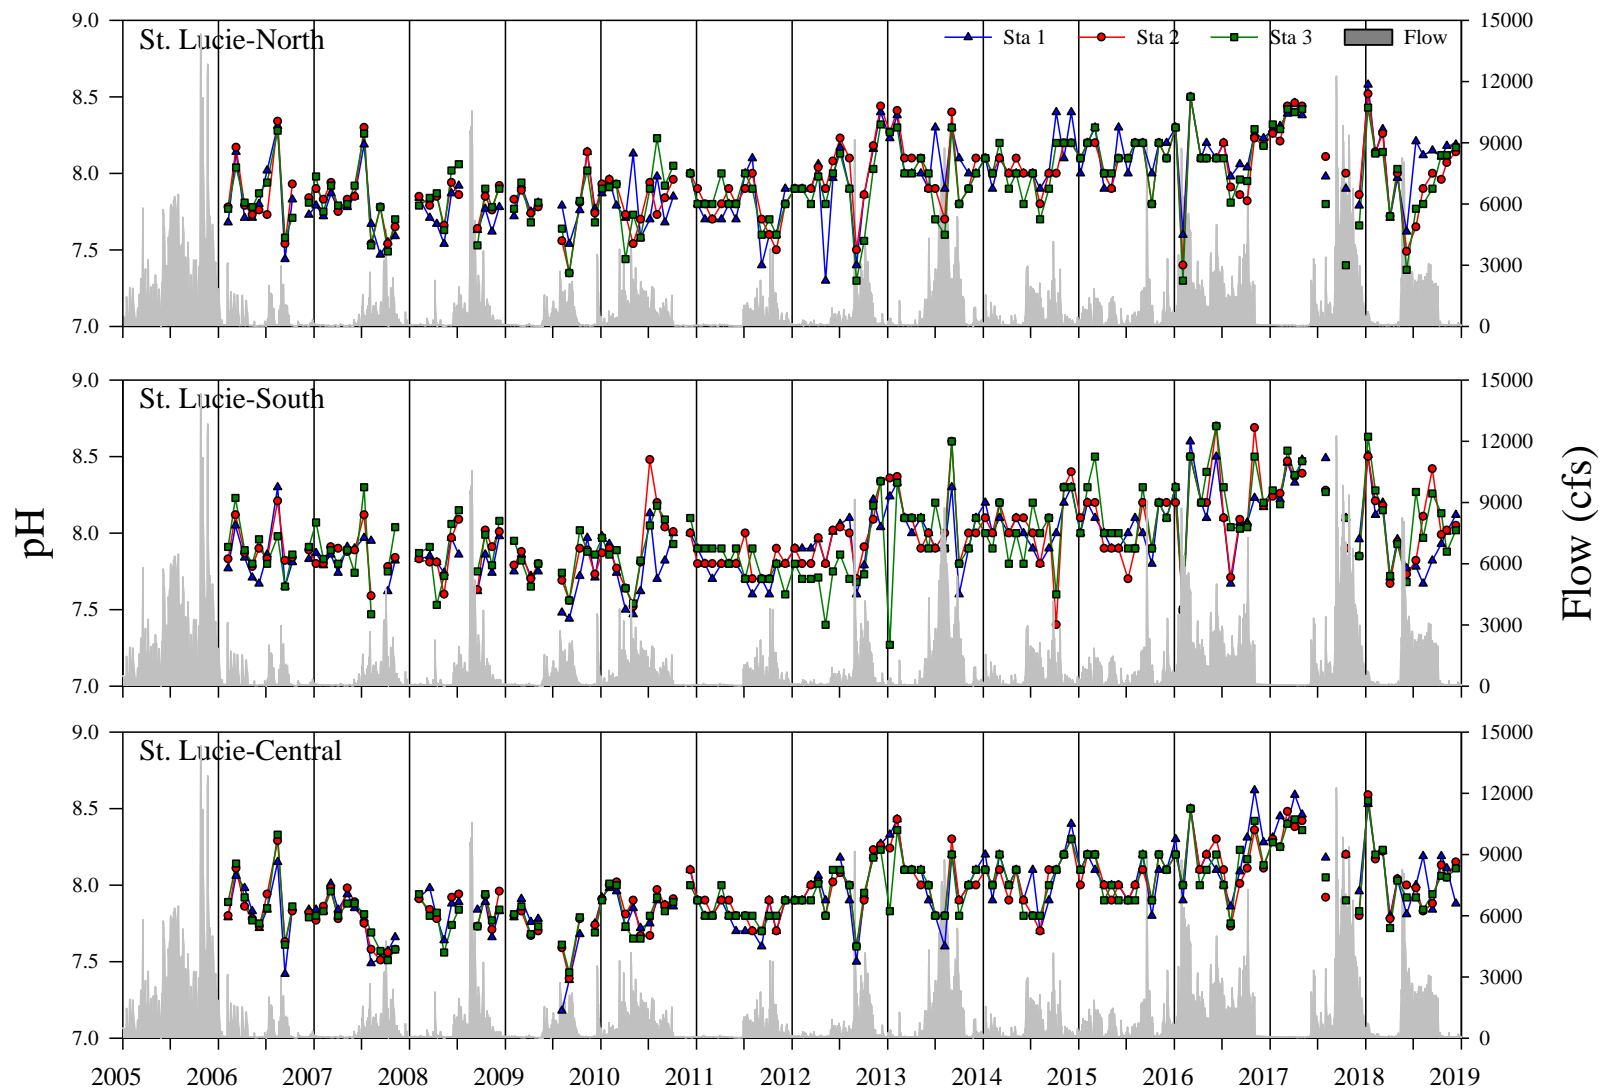
Figure A9. Monthly pH recorded at stations from 2006 – 2018 in the St. Lucie-North (top), St. Lucie-South (middle) and St. Lucie-Central (bottom) study sites and the sum of the mean flow rate at the S80, S97, S49 and Gordy structures as recorded by the South Florida Water Management District.

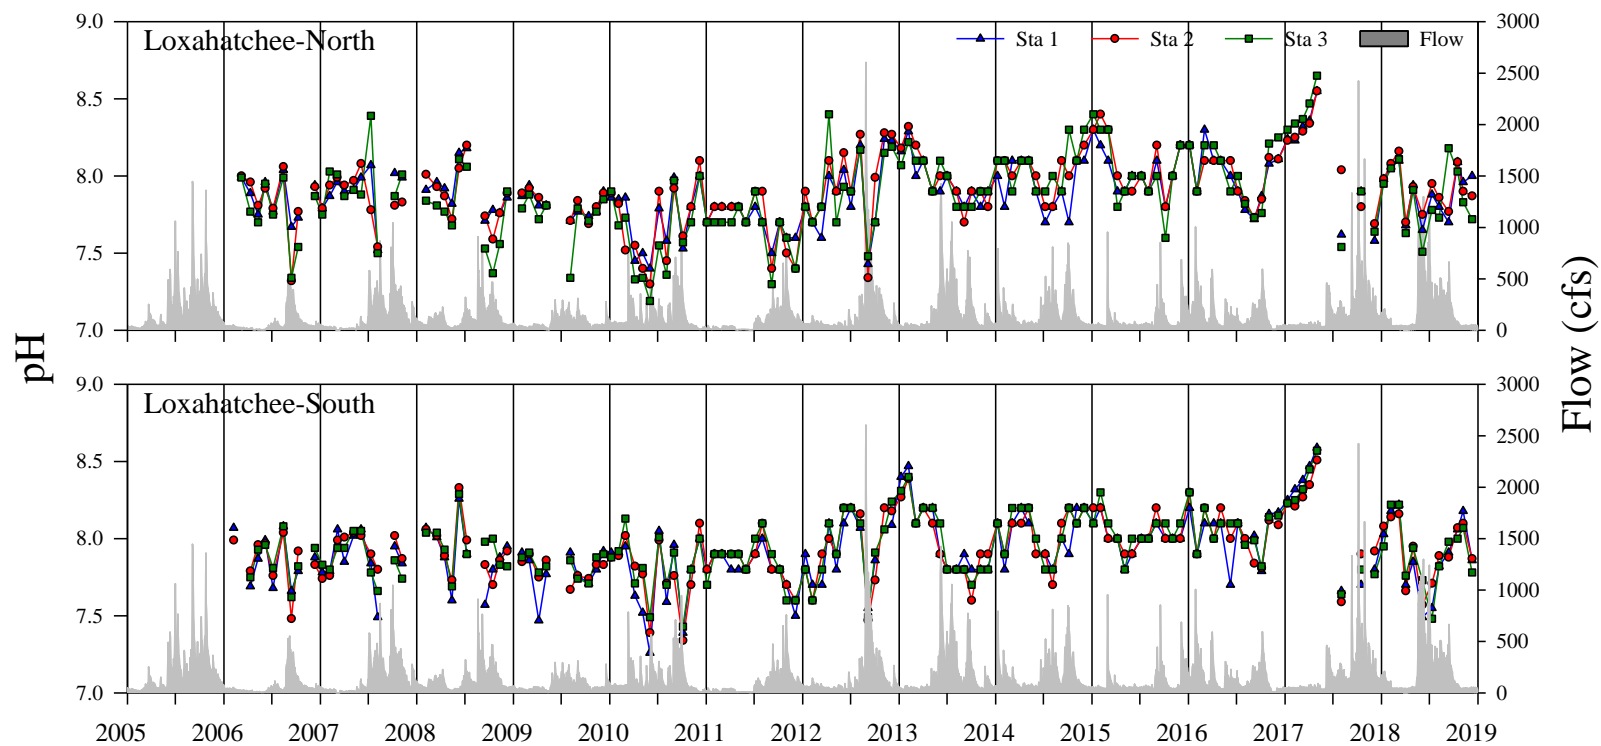
Figure A10. Monthly pH recorded at stations from 2006 – 2018 in the Loxahatchee-North (top) and Loxahatchee-South (bottom) study sites and the sum of the mean daily flow rate at the Lainhart Dam and S46 structures as recorded by the U.S. Geological Survey and the South Florida Water Management District.

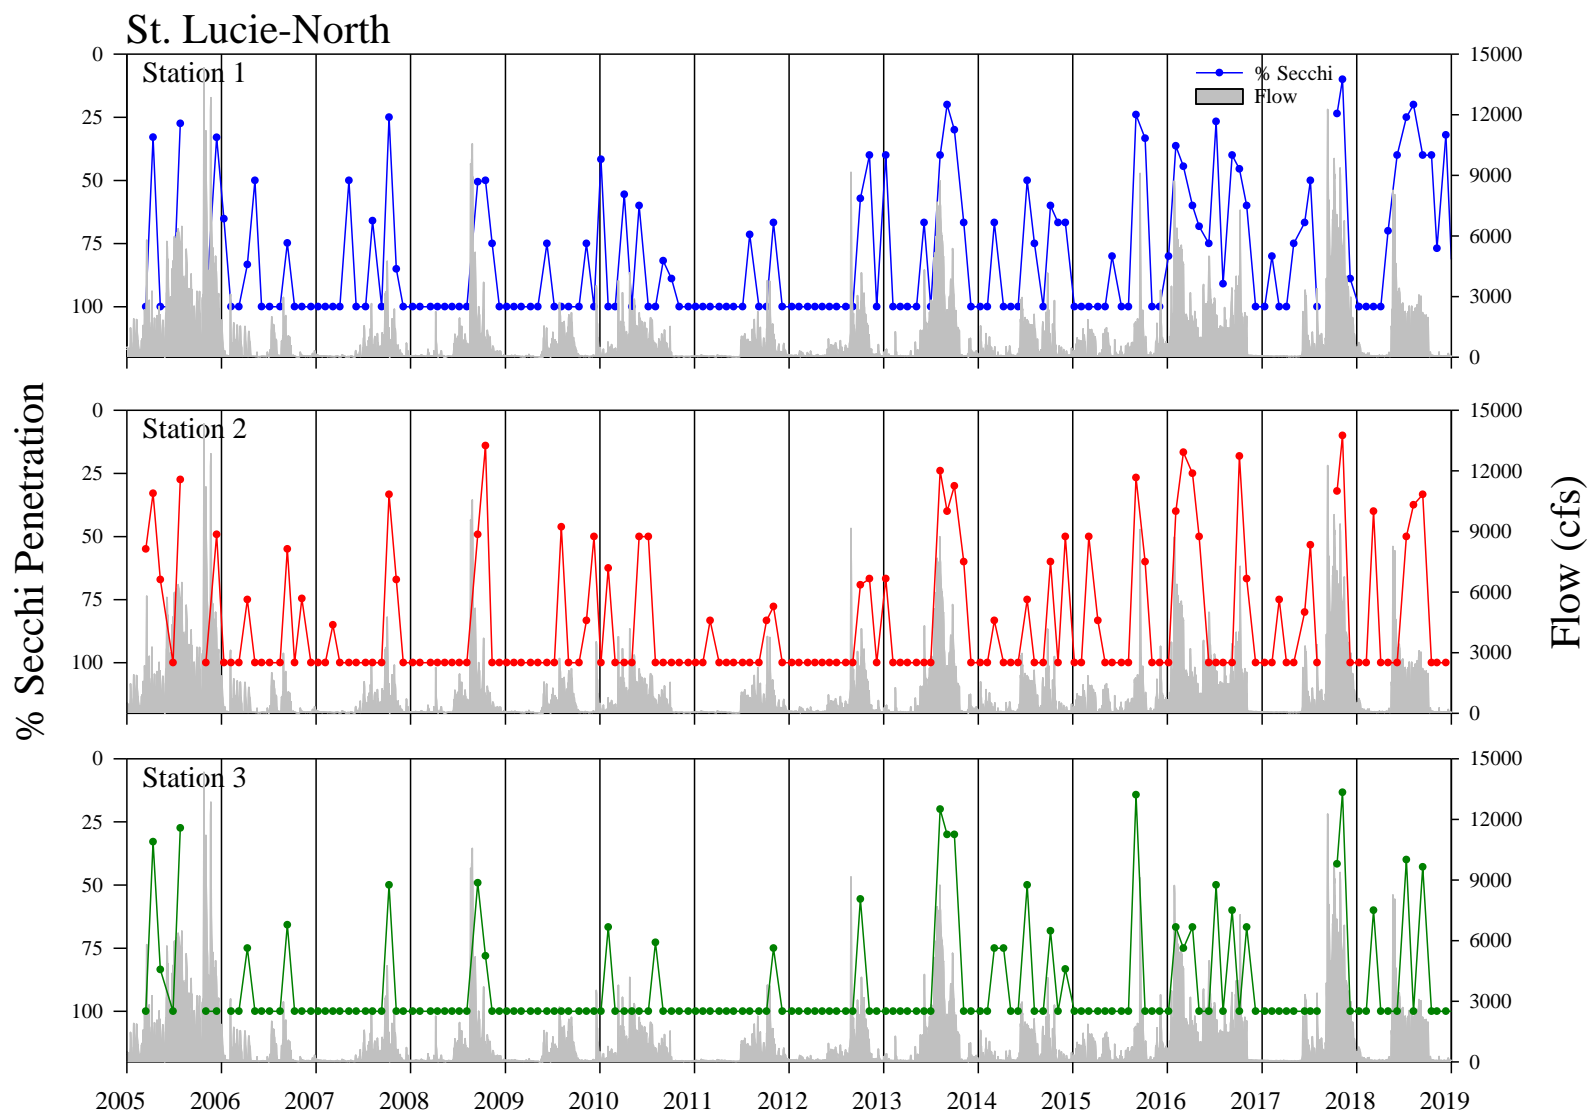
Figure A11. Monthly percent Secchi penetration recorded from 2005 – 2018 at St. Lucie-North Station 1 (top), Station 2 (middle) and Station 3 (bottom) and the sum of the mean daily flow rate at the S80, S97, S49 and Gordy structures as recorded by the South Florida Water Management District.

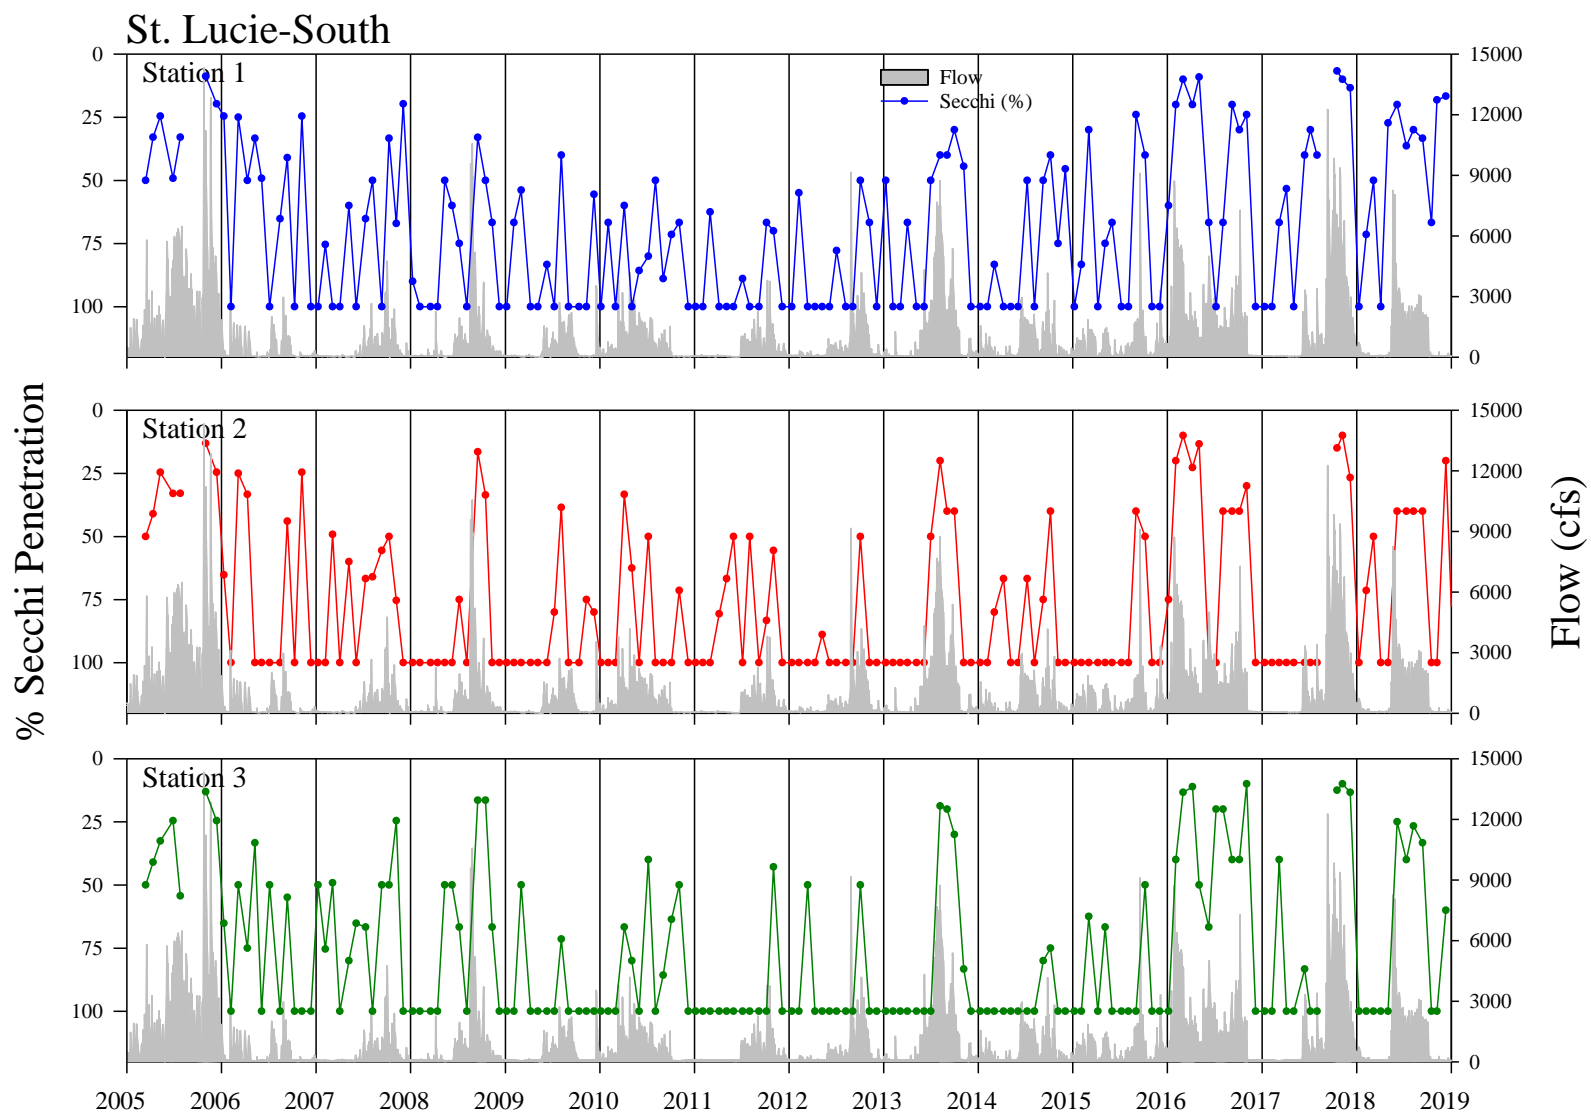
Figure A12. Monthly percent Secchi penetration recorded from 2005 – 2018 at St. Lucie-South Station 1 (top), Station 2 (middle) and Station 3 (bottom) and the sum of the mean daily flow rate at the S80, S97, S49 and Gordy structures as recorded by the South Florida Water Management District.

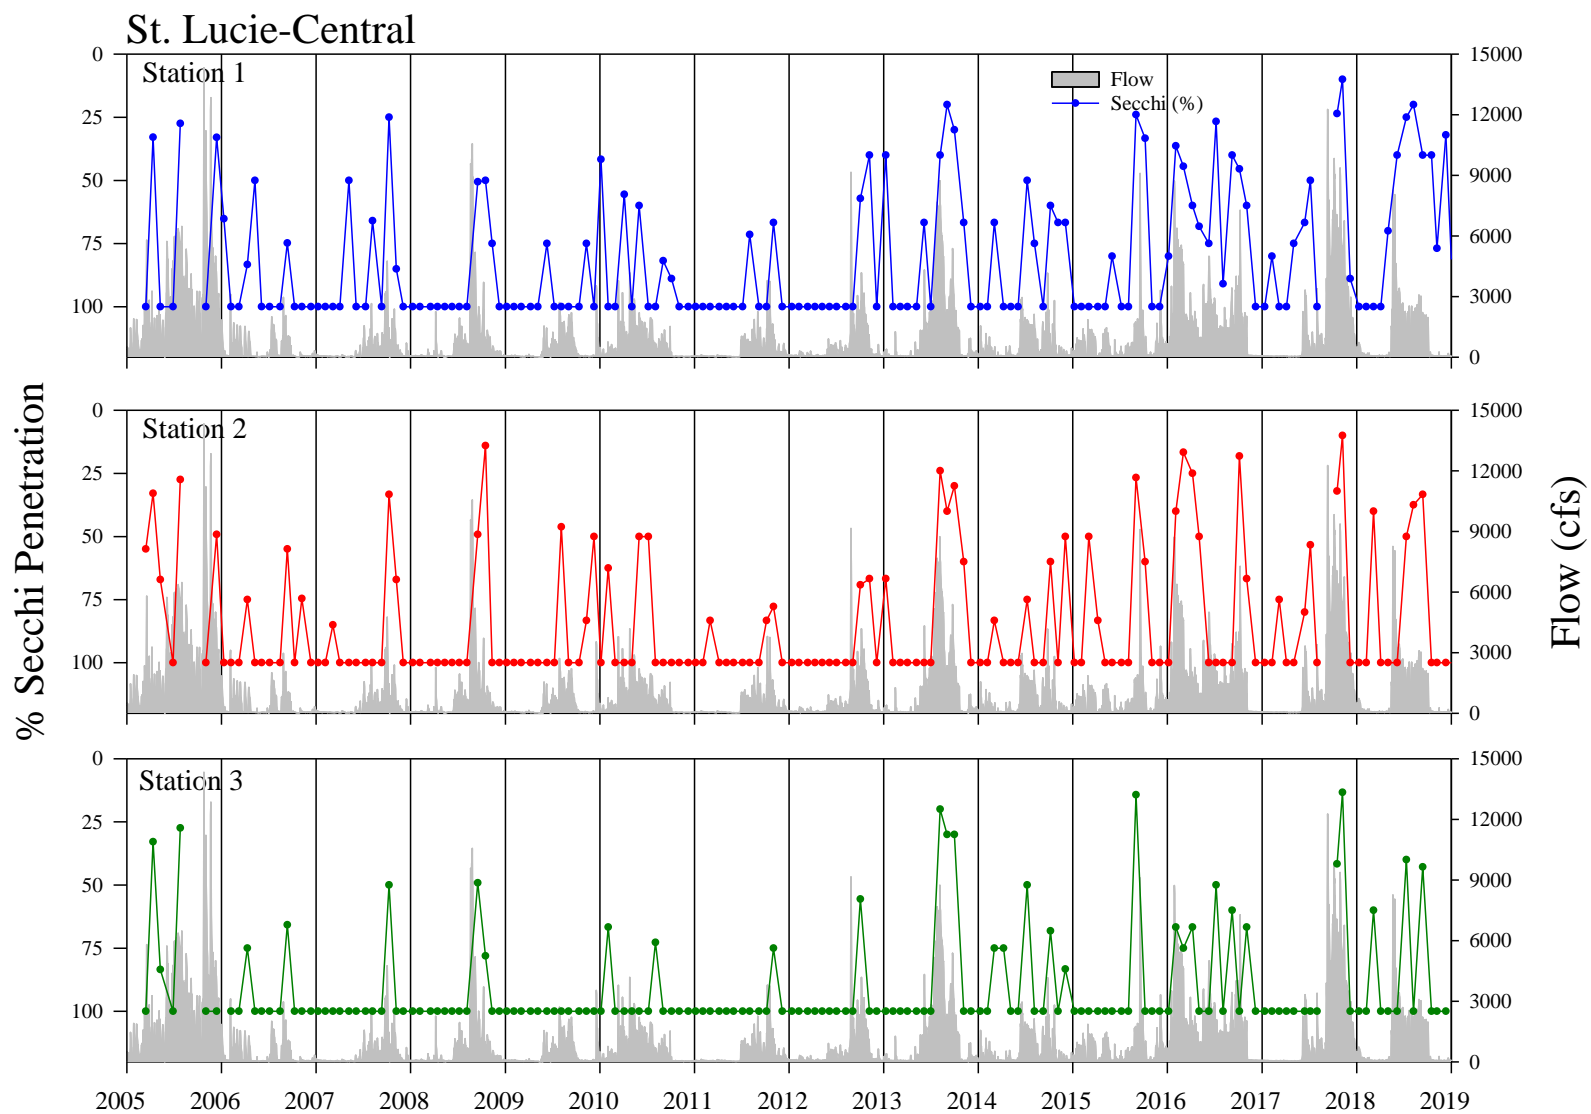
Figure A13. Monthly percent Secchi penetration recorded from 2005 – 2018 at St. Lucie-Central Station 1 (top), Station 2 (middle) and Station 3 (bottom) and the sum of the mean daily flow rate at the S80, S97, S49 and Gordy structures as recorded by the South Florida Water Management District.
