APPENDIX A

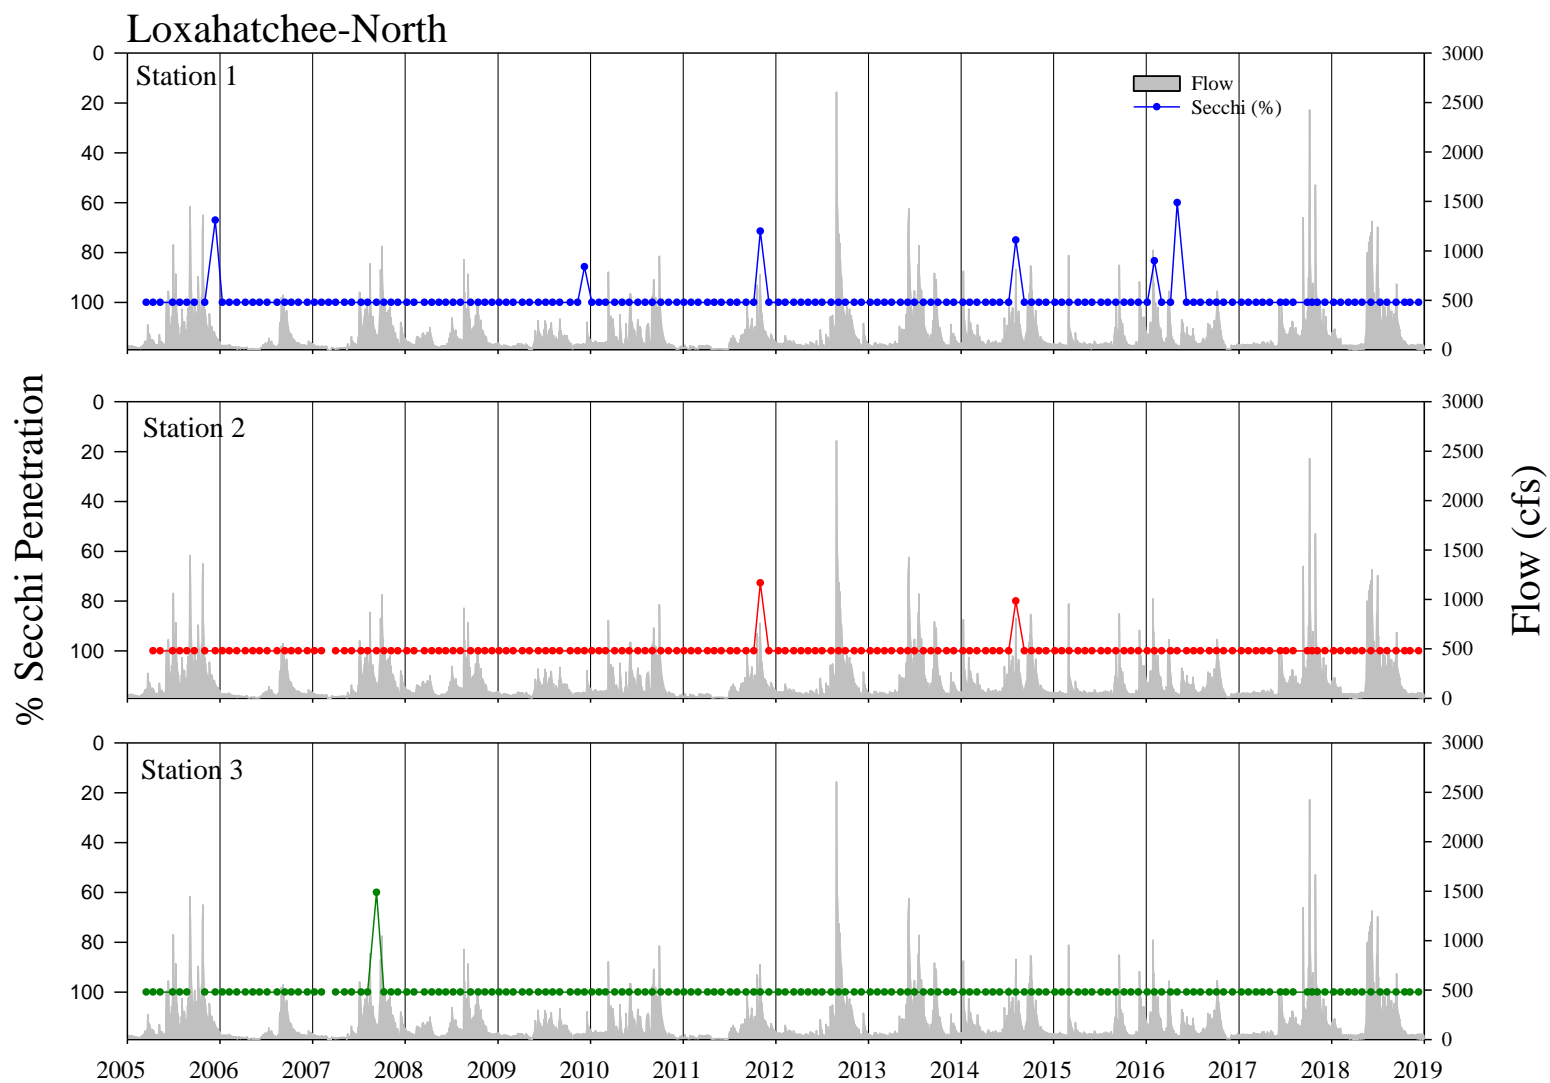
Figure A14. Monthly percent Secchi penetration recorded from 2005 – 2018 at Loxahatchee-North Station 1 (top), Station 2 (middle) and Station 3 (bottom) and the sum of the mean daily flow rate at the Lainhart Dam and S46 structures as recorded by the U.S. Geological Survey and the South Florida Water Management District.

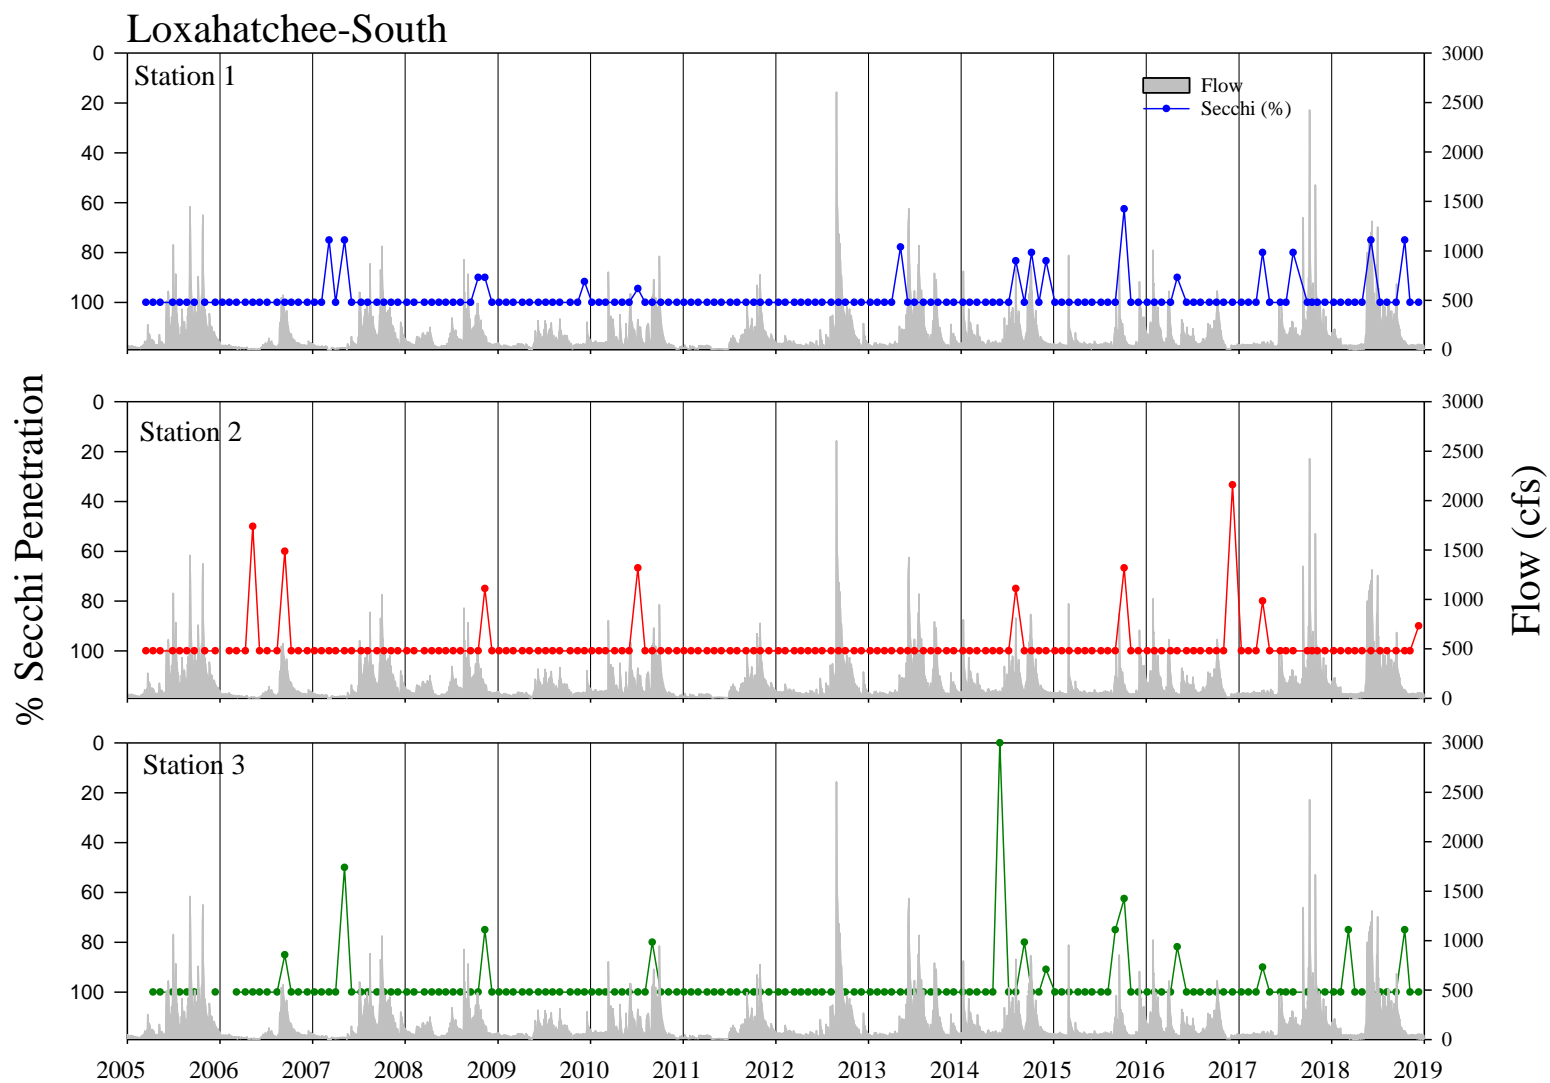
Figure A15. Monthly percent Secchi penetration recorded from 2005 – 2018 at Loxahatchee-South Station 1 (top), Station 2 (middle) and Station 3 (bottom) and the sum of the mean daily flow rate at the Lainhart Dam and S46 structures as recorded by the U.S. Geological Survey and the South Florida Water Management District.
