APPENDIX C

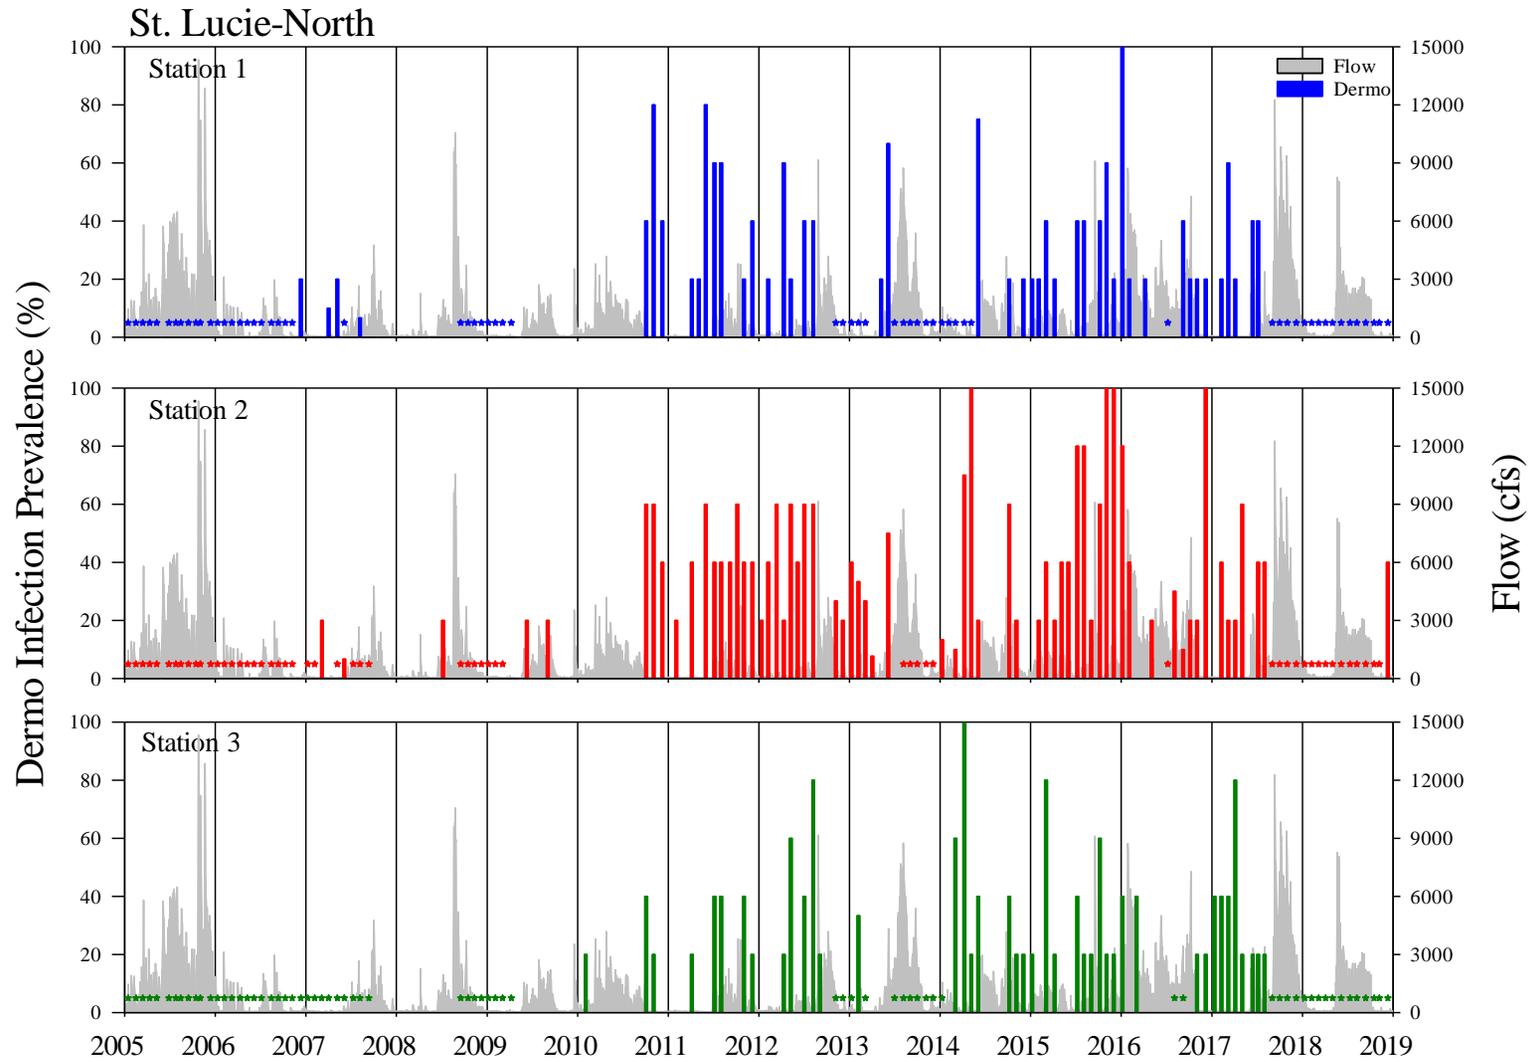
Figure C1. Monthly prevalence (%) of oysters infected with *Perkinsus marinus* at St. Lucie-North Station 1 (top), Station (middle) and Station 3 (bottom) from 2005 – 2018 and the sum of the mean daily flow rate at the S80, S97, S49 and Gordy structures as recorded by the South Florida Water Management District. Asterisks indicate months when live oysters were not available for analysis.

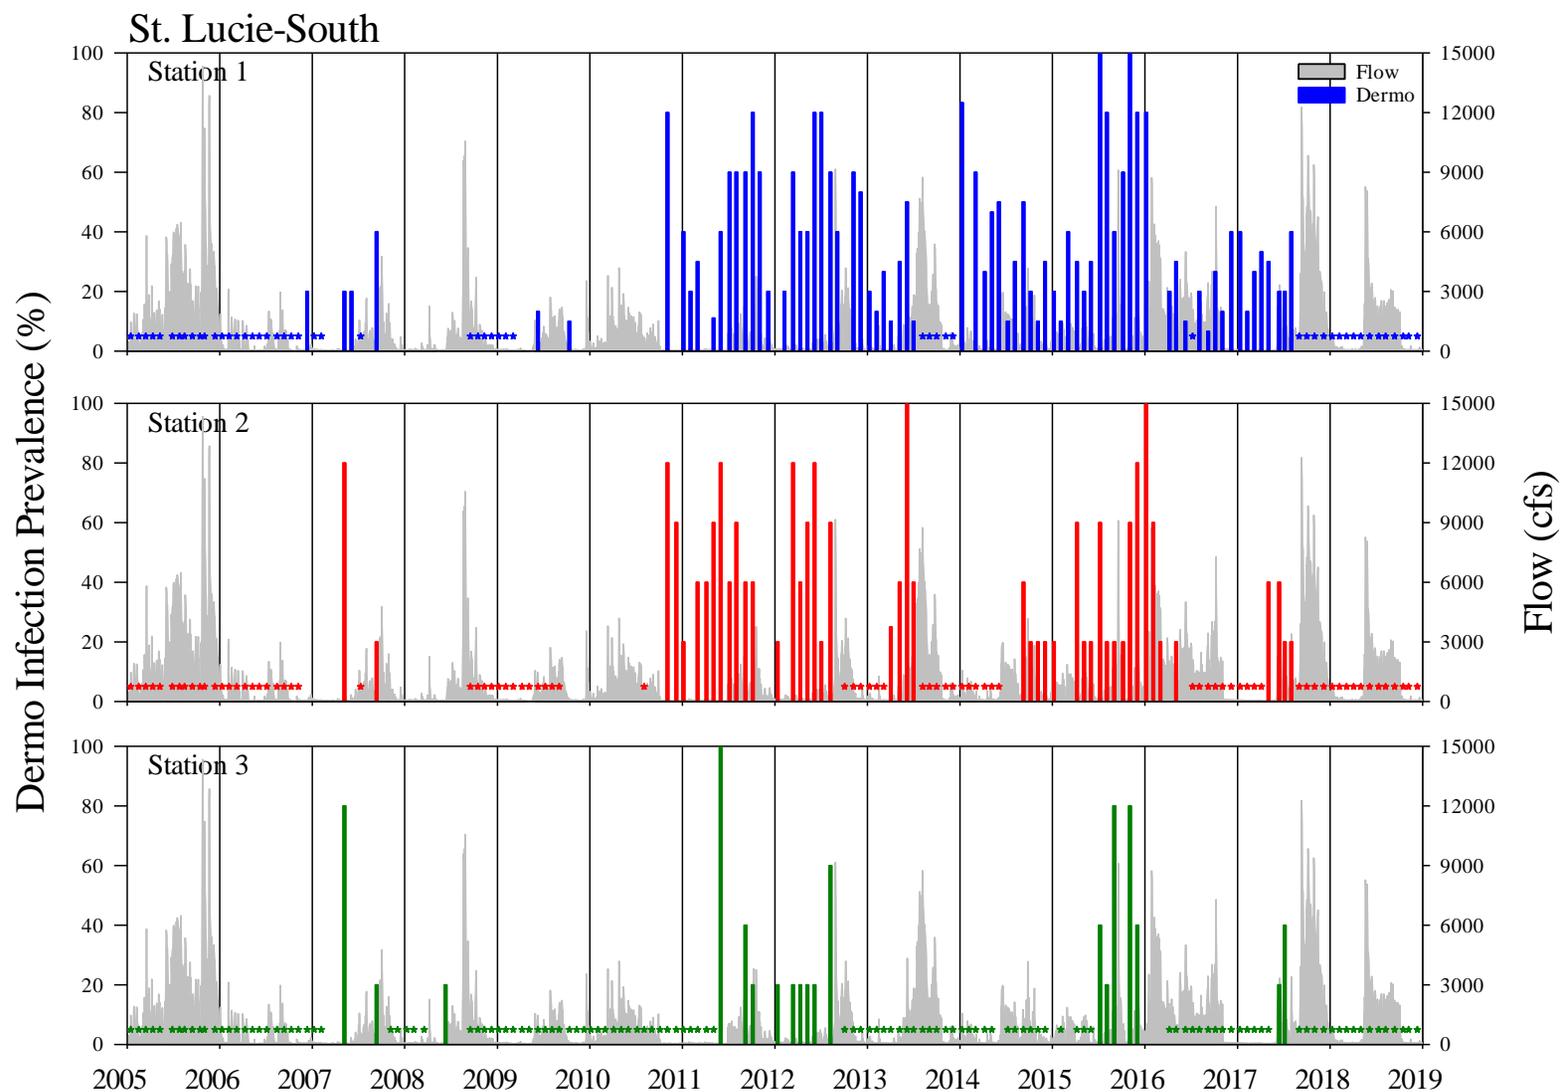
Figure C2. Monthly prevalence (%) of oysters infected with *Perkinsus marinus* at St. Lucie-South Station 1 (top), Station (middle) and Station 3 (bottom) from 2005 – 2018 and the sum of the mean daily flow rate at the S80, S97, S49 and Gordy structures as recorded by the South Florida Water Management District. Asterisks indicate months when live oysters were not available for analysis.

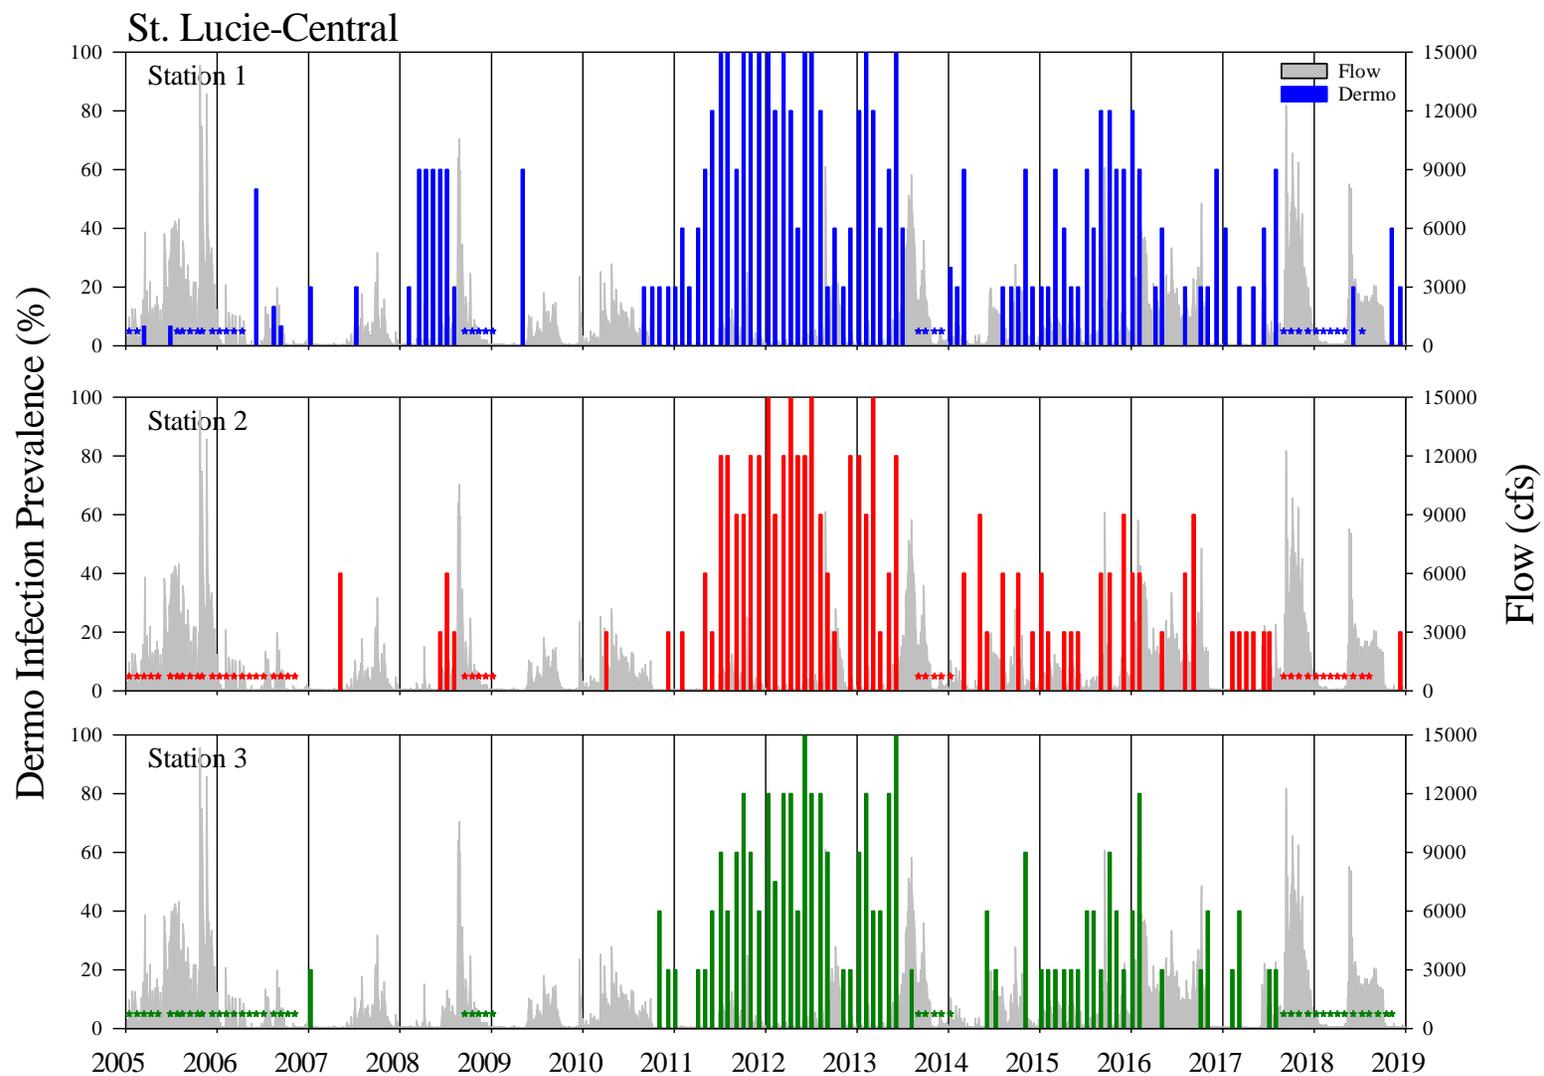
Figure C3. Monthly prevalence (%) of oysters infected with *Perkinsus marinus* at St. Lucie-Central Station 1 (top), Station (middle) and Station 3 (bottom) from 2005 – 2018 and the sum of the mean daily flow rate at the S80, S97, S49 and Gordy structures as recorded by the South Florida Water Management District. Asterisks indicate months when live oysters were not available for analysis.

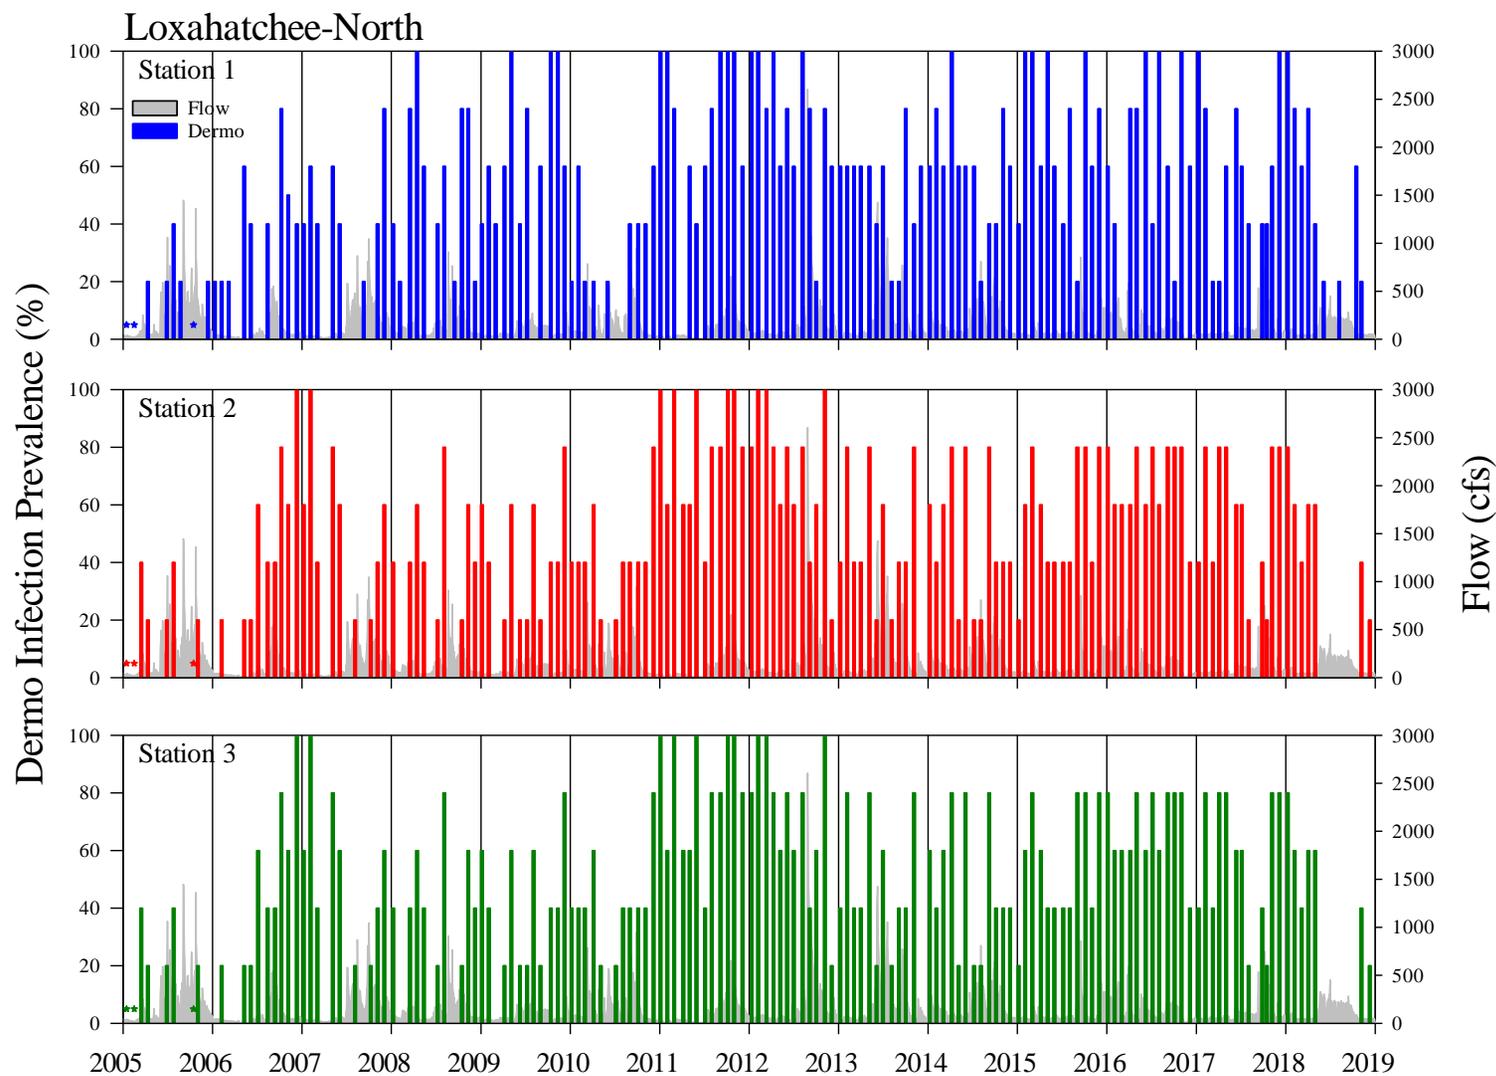
Figure C4. Monthly prevalence (%) of oysters infected with *Perkinsus marinus* at Loxahatchee-North Station 1 (top), Station (middle) and Station 3 (bottom) from 2005 – 2018 and the sum of the mean daily flow rate at the Lainhart Dam and S46 structures as recorded by the U.S. Geological Survey and the South Florida Water Management District.

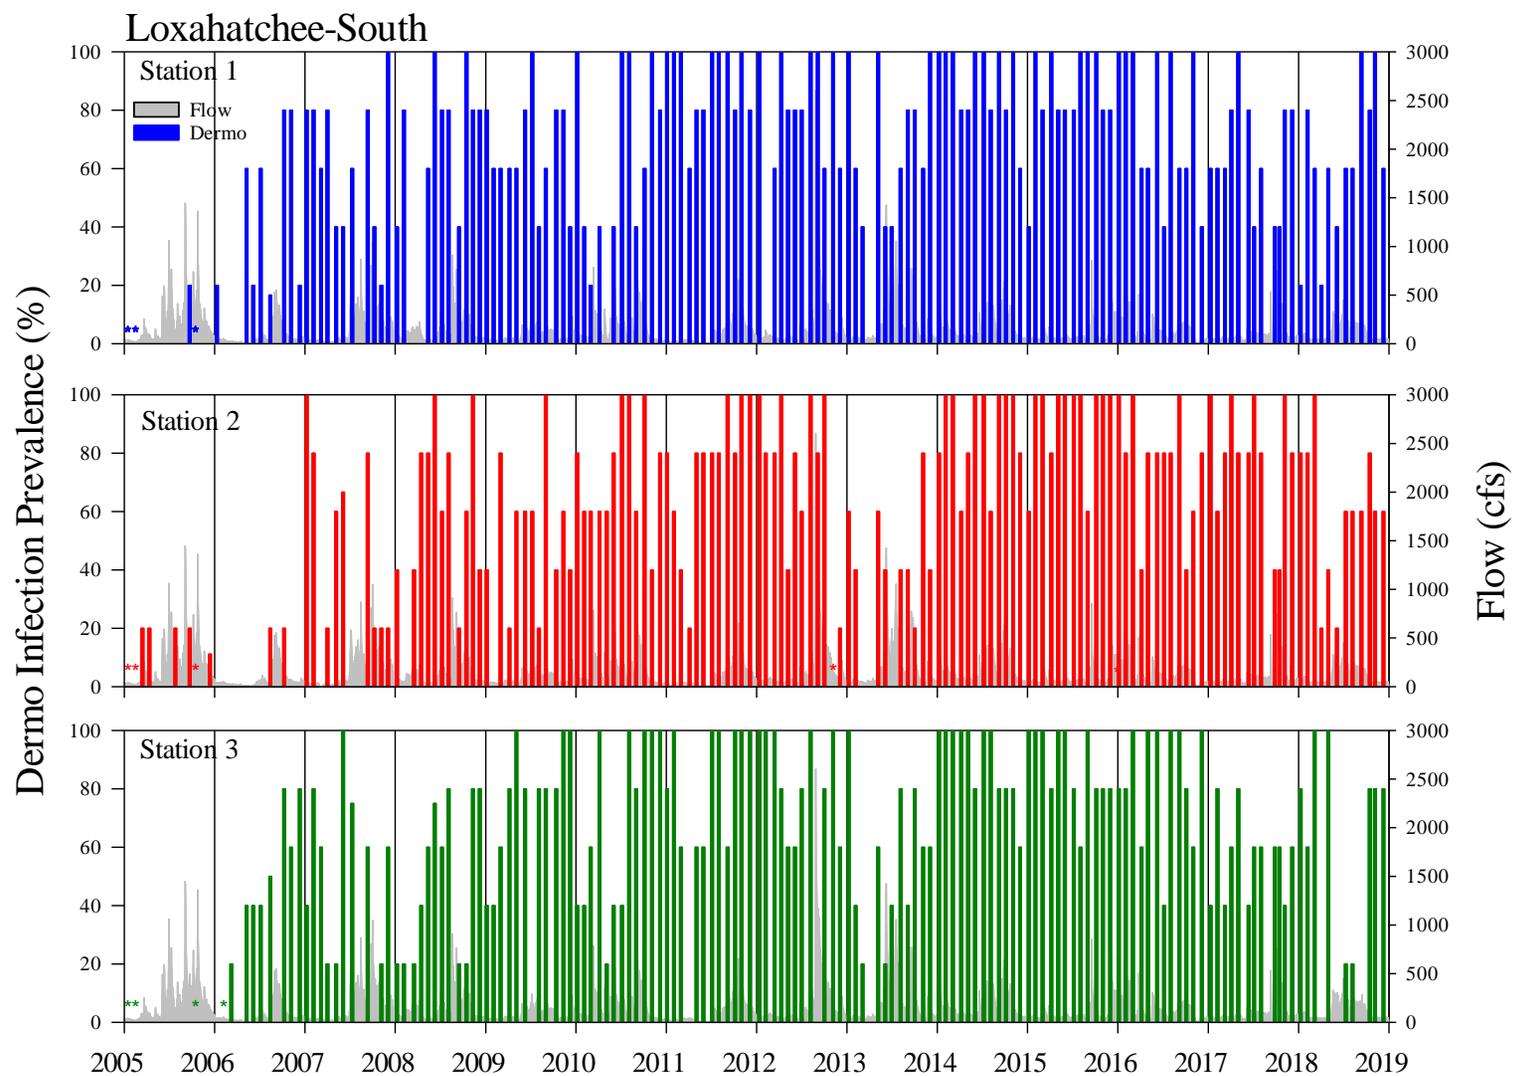
Figure C5. Monthly prevalence (%) of oysters infected with *Perkinsus marinus* at Loxahatchee-South Station 1 (top), Station (middle) and Station 3 (bottom) from 2005 – 2018 and the sum of the mean daily flow rate at the Lainhart Dam and S46 structures as recorded by the U.S. Geological Survey and the South Florida Water Management District.

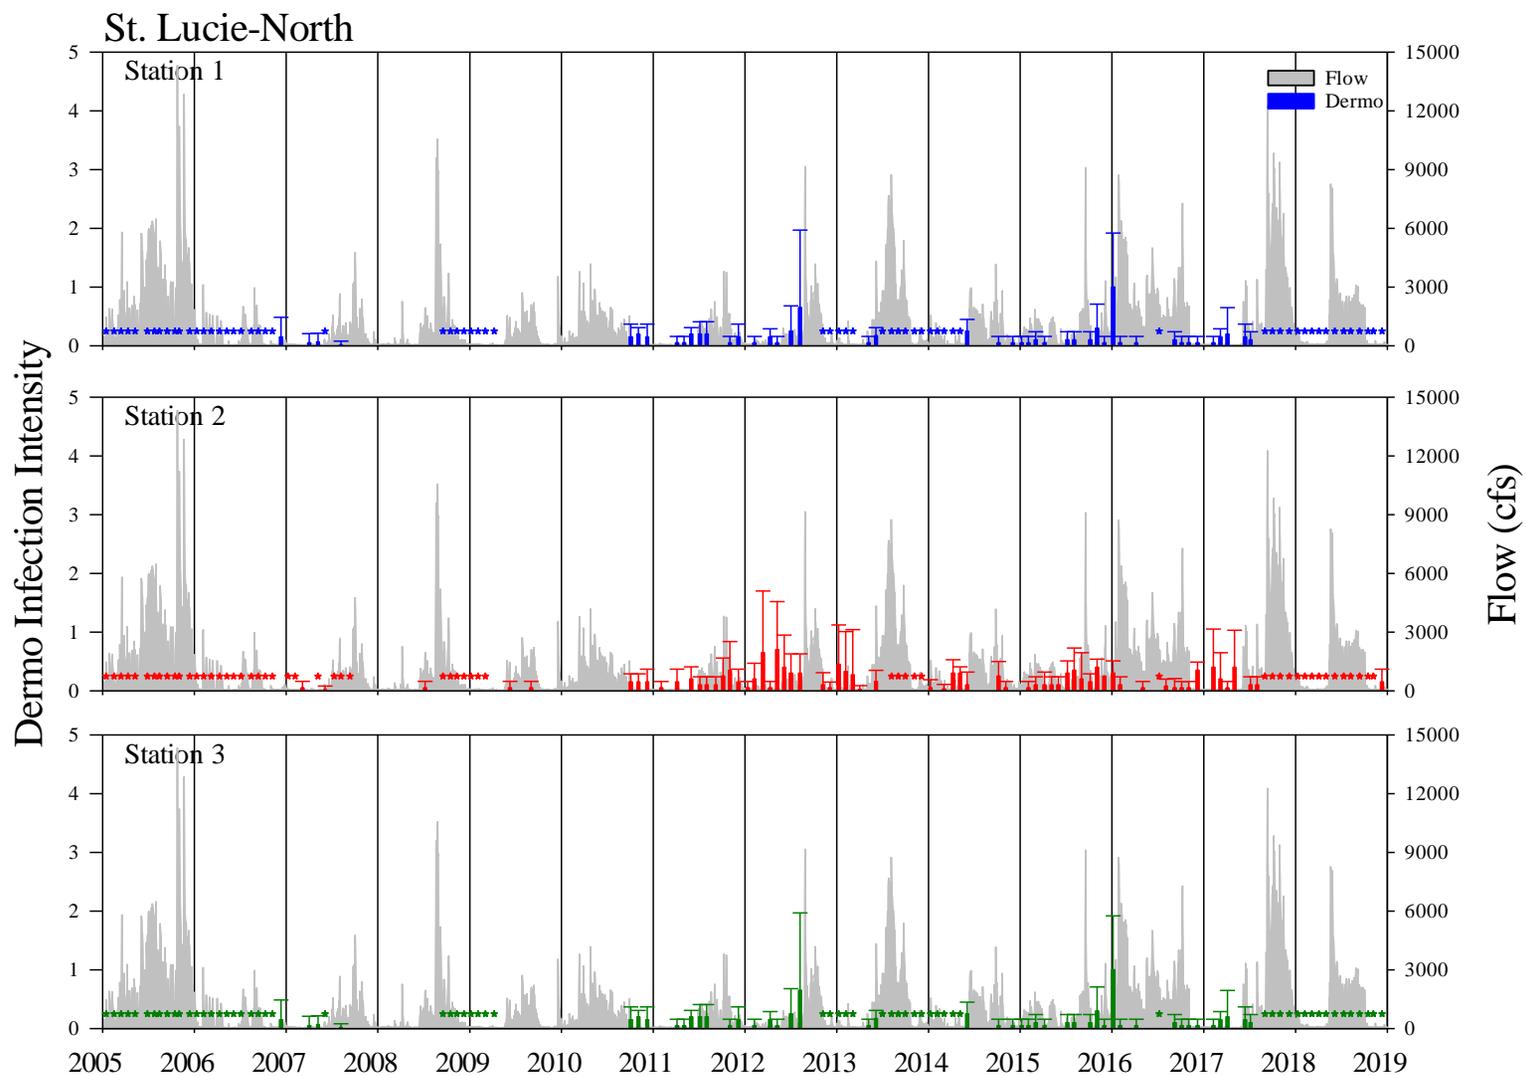
Figure C6. Mean monthly infection intensity (\pm S.D.) of oysters infected with *Perkinsus marinus* at St. Lucie-North Station 1 (top), Station (middle) and Station 3 (bottom) from 2005 – 2018 and the sum of the mean daily flow rate at the S80, S97, S49 and Gordy structures as recorded by the South Florida Water Management District. Asterisks indicate months when live oysters were not available for analysis.

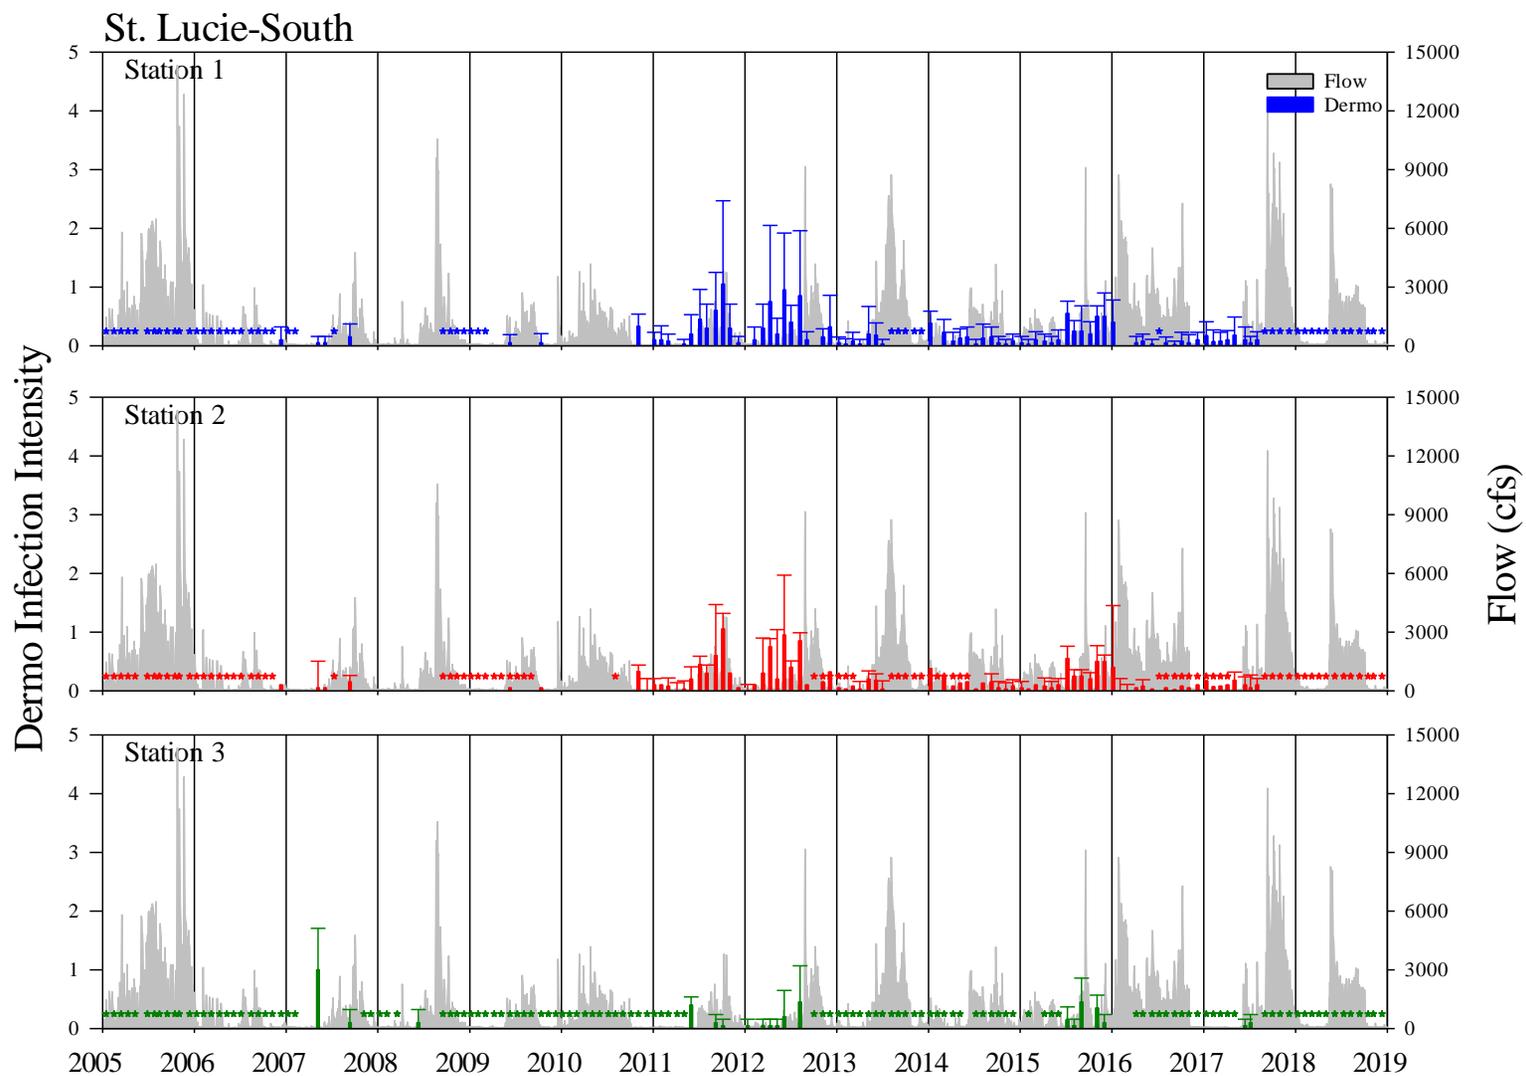
Figure C7. Mean monthly infection intensity (\pm S.D.) of oysters infected with *Perkinsus marinus* at St. Lucie-South Station 1 (top), Station (middle) and Station 3 (bottom) from 2005 – 2018 and the sum of the mean daily flow rate at the S80, S97, S49 and Gordy structures as recorded by the South Florida Water Management District. Asterisks indicate months when live oysters were not available for analysis.

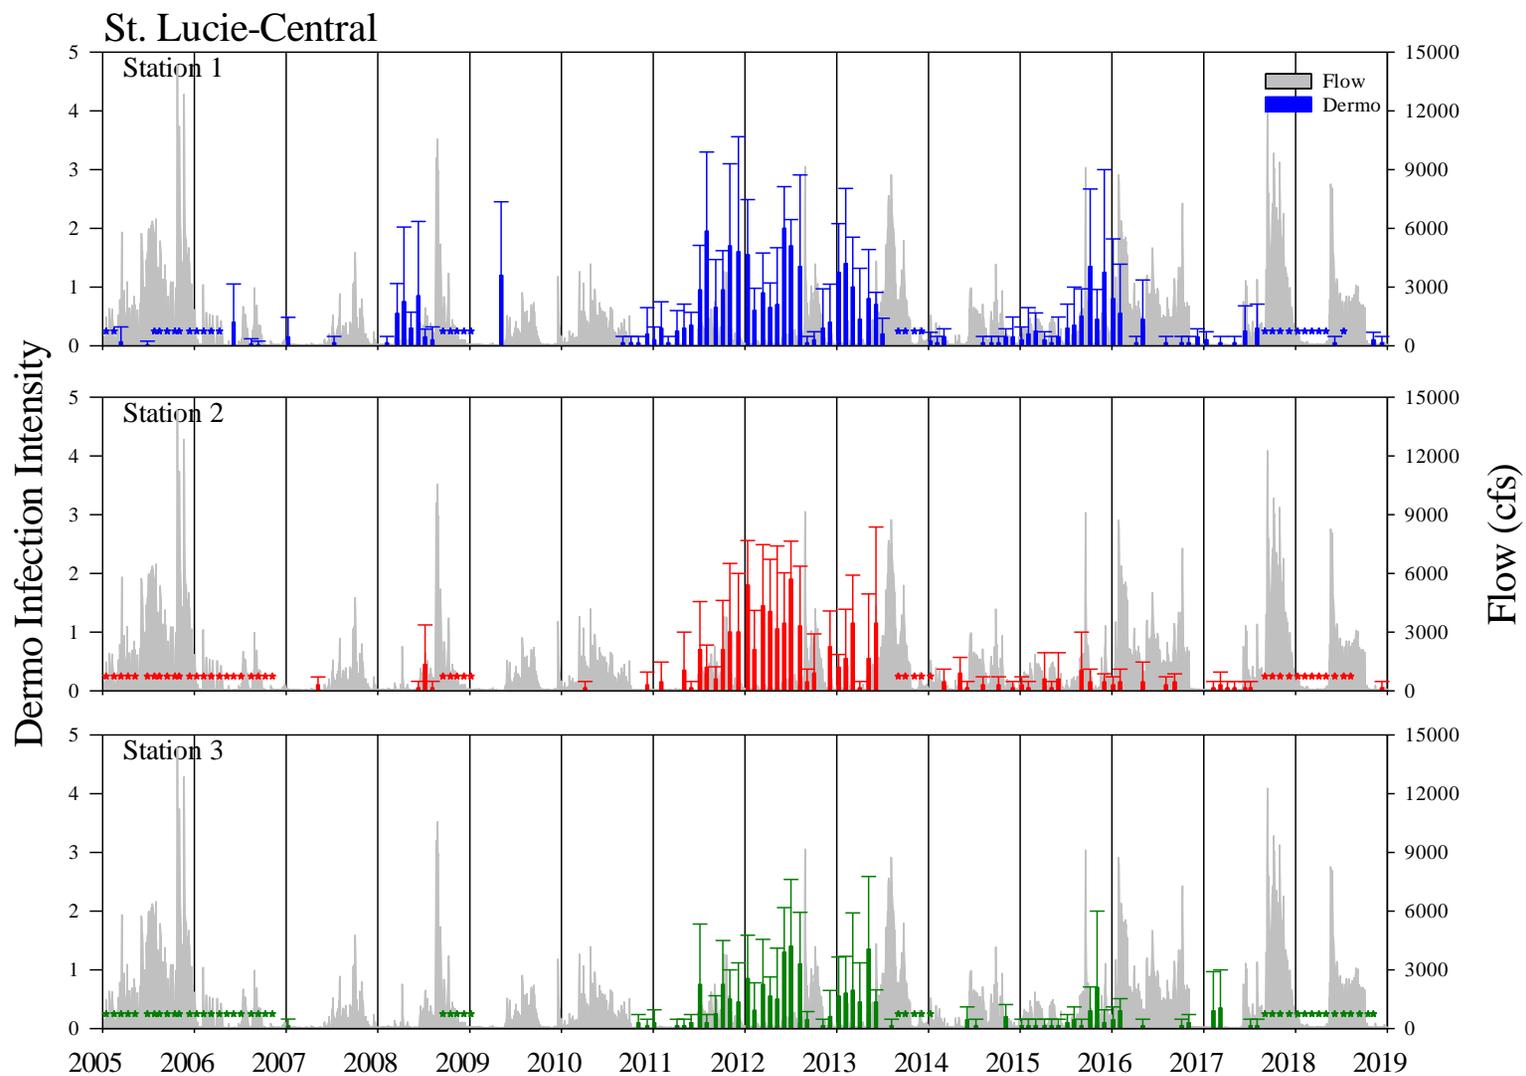
Figure C8. Mean monthly infection intensity (\pm S.D.) of oysters infected with *Perkinsus marinus* at St. Lucie-Central Station 1 (top), Station (middle) and Station 3 (bottom) from 2005 – 2018 and the sum of the mean daily flow rate at the S80, S97, S49 and Gordy structures as recorded by the South Florida Water Management District. Asterisks indicate months when live oysters were not available for analysis.

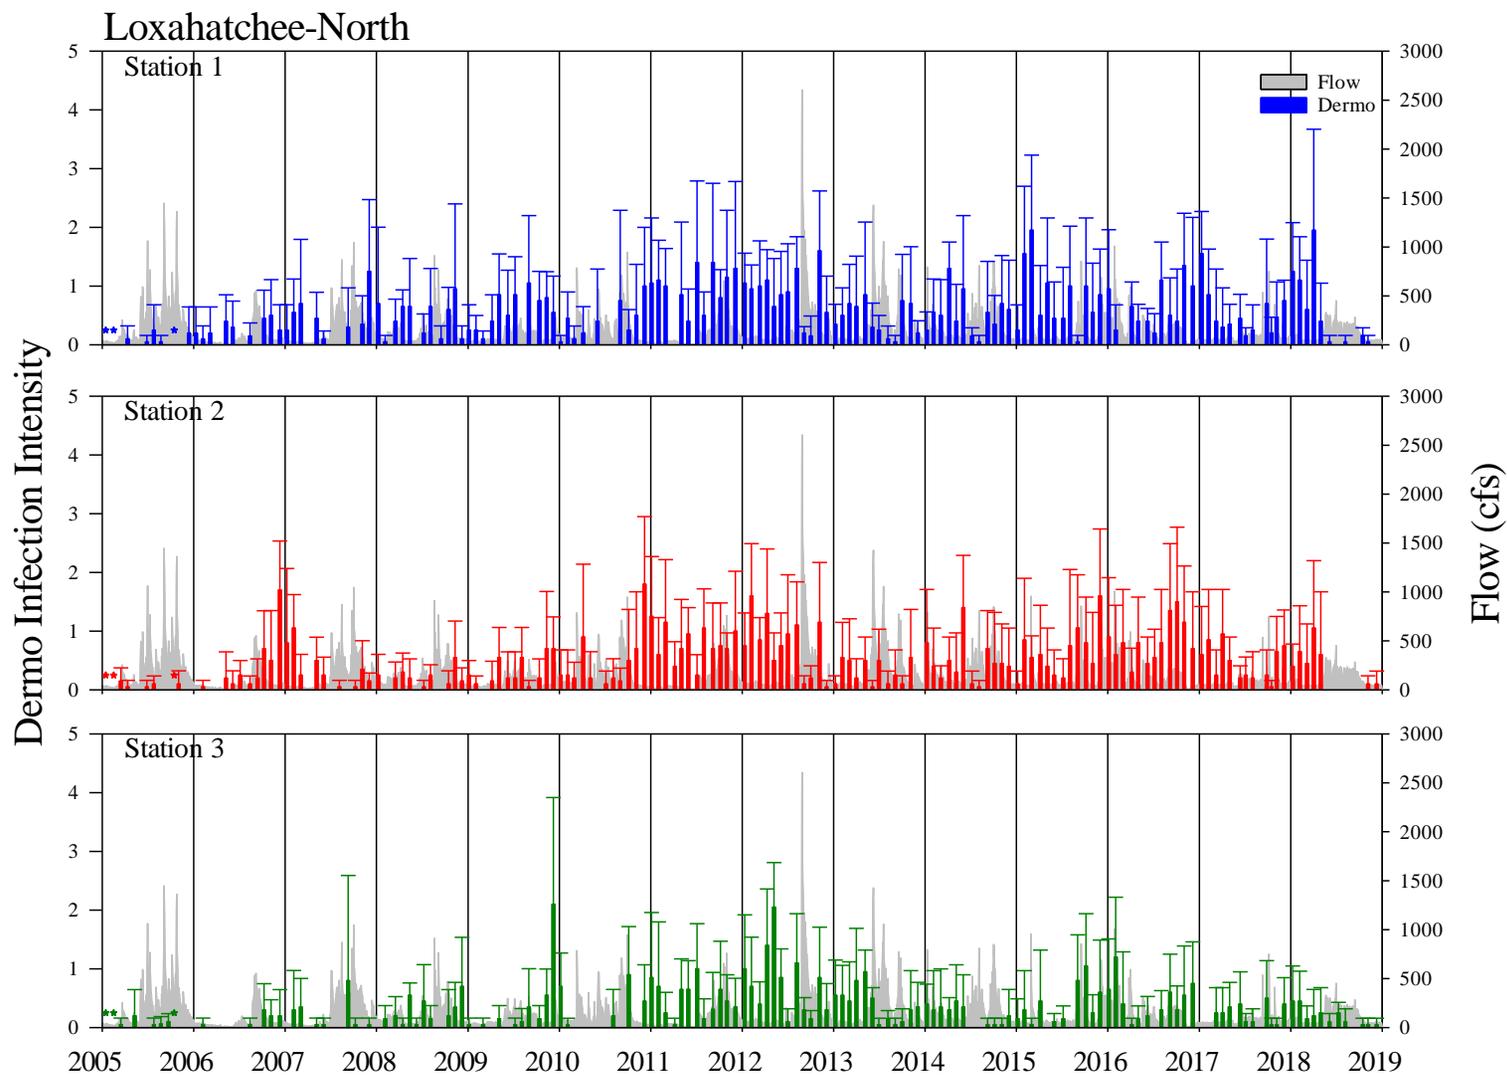
Figure C9. Mean monthly infection intensity (\pm S.D.) of oysters infected with *Perkinsus marinus* at Loxahatchee-North Station 1 (top), Station (middle) and Station 3 (bottom) from 2005 – 2018 and the sum of the mean daily flow rate at the Lainhart Dam and S46 structures as recorded by the U.S. Geological Survey and the South Florida Water Management District.

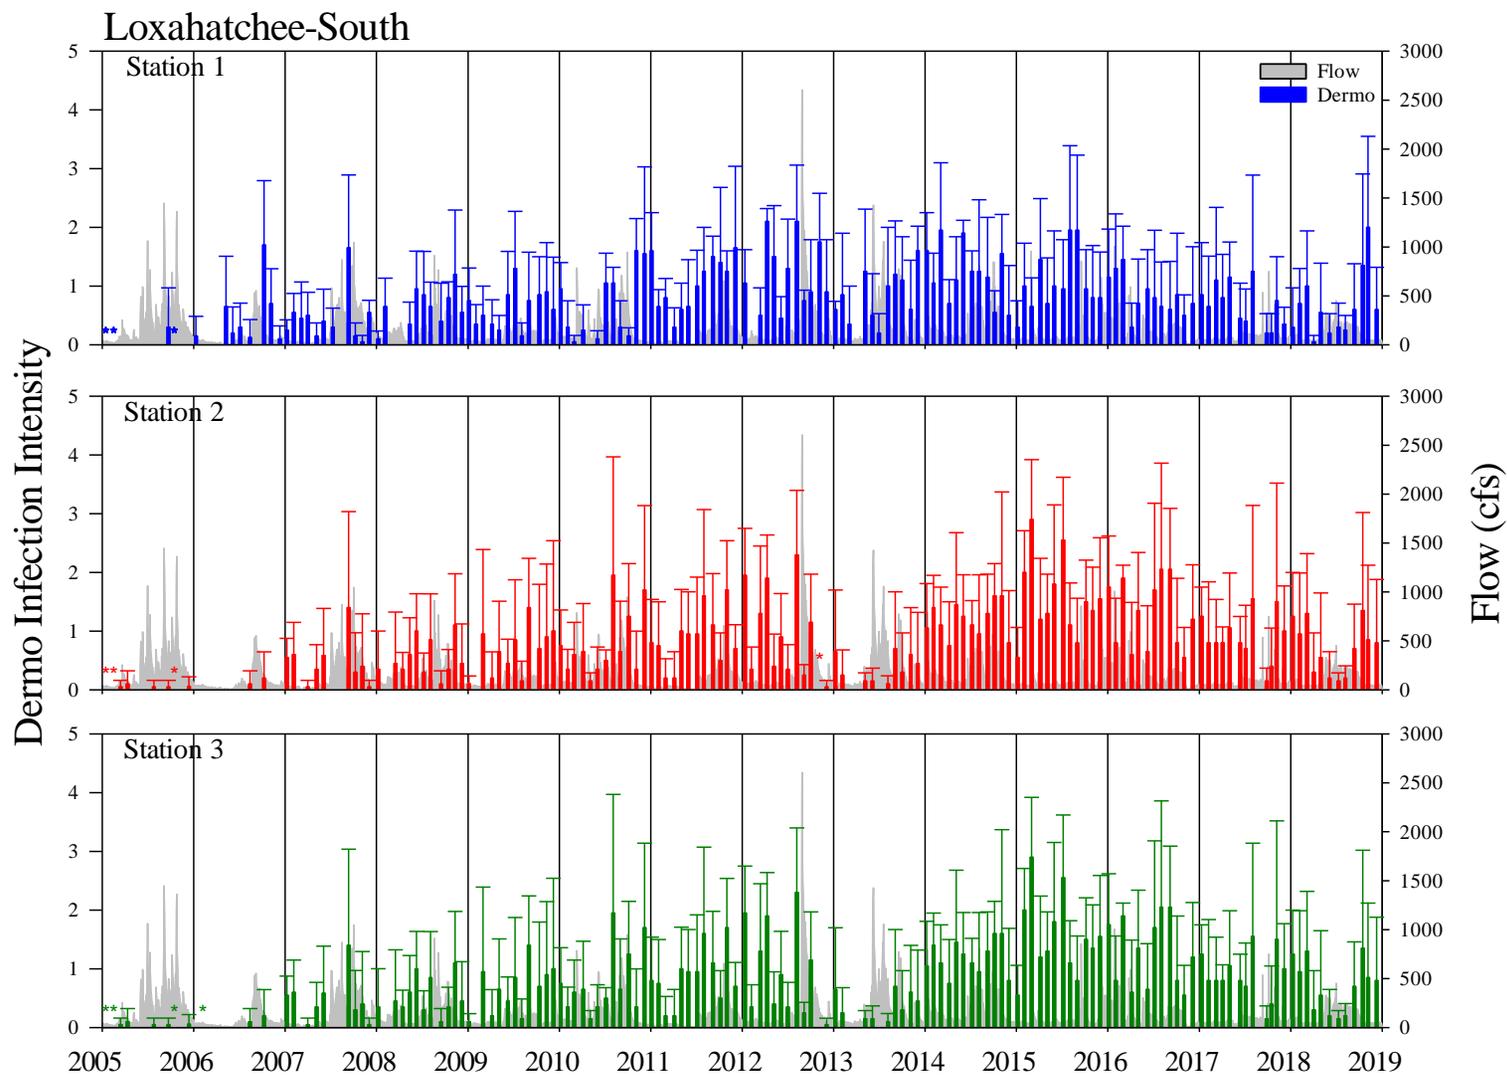
Figure C10. Mean monthly infection intensity (\pm S.D.) of oysters infected with *Perkinsus marinus* at Loxahatchee-South Station 1 (top), Station (middle) and Station 3 (bottom) from 2005 – 2018 and the sum of the mean daily flow rate at the Lainhart Dam and S46 structures as recorded by the U.S. Geological Survey and the South Florida Water Management District.
